AVIATION INVESTIGATION REPORT

A00P0040

FAN COWL SEPARATION

AIRBUS A330-200 C-GGWA

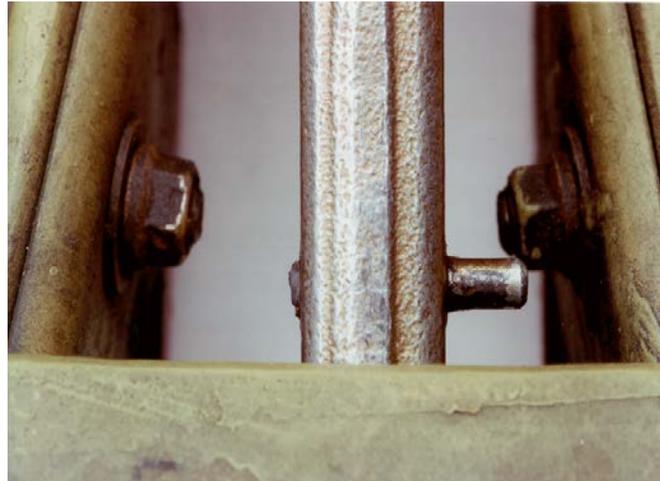
The fan cowl latch mechanism on the occurrence aircraft employs a latch fitting constructed of two sub-assemblies that are joined using four hex bolts, flat washers, and nuts. Examination of the latch mechanisms indicated that the latch fitting sub-assemblies had been assembled with the bolt threads, washers, and nuts inside the sub-assembly. Further examination revealed that interference between the trigger/safety pins and the nuts / threaded end of the bolts appeared to

be the cause of several bent and one broken trigger/safety pins (Figure 1). With the bolts installed in this fashion, the combined washer and nut thickness is almost double that of the bolt head alone.

1. ensure that all Canadian-registered aircraft fitted with fan cowl latch fitting sub-assemblies have the fastener bolts correctly installed;
2. advise Canadian air carriers of the increased safety that is attained by making latch handles more conspicuous;

1. issued a service bulletin (CF6-80E1-NAC-71-032) on 01 January 2001 covering the correction to the direction of latch fitting sub-assembly bolts;
2. will add a warning to the applicable maintenance manuals regarding potential damage to the latching systems from unauthorized use of tools to operate the latches; and

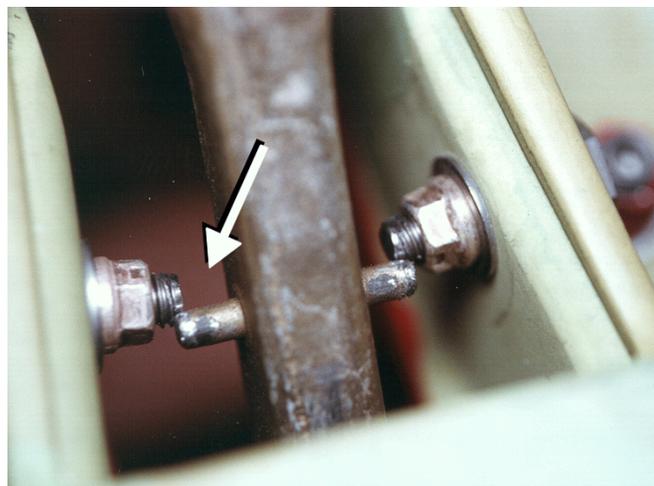
Indications of interaction between the trigger/safety pins and the fitting sub-assembly fasteners were also observed on a comparison aircraft, as shown by damage to the ends of the pins, grooves in the innermost end of the nuts, and thread imprints in the trigger/safety pins (Figure 2).

1. There is no cockpit indication to notify the crew whether fan cowls are closed and secured.
2. Interaction between the trigger/safety pins and the fitting sub-assembly fasteners can damage the ends of the pins and thereby increase the risk of component failure.

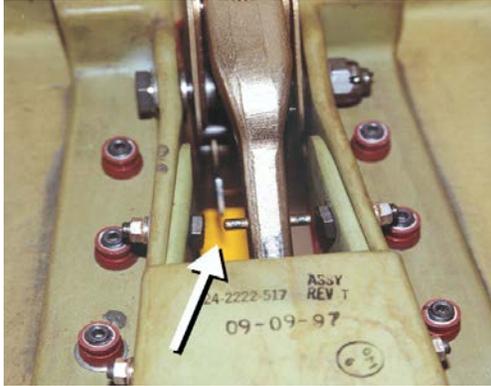
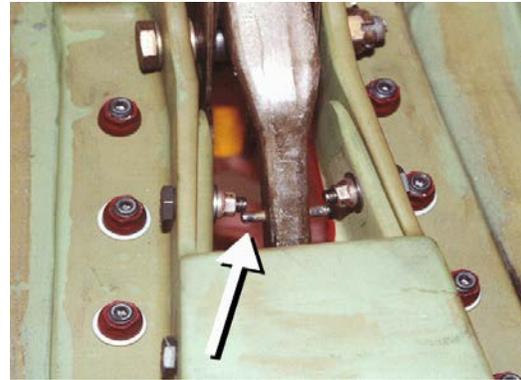
Investigators observed that the latch fitting sub-assembly bolts on the fan cowls of one engine of a similarly equipped Airbus A330 were oriented with the threaded portion facing outward (Figure 3) while those on the other engine fan cowls were oriented inward (Figure 4). Also, the bolts used in the comparison aircraft's sub-assembly were noticeably longer than those that had been used on the occurrence aircraft. The increased length exacerbated interference between the assembly bolts and the trigger/safety pins. Discussion with a representative of the manufacturer revealed that the original latch fitting sub-assembly drawing showed the fasteners installed with the threaded end of the bolts facing inward (Figure 4).

3. Orientation of latch fitting sub-assembly bolts with the threads inward and use of longer-than-required bolts exacerbates any interference between the assembly bolts and the trigger/safety pins.

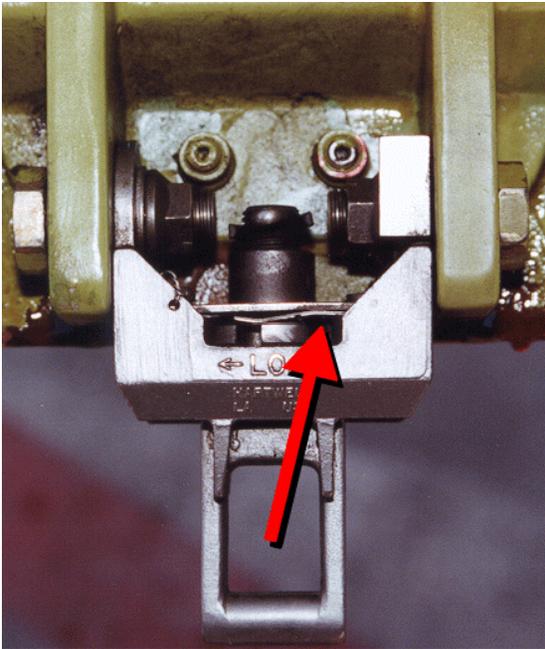
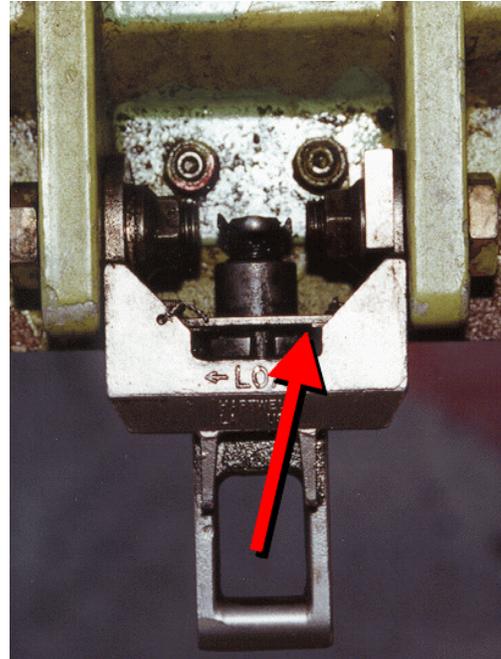
Engine fan cowl latch tension is adjusted through the use of a radially slotted adjustment star in the keeper mounting assembly. The position of the star is retained by a top and a bottom spring (adjustment star retention springs) in each assembly (Figure 5). These springs engage the corresponding top and bottom slot of the adjustment star.

No specific damage was noted to the adjustment star retention springs of the occurrence aircraft. However, based on a brief survey of comparison aircraft that used similar components, several keeper mounting assemblies were observed, in service, with broken adjustment star retention springs. (See Figure 6 as one example.) In some of these cases, the top and the bottom springs on the same eye-bolt had failed, and there were two cases where more than one adjustment assembly was affected on the same cowl. A specific inspection procedure for the eye-bolt adjustment retention springs could not be found.

4. Failure of adjustment star retention springs increases the risk that the engine fan cowl latch tension will move out of adjustment.
5. By design, the height of the latches and their position at the bottom centreline of the fan cowls makes it difficult to visually detect an unlatched latch.

3. advise or issue a warning to Canadian air carriers regarding the dangers of using tools to operate latches not designed for tool use;
4. advise Canadian air carriers of the TSB's survey results regarding eye-bolt adjustment retention spring failures and take appropriate action to correct the deficiency;
