AVIATION INVESTIGATION REPORT

A00P0090

LOSS OF SEPARATION

VANCOUVER AREA CONTROL CENTRE—WEST SECTOR

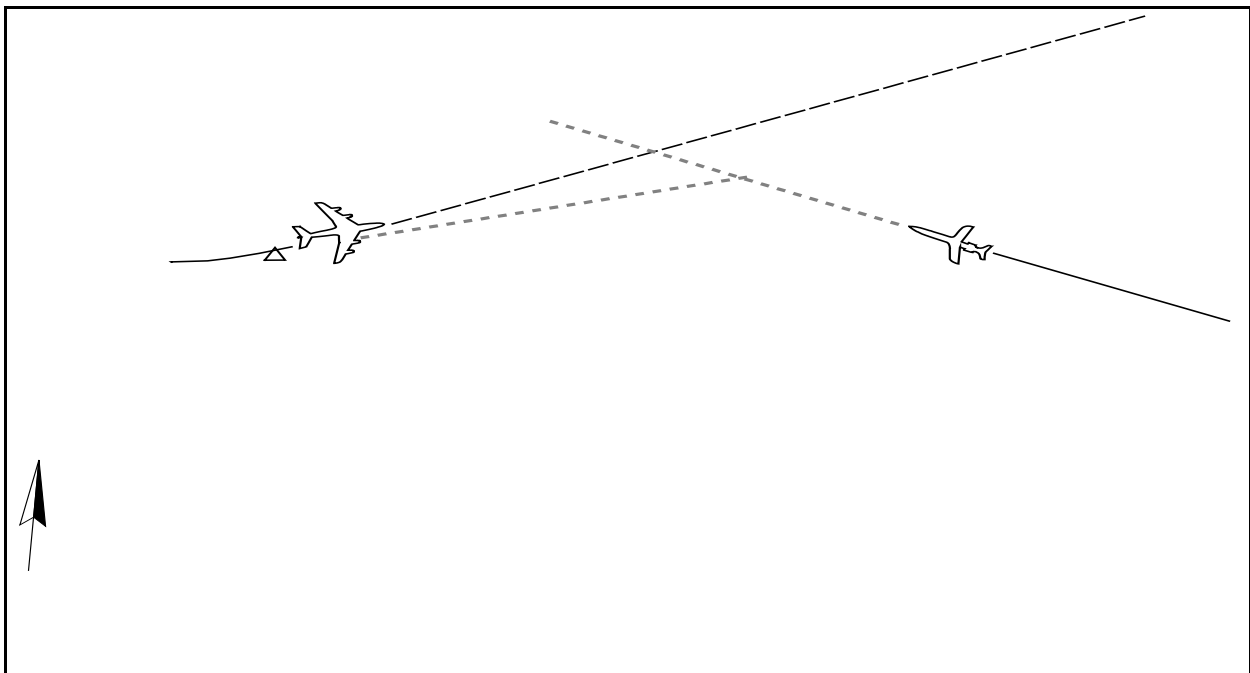
At 0940:00, CDN4 was cleared to descend from flight level (FL) 350 to 17 000 feet; the crew reported leaving FL350 at 0941:35. The descent clearance made no reference to ASA131. At 0942:27, CDN4 was near the INHAM intersection, in a descending left turn to intercept the CASDY ONE arrival track, when the crew sighted ASA131. (See Figure 1.) Shortly thereafter, the crew of CDN4 received a traffic alert and collision-avoidance system (TCAS) traffic advisory (TA), followed by a TCAS resolution advisory (RA) to climb. Because the intruder aircraft was in sight and there was no chance of collision, the captain of CDN4 chose not to comply with the TCAS RA and continued to descend. This decision is in accordance with the *Canadian Airlines Flight Operations Manual*. CDN4 then initiated contact with the west sector controller to advise him of the situation. At approximately the same time, the crew of ASA131 received a TCAS TA, visually confirmed that the descending Boeing 747 would cross behind their aircraft, and took no further action. Radar data indicate that, at 0943:20, CDN4 passed approximately 1 nautical mile behind and 700 feet above ASA131.
