**AVIATION INVESTIGATION REPORT
A01P0003**

LOSS OF MAIN ROTOR DRIVE

**HAYES HELI-LOG SERVICES LTD.
SIKORSKY S-61N (SHORTSKY) HELICOPTER C-FHFS
PORTEAU COVE, BRITISH COLUMBIA
15 JANUARY 2001**

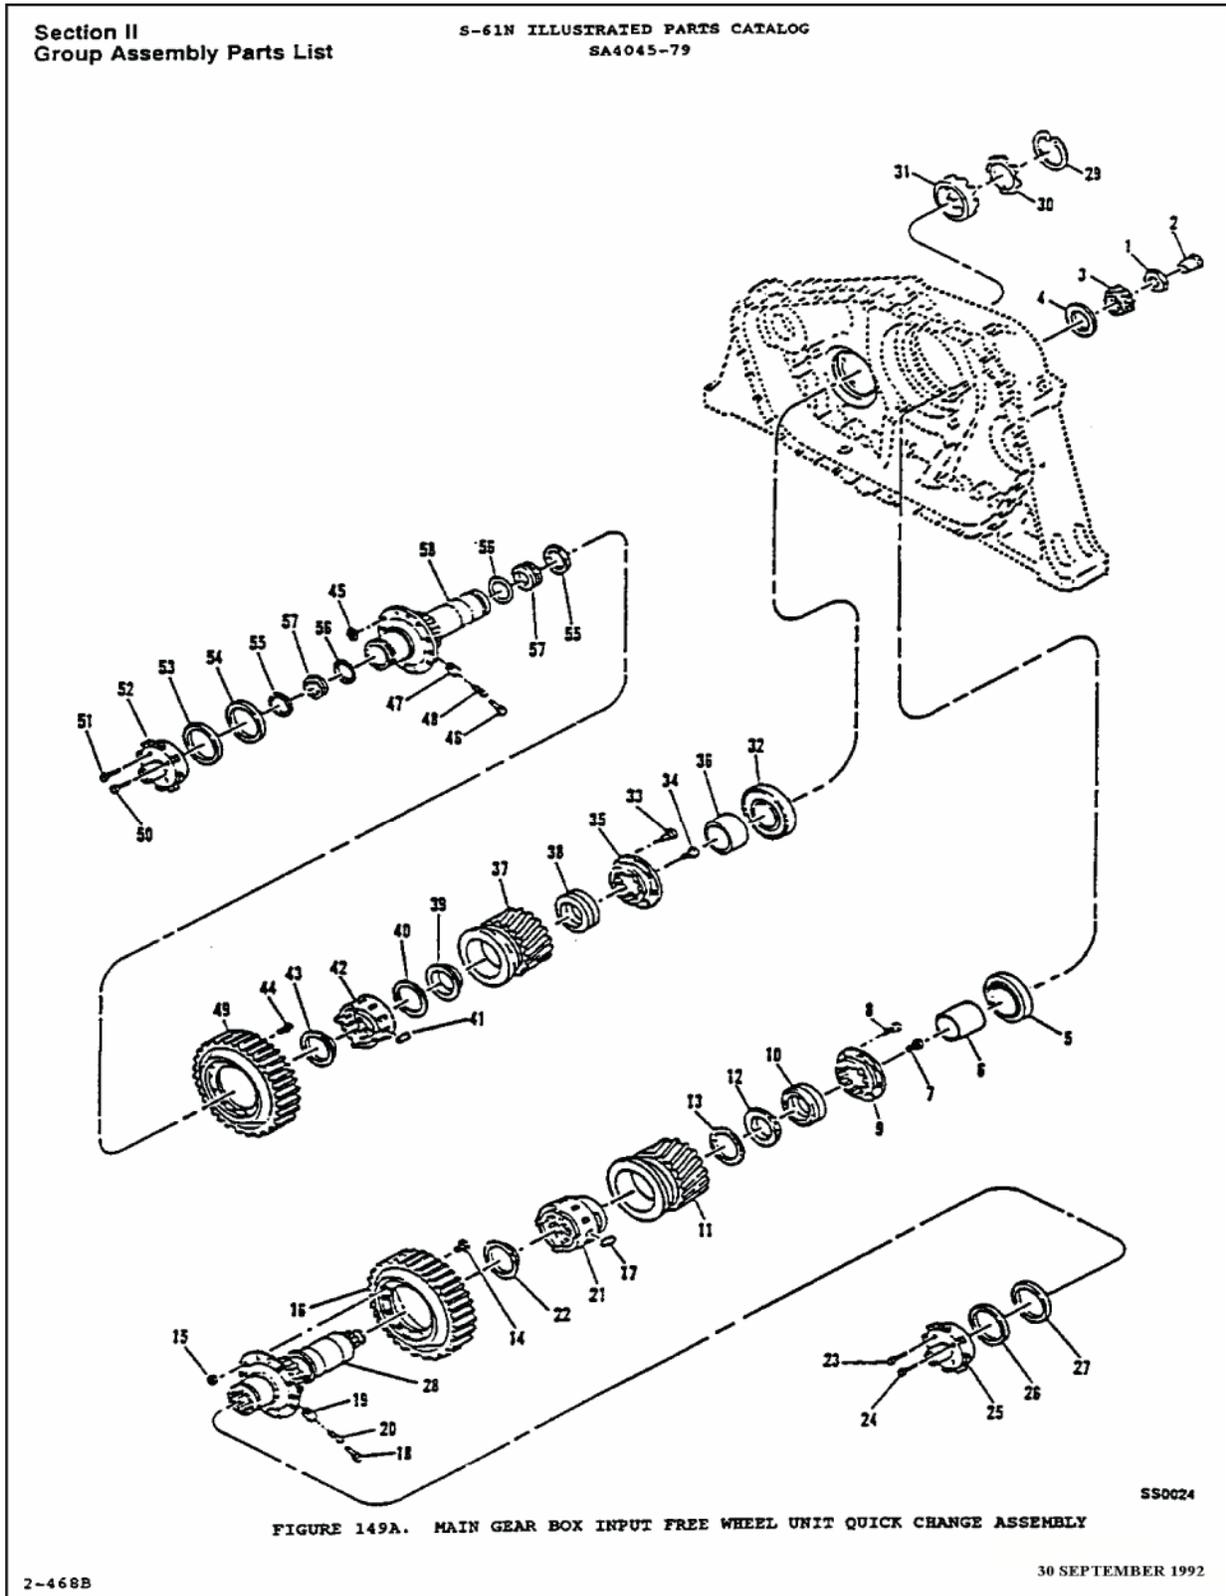
Appendix A1 – Input Freewheel Unit Assemblies

The main-rotor transmission, which had accumulated approximately 710 hours since its last overhaul, was also subjected to a post-accident teardown inspection, conducted at an approved Sikorsky main transmission overhaul facility in Richmond, British Columbia, under the supervision of TSB investigators. Initial disassembly of the front section revealed extensive wear and damage to both input freewheel units (IFWUs) (see Appendices A1 and A2).

The IFWUs had been replaced, as a matter of practice, about 500 hours after the last main-transmission overhaul. The IFWUs that were removed demonstrated normal wear. The replacement IFWU (part number 61047-35000-060) had accumulated approximately 210 hours of flight time and about 70 engagements since installation. They were made up of new cams and rollers. During routine maintenance before the accident, there was no significant metal found in the main-rotor transmission oil filters. Also, no illuminated chip lights were reported. After the accident, during a teardown inspection of the main-rotor transmission, metal particles were found in the transmission, but chip sensors were not activated. A more detailed inspection of the metal found in the transmission oil filters revealed numerous flakes of bronze, some flattened. The bronze Oilite bushings (part number S6135-20459-101), on which the roller retainer sits, showed damage consistent with that found when they are comprised of material that cannot withstand the normal forces, or that have been exposed to an abnormally high level of vibrations. Other components of the IFWUs showed the following signs of instability, slippage, and skidding:

- The camshaft flats were dented by the rollers.
- The rollers had flat spots and were contaminated with bronze.
- The input gear housing was contaminated with bronze, and the inner surfaces were heavily damaged by slipping and skidding of the rollers.
