AVIATION INVESTIGATION REPORT

A03O0088

STALL/SPIN AND COLLISION WITH TERRAIN

FBA-2C1 BUSH HAWK C-GTUP

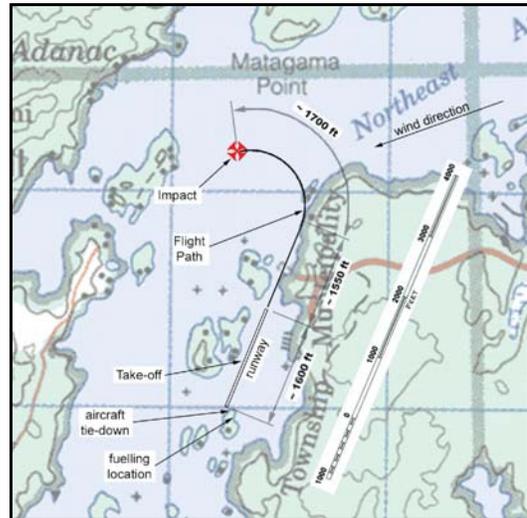
Figure 1. Accident Site

The flight path of the aircraft is presented at Figure 1. The runway and initial climb path were sheltered by trees on the right. As the aircraft emerged above the height of the trees during the climb, it was increasingly exposed to the wind from the northeast. When the aircraft turned to the left, the wind changed from a quartering head-wind to a tail-wind. The Transport Canada Flight Instructor Guide⁴ describes a number of illusions that can be created by drift of an aircraft in low-level flight. Specifically, a turn from headwind to downwind produces an illusion of a slip inwards followed by an illusion of increased airspeed.
