AVIATION INVESTIGATION REPORT

A04W0200

NAVIGATION DEVIATION

GOVERNMENT OF CANADA
DEPARTMENT OF TRANSPORT
BEECH KING AIR C90A C-FGXH
EDMONTON, ALBERTA
10 SEPTEMBER 2004

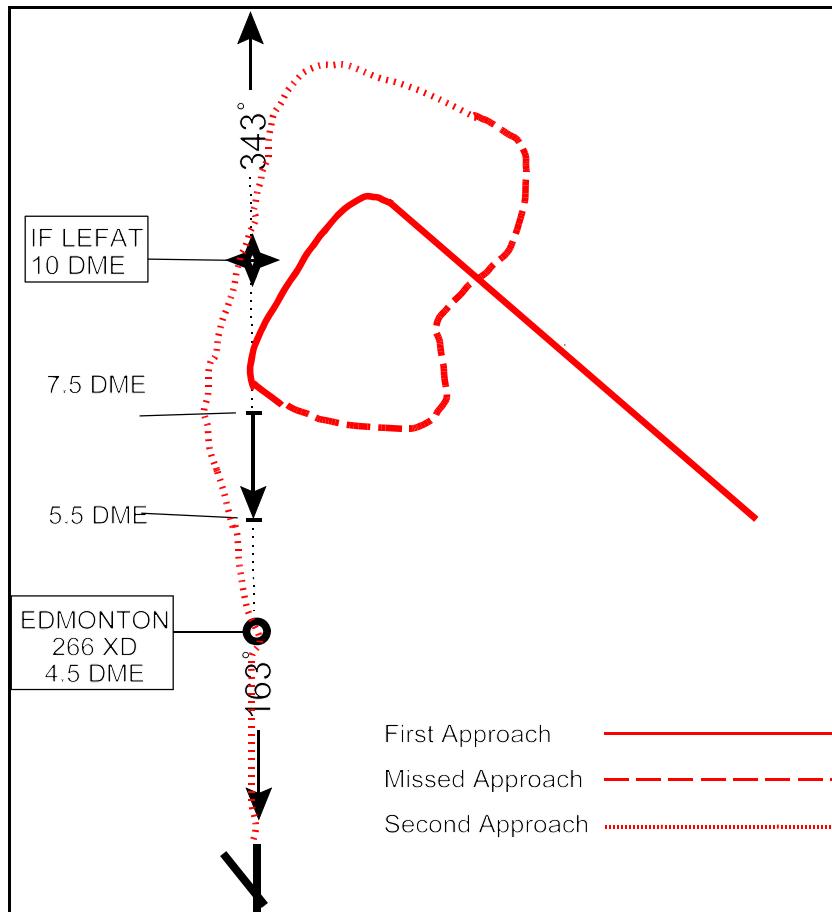
Figure 1. Plan view of approaches at CYXD

Prior to descent, the crew briefed the expected LOC(BC)/DME RWY 16 instrument approach to CYXD. When the aircraft was 2.5 nautical miles (nm) from intercepting the localizer, the Edmonton terminal arrival controller vectored the flight to intercept the approach inbound course at the minimum sector vectoring altitude of 4100 feet, and cleared it for the approach. (See Appendix A, Figure 1.)

Upon intercepting the localizer at 8.8 nm from the threshold, the aircraft immediately turned off course to the left. The FO initiated a missed approach by disengaging the autopilot, increasing pitch attitude, and increasing power. Shortly afterward, the airspeed was observed to decrease to about 90 knots indicated air speed (KIAS) before recovering to 130 KIAS. The minimum C90A single engine control speed (Vmca) was 90 KIAS, and the balked landing initial climb speed was 101 KIAS. The FO did not refer to the flight director during the missed approach.

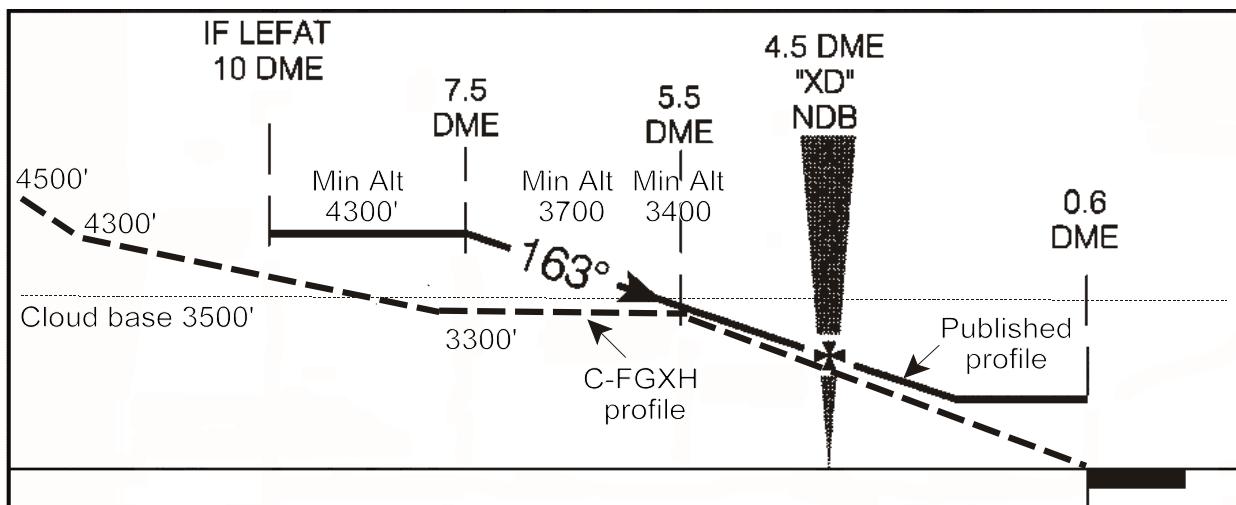
Figure 2. Profile view, second approach

During the approach, the captain gave their position as 4.7 DME (distance measuring equipment) when the aircraft was actually 10 nm from the airport because he had read the global positioning system (GPS) display of the distance to the final approach fix instead of the DME display. Radar data indicated that the aircraft descended to about 3500 feet, or 800 feet below the minimum step-down altitude of 4300 feet, before descending below the cloud base. (See Appendix A, Figure 2.)

The crew's dependence on GPS information resulted in their estimating their position as 4.5 nm closer to the airport than it actually was. The significant deviation from the approach centreline and the premature descent profile suggest that the crew did not have an accurate perception of their position in relation to the approach centreline or of their distance from the airport. Under the prevailing weather conditions, the aircraft would have been in cloud until it descended to about 1300 feet agl, and its margin of protection from obstacles would have been reduced.
