AVIATION INVESTIGATION REPORT

A05C0123

IN-FLIGHT COLLISION

Between
Waco UPF-7 N2369Q and
Wolf-Samson N985PW
Moose Jaw, Saskatchewan
10 July 2005

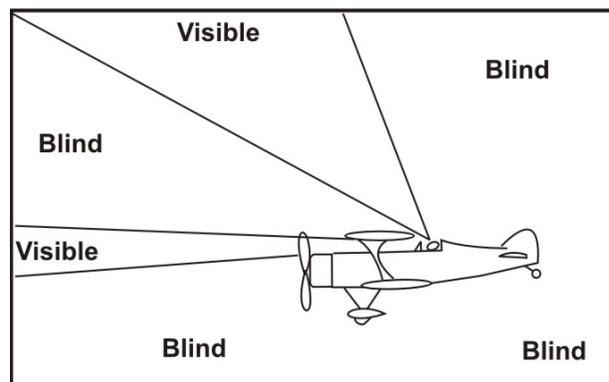
Figure 1. Blind spots for generic biplane

Both biplanes were highly manoeuvrable with ample power for the planned display. All aircraft have design limitations that restrict pilot visibility. Because the upper wing of biplanes is mounted ahead of and above the pilot, a significant additional blind spot is created in the pilot’s field of vision (see Figure 1). The blind spot was reduced in the Waco because of the cockpit modification. However, because of the inherent manoeuvrability of the two aircraft, the display pilots could quickly move the nose or wings out of the way to locate the other performers. Additionally, the aircraft were equipped with smoke generators. The display pilots used the smoke to quickly acquire the position of other performers. Temporary loss of visual contact between performers is considered acceptable when manoeuvres are flown as scripted because the performers know when and where visual contact will be regained. Manoeuvres must be planned so this temporary loss of contact does not compromise safety.

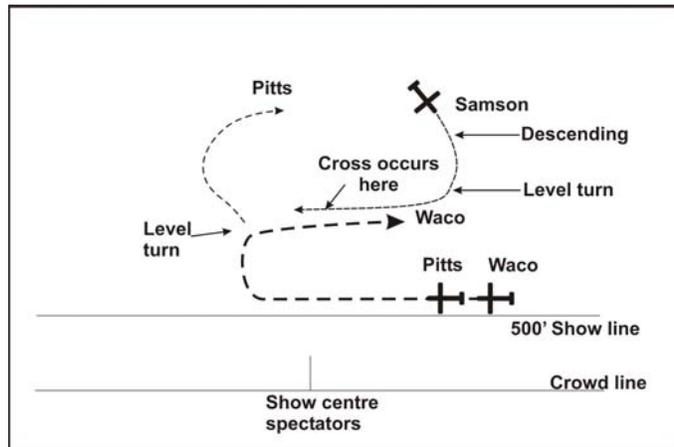
Figure 2. Original Dairy Turn

The Dairy Turn (see Figure 2) is a scripted manoeuvre that was flown immediately before a series of crosses and chases involving the jet-powered truck on the runway. From outside the 1500-foot show line at show right, the pilot of the Wolf-Samson begins a right descending turn with the intention of rolling out in the vicinity of and parallel to the 1500-foot show line. The pilot of the Pitts also enters from show right at low level along the 500-foot show line, chased closely by the Waco. Past show centre, the pilot of the Pitts makes a hard 90° turn, banking steeply to the right away from the spectators. He then makes another hard 90° turn to the left by using a pushing force on the control column, without changing the bank angle. The pilot of the

Waco follows the first 90° turn of the Pitts to the right and then banks steeply to the left toward the Pitts to simulate following the Pitts. However, the pilot of the Waco does not pull in the direction of the Pitts, but instead continues straight away from the crowd toward the turning Wolf-Samson. The Waco then banks right and makes a hard right turn toward the Wolf-Samson, flying between the Wolf-Samson and the spectators. The intention of the manoeuvre is to create the illusion of a close call as the Waco and the Wolf-Samson cross near show centre.

Other display team members understood that the contract for safe separation required the pilot of the Wolf-Samson to establish visual contact with the Waco and maintain separation visually. The Waco pilot was expected to fly the manoeuvre as planned. The Waco had been too far behind the Pitts in the tail chase down the 500-foot show line on several occasions since the display had been developed. The consequent lateness of the turn toward the Wolf-Samson had not previously caused any difficulties for the performers.

The Dairy Turn, as originally conceived and flown, had not caused problems when the Waco was too far behind the Pitts because the Waco turned between the Wolf-Samson and the spectators. This resulted in flight paths that did not cross and gave the pilot of the Waco visual contact with the Wolf-Samson or its smoke during the second 90° turn. While this variation of the manoeuvre gave the crowd the illusion of danger, safety was readily controlled by the performers.

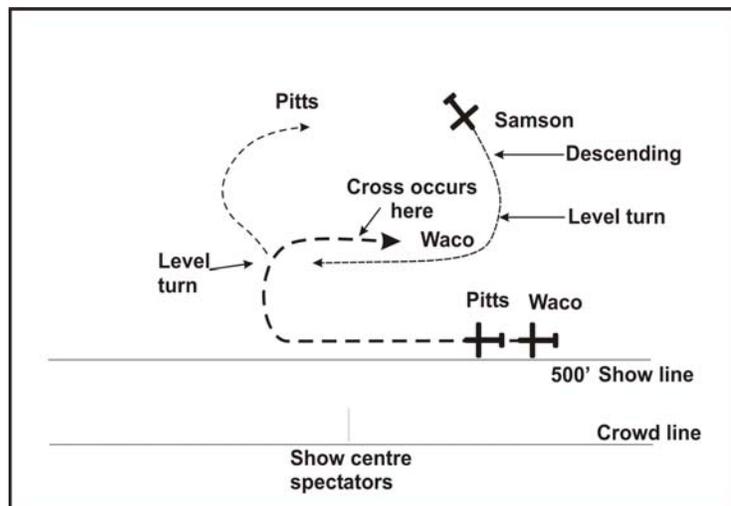
Figure 3. Modified Dairy Turn

Information gathered during the investigation indicated that the cross had been recently modified (see Figure 3). In this variation, the Waco flies across the projected path of the Wolf-Samson before making the hard right turn. The modified cross occurs when the two biplanes pass with the Wolf-Samson between the Waco and the spectators. A videotape of a recent display by the performers shows that the manoeuvre had been modified. Whether the contract for safe separation was also revised could not be established.

The modified Dairy Turn, however, resulted in flight paths that crossed twice resulting in two points of possible collision (see Figure 3). The first point of possible collision was more dangerous because the tracks intersected at 90°, with the potential for both aircraft to be banked away from the other. Because of the manoeuvre’s timing, it was critical for either pilot to obtain visual contact with the other pilot. As shown in Figure 3, the manoeuvre becomes dangerous if the Waco is a few seconds late. This is a significant difference from the original manoeuvre, and the risk of collision was no longer just an illusion. The modified manoeuvre did not ensure safe execution unless at least one of the pilots had visual contact with the other. Because of the increased risk, the two pilots should have ensured that a clearly understood contract was in place.

1. The Dairy Turn manoeuvre had been modified such that a temporary loss of visual contact could occur immediately before the aircraft crossed flight paths. This modification made timing critical and added two potential points of collision.
2. The manoeuvres immediately before the collision indicated that the performers had not established a clearly understood contract for the revised manoeuvre. The actions of each performer negated the actions of the other, and neither pilot took positive action to regain visual contact.
3. The timing of the manoeuvre was lost when the Waco turned late at show centre.

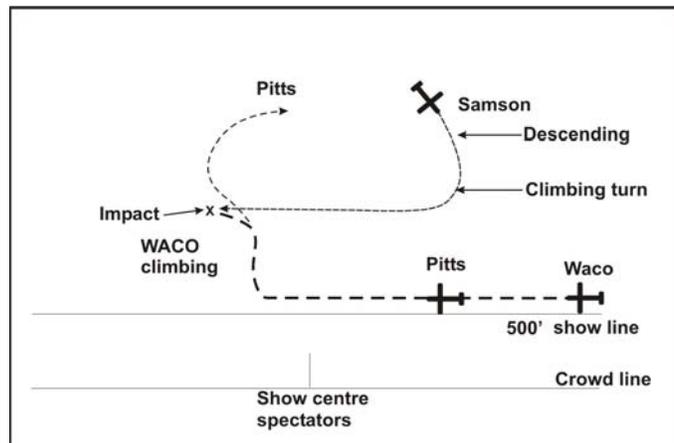
Figure 4. Accident sequence

The pilot of the Wolf-Samson flew a right-hand turn toward the spectators from outside the 1500-foot show line from show right (see Figure 4). As he approached the 1500-foot show line, he began a climb while maintaining the bank angle. The climb was maintained until impact. He made no radio transmission indicating that he was climbing. Further, there was no movement of the aircraft that would have indicated an attempt to visually acquire the Waco and ensure separation. Close scrutiny of several videotapes of the turn show that the pilot of the Wolf-Samson was in a position to see the Pitts cross show centre and break right without the Waco in close proximity. However, the videotapes also indicate that it would have been impossible for the pilot of the Wolf-Samson to see the Waco in the last 90 degrees of turn without movement of the biplane's wings or nose.

The pilot of the Waco entered from show right chasing the Pitts down the 500-foot show line (see Figure 4). In the vicinity of show centre, he made a hard 90° turn away from the spectators, following the Pitts. However, he was significantly behind the Pitts. He then banked steeply to the left, entering a climb. He maintained a steep bank angle and the aircraft started to turn to the left as the jet engine was heard to increase in power. Videotapes show that once the bank to the left was started, the pilot of the Waco could not have seen the Wolf-Samson. The bank was maintained until impact. As with the pilot of the Wolf-Samson, there was no radio transmission from the pilot of the Waco and no movement of the aircraft that would have indicated an attempt to visually acquire the other performer and ensure separation.

The climb initiated and maintained by the Wolf-Samson pilot was not part of the planned manoeuvre. The climb was consistent with the pilot concluding that the Waco was late and, because he did not have visual contact with the Waco, that there was an imminent risk of collision. His climb would have permitted the Waco to pass ahead and below. If the Wolf-Samson pilot’s contract was to maintain separation, his action would have established an altitude separation between the two aircraft. However, his action did not positively regain visual contact at a critical point in the manoeuvre. Visual contact was the only means to ensure safe separation.

The climb of the Waco pilot was consistent with the pilot concluding that the lateness of his turn toward the Wolf-Samson had created an imminent risk of collision if the manoeuvre was continued as scripted. If the Waco pilot's contract was to maintain separation, his action would have established an altitude separation between the two aircraft. However, his action did not positively regain visual contact at a critical point in the manoeuvre. His subsequent turn to the left is consistent with an attempt to fly away from the potential collision and may indicate that the pilot was uncertain that a safe contract was being flown.

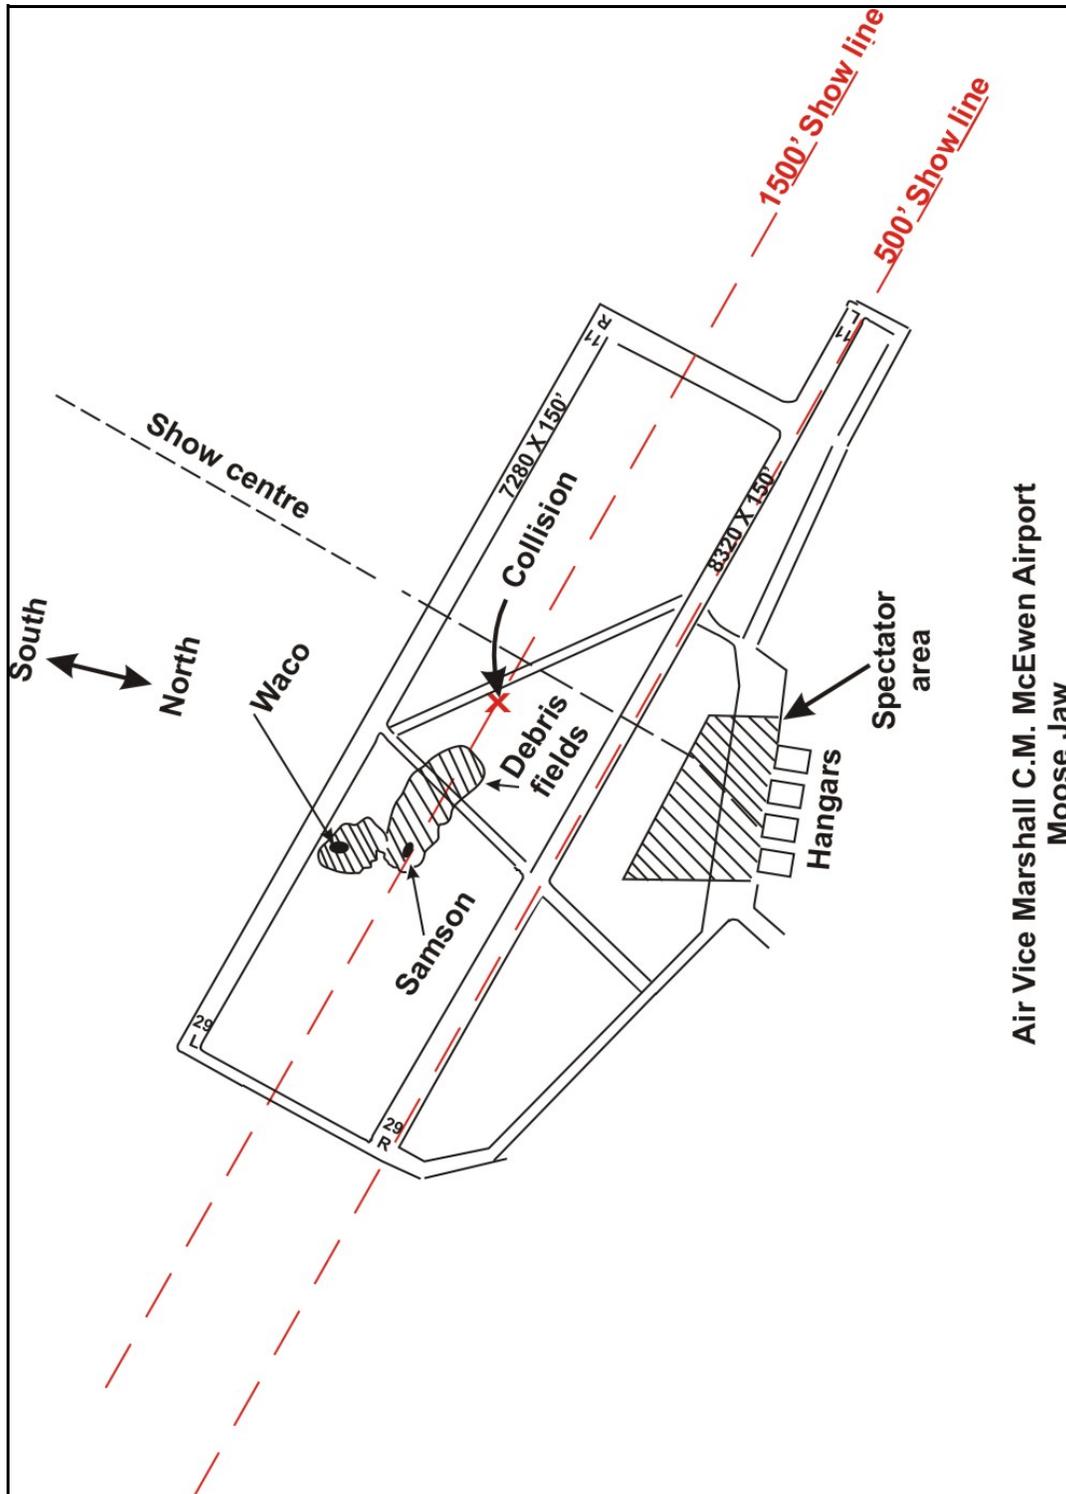
Appendix A – Air Vice Marshall C.M. McEwen Airport,
Moose Jaw, Saskatchewan

The layout of the air show is shown in Appendix A. Two show lines were used. The 500-foot show line was used for lower-speed aircraft such as the biplanes. The 1500-foot show line was used by higher-speed aircraft. Turns toward the spectators had to be completed before these lines. The purpose of show lines is to ensure that debris is directed away from spectators in the event of a mishap. The show centre was based on the spectators and is represented by the line perpendicular to the two show lines. For the purposes of this report, the area to the left of show centre, as viewed by the spectators, is "show left" and similarly, the other half of the display is "show right."

The debris field is indicated on Appendix A. It began about 200 to 300 feet left of show centre outside the 1500-foot show line. Debris from the Wolf-Samson indicates that its flight path was at a shallow angle to the 1500-foot line. Debris from the Waco indicates that it had begun to turn to the left away from the Wolf-Samson. The debris trail of the Waco was about 1200 feet long. One blade of the Wolf-Samson's propeller was imbedded in the spinner of the Waco, which, in conjunction with videotape information, indicates that the two biplanes were belly to belly at impact.
