**AVIATION INVESTIGATION REPORT
A05O0112**

MISRIGGED ELEVATOR TRIM TABS

**FLIGHT OPTIONS LLC
RAYTHEON/HAWKER 800XP N829LX
TORONTO/LESTER B. PEARSON INTERNATIONAL
AIRPORT, ONTARIO
02 JUNE 2005**

Report Number A05O0112

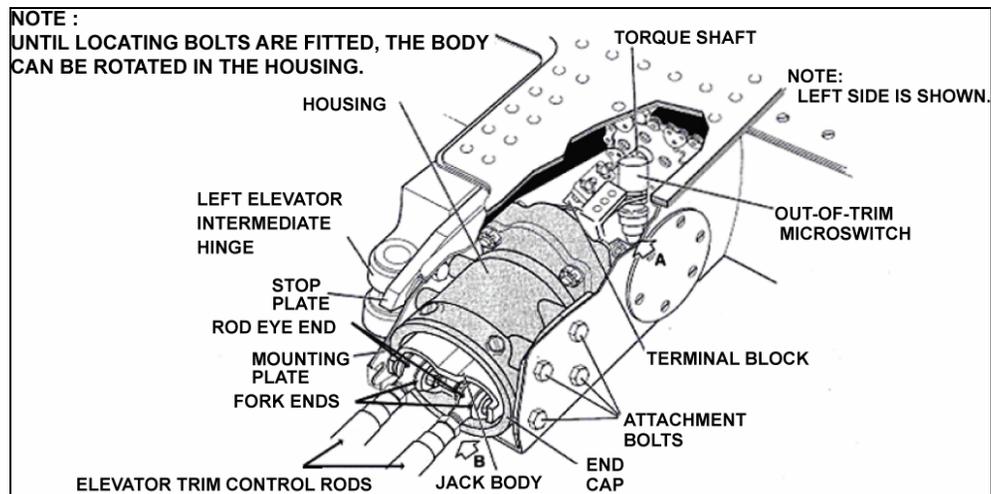
Figure 1. Elevator trim jack

Removal of the elevator trim control rods was accomplished by loosening the jam nuts at the rod eye end fitting where it attaches to the screw jack fork end and unscrewing the control rods from the eye end fitting. The senior AME removing the rods counted the number of full turns required to remove the rods and marked this number on a tag that was securely attached to each rod (Figure 1). This would later aid in the reassembly of the aircraft.

To check the flight control rigging, the elevator was pinned at the neutral position and the elevator trim wheel was set to 35 degrees, as per the maintenance manual. The maintenance manual, 27-30-00, Figure 504, indicated that the elevator trim tab trailing edges should fair flush with the trailing edge of the elevator when set as indicated above. However, both the left and

right trim tab trailing edges were 0.250 inches below the trailing edge of the elevator, giving the aircraft a nose-up trim condition. Next, the trim wheel was rotated to maximum nose-down trim (against the mechanical stops). When the wheel reached its stop, the trim tab's trailing edge was still slightly below the elevator's trailing edge. As such, with full nose-down trim selected, the aircraft was rigged in a nose-up condition.

1. The elevator trim tabs were not rigged in accordance with the aircraft maintenance manual, resulting in a misrigged condition and a lack of sufficient nose-down trim authority.

- amended its quality assurance program to ensure closer scrutiny in all aspects of maintenance than was previously possible;
- implemented a process for regular discussions on process control;
- implemented the process of a full control-travel check before disassembly; consequently, this process revealed that many aircraft received to work on had controls not rigged within the specified limits;
- implemented additional training on human factors, improving the reporting of potential problems; and
- the company is in the process of implementing a Safety Management System (SMS).
