AVIATION INVESTIGATION REPORT

A08A0106

LOSS OF CONTROL — STALL / SPIN

KITFOX IV C-GCSU

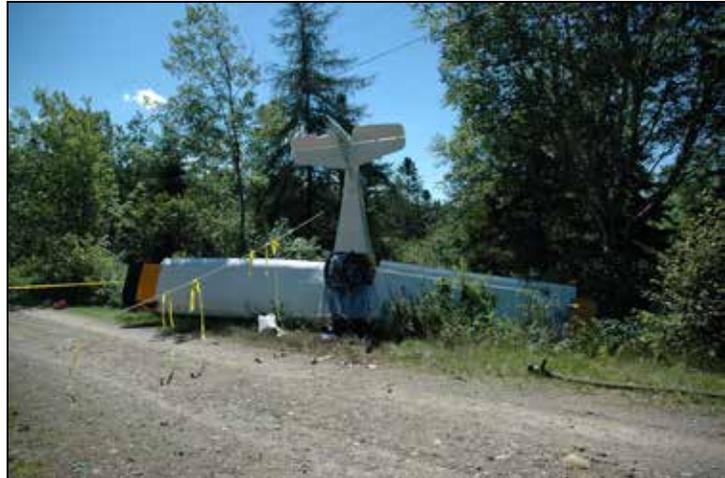
Photo 2. Aircraft impact orientation

The aircraft contacted the ground in a direction of travel between 200 and 205 degrees magnetic, close to vertical, with the right wing contacting the ground slightly before the left wing. The aircraft bounced once and then came to rest on its nose about six feet from the initial impact point. The ground contact marks also showed some rotation to the right about the longitudinal axis. The trees surrounding the site were undamaged as were the hydro cables along the road, indicating a near vertical descent. The forward section of the aircraft collapsed and the engine folded up and inward toward the instrument panel, moving rearward into the cockpit area. Little space remained in the cockpit; the pilot's upper body was forced out through the left-hand entry door, which had sprung open during the impact.

The aircraft impact orientation (See Photo 2) and airframe damage was consistent with a steep nose-down inverted attitude typical of a low-altitude aerodynamic stall/spin event ². The accident aircraft was not equipped with a stall warning device, nor is one required for this category of aircraft.

The aircraft’s impact orientation indicates there was a departure from controlled flight, resulting from a stall/spin scenario. The stall/spin scenario was not a result of a structural failure in flight, no engine or control anomalies were noted during the wreckage examination, the weather was determined not to be a factor, and a stall/spin scenario would not have been deliberately initiated at such a low altitude. The most likely scenario leading to the accident would be the pilot’s lack of currency and inexperience on type, leading to a failure to detect the symptoms of an approaching stall and apply the appropriate corrections in a timely manner,
