## AVIATION INVESTIGATION REPORT

A09P0096

### LOSS OF SEPERATION

NAV CANADA – VANCOUVER AREA CONTROL CENTRE  
PENTICTON, BRITISH COLUMBIA, 20 nm SW

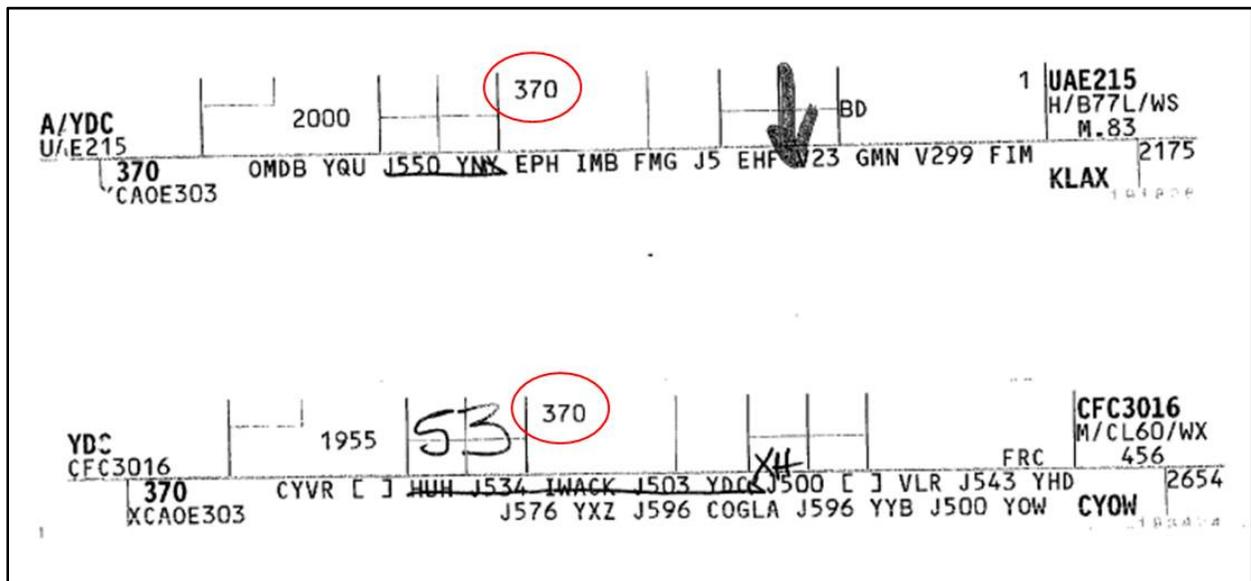
Figure 1. Flight Progress Strips showing flight levels

Flight progress strips are distributed to appropriate sectors at least 15 minutes prior to transfer of control to the controller. Shortly after the controller took over the position and UAE215 was transferred to the control of the Mountain High Specialty, the controller noted from the printed flight progress strips in the strip bay that both aircraft would be at FL370. The controller had identified the potential problem between CFC 3016 and UAE 215 which were both cleared to FL370 and on crossing tracks. Contrary to ATC MANOPS, red Ws had not been posted on the flight progress strips. It is unknown whether the flight progress strips were cocked.

The controller identified the conflict between CFC3016 and UAE215 early on. The controller resolved to change UAE215's route toward the west and issue a climb to FL380. A solution in hand, the controller did not think it necessary to mark the flight progress strips with the required red W. Thus, an important aide-memoire was not used. The controller's attention became focused on other traffic in the sector. The conflict went unresolved until the TFC CA sounded.

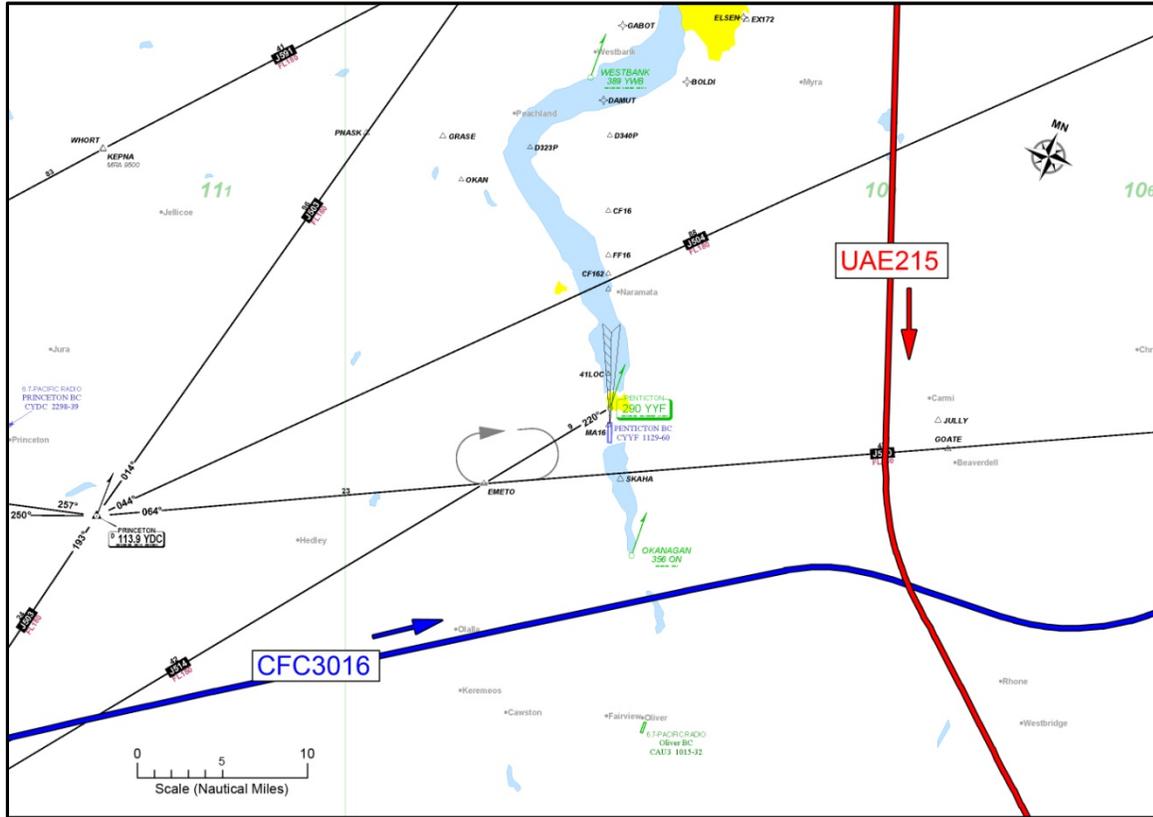
# Appendix A – Aircraft Flight Paths

At 1259:33, vertical spacing of 1000 feet had been achieved between the two aircraft at which point the horizontal spacing was 1.8 nm. The minimum required spacing was 1000 feet vertically or 5 nm horizontally. The turns issued to the aircraft resulted in UAE215 directly overflying CFC3016 (see Appendix A – Aircraft Flight Paths).

The controller cleared CFC3016 to turn right, and UAE215 to turn left. The geometry of this crossing track conflict was such that the turns resulted in one aircraft flying directly overtop of the other. The turns issued by the controller were ineffective in establishing the minimum lateral radar separation. Altitude spacing was achieved by the controller's initial descent instruction to CFC3016 and UAE215's response to the TCAS RA.
