**AVIATION INVESTIGATION REPORT
A09P0187**

**WAKE TURBULENCE ENCOUNTER - COLLISION WITH
TERRAIN**

**INTEGRA OPS LTD. (DBA CANADIAN AIR CHARTERS)
PIPER PA-31-350 CHIEFTAIN, C-GNAF
RICHMOND, BRITISH COLUMBIA
09 JULY 2009**

Report Number A09P0187

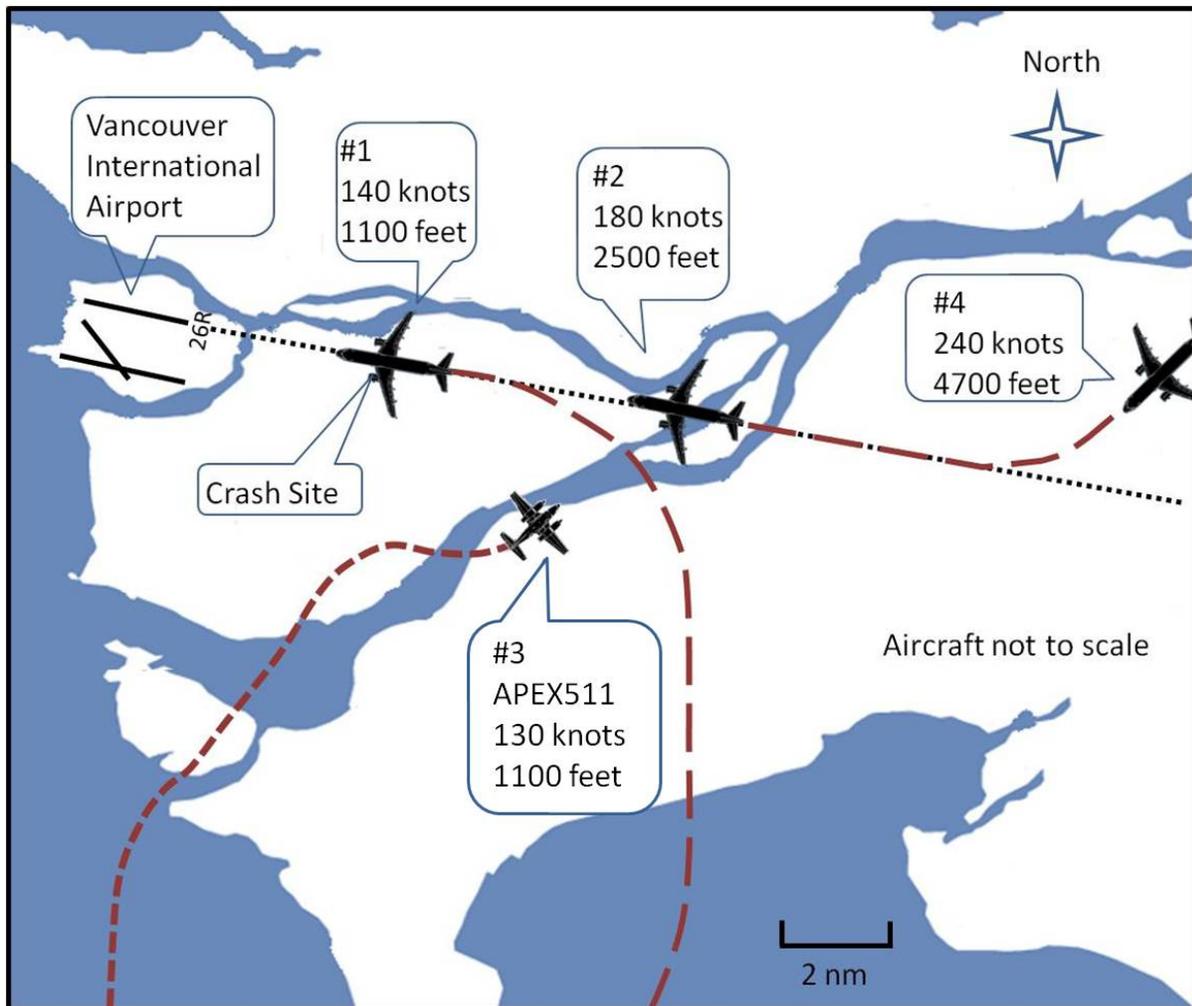
Figure 1. Aircraft traffic pattern at 2204:42

At 2201, APEX 511 was advised by Vancouver tower that it would be second or third on the approach (see Figure 1). At 2202, APEX 511 crossed the Vancouver VOR (very high frequency omnidirectional radio range), 7 nm south of the airport, at 1500 feet asl and proceeded northwest toward a checkpoint about 2 nm southeast of the airport. After crossing the VOR, APEX 511 descended to 1000 feet asl. At 2203, APEX 511 was advised that it would be number 3 behind an Airbus. The airport controller instructed APEX 511 to widen its approach to the east, downwind and issued a wake turbulence cautionary, including the position of the aircraft it was to follow. The crew of APEX 511 queried the airport controller as to whether they should do a 360° turn. The airport controller confirmed to widen its approach to the east and follow the traffic when in sight.

At 2204, the airport controller pointed out the traffic on final approach, 6.5 nm away and descending through 3000 feet asl. APEX 511 reported the traffic in sight. APEX 511 was then instructed to follow that traffic, but not too far behind, as another Airbus flight was 8 nm from the preceding Airbus. APEX 511 was again cautioned about wake turbulence. The crew indicated that they would keep it in tight. This was the last communication from APEX 511.

Before APEX 511 sighted the traffic, the airport controller monitored the flight for potential traffic conflicts. Once APEX 511 reported the traffic in sight, the airport controller instructed APEX 511 to follow that traffic. A second wake turbulence cautionary was issued at the same time. APEX 511 was also pointed out as traffic ahead and 2 nm left for the Airbus that it was going to follow (see Figure 1).
