**AVIATION INVESTIGATION REPORT
A09P0397**

LOSS OF CONTROL - COLLISION WITH WATER

**SEAIR SEAPLANES LTD.
DE HAVILLAND DHC-2 MK 1 (BEAVER) C-GTMC
LYALL HARBOUR, SATURNA ISLAND, BRITISH COLUMBIA
29 NOVEMBER 2009**

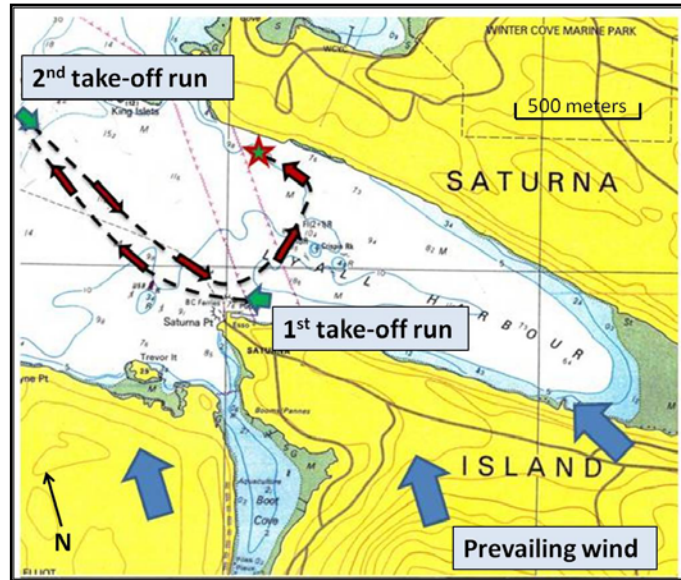
Figure 1. Lyall Harbour with Flight Route and Winds

Around the time of the accident, the wind was of particular significance in Lyall Harbour. While local recordings showed the wind direction varying from 082° to 165° true, it was estimated to be generally from the southeast at 18 knots with gusts to 26 knots. With the winds from the southeast, the area used by floatplanes is in the lee of high terrain on the island (see Figure 1). These conditions are conducive to the creation of mechanical turbulence and mountain waves.

Floatplane pilots departing Lyall Harbour typically take off in a westerly to northwesterly direction, which offers an unobstructed flight path and a more favourable route to Vancouver. After unsuccessfully trying to take off in a northwesterly direction (downwind), the pilot turned the aircraft into the wind and took off towards Lyall Harbour (see Figure 1).

The conditions in Lyall Harbour at the time of the occurrence were conducive to the development of mechanical turbulence and mountain waves. The turbulence associated with these phenomena likely contributed to vertical gusts, which subjected the aircraft to temporary, but significant increases in aerodynamic load.

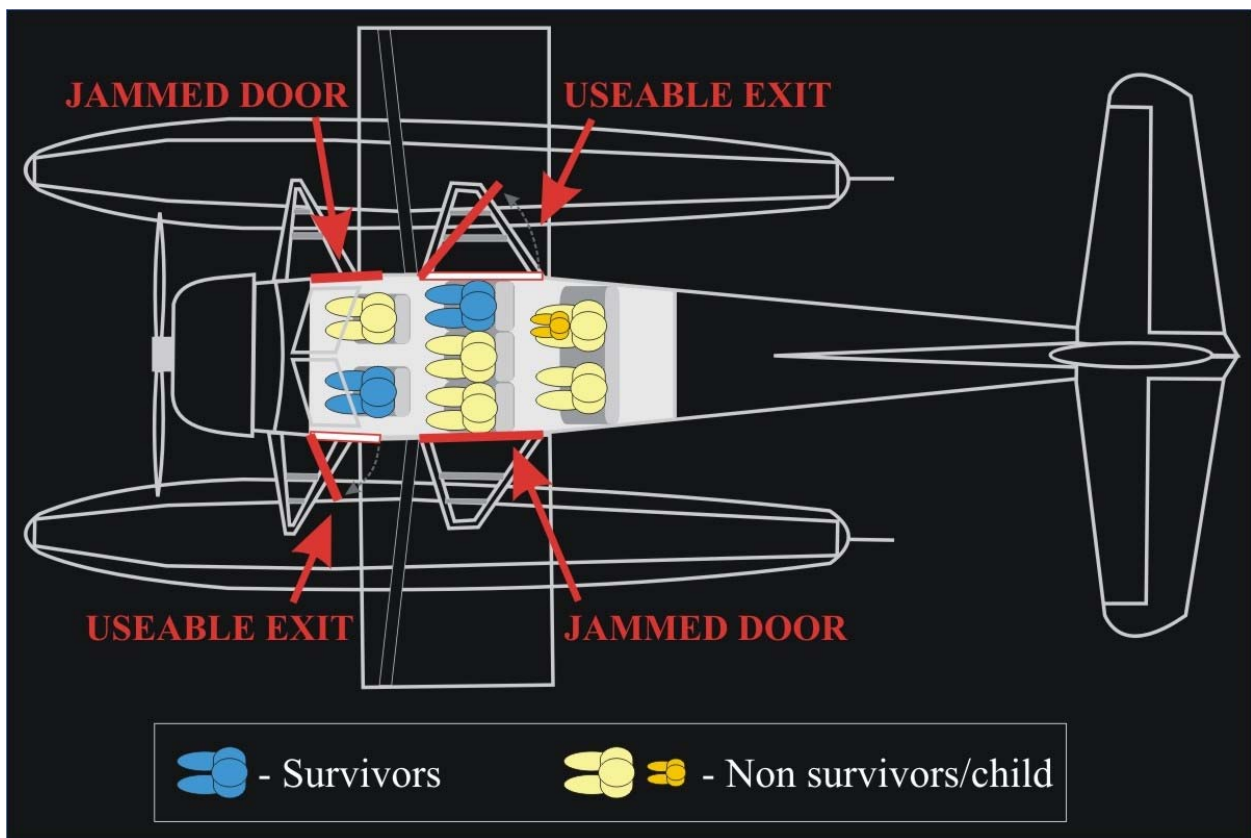
Figure 2. Seating Configuration and Egress Points

Rescue divers found the aircraft in 14 meters of water in a nose-down, tail-up position. The right cabin and left cockpit doors were both open. The right cockpit and left cabin doors could not be opened.

Four adult passengers had their seat belts undone. They were unable to exit the aircraft and drowned. The seating configuration is shown in Figure 2, which also indicates the useable and jammed doors.

In this occurrence, the aircraft was not equipped with jettisonable doors or windows. As a result, the only possible egress points were the 4 doors on the aircraft. However, impact damage jammed 2 of the 4 doors and restricted egress from the sinking aircraft, which meant all 7 passengers and the pilot would have had to exit via 1 of 2 usable egress points. Rather than deliberately attempting to open a door, the surviving passenger exited through the door that had opened as a result of impact forces. It is likely that the pilot's recent egress training contributed to him being able to open the door and escape from the aircraft. The lack of alternate emergency exits, such as jettisonable windows, increases the risk that passengers and pilots will be unable to escape a submerged aircraft due to structural damage to primary exits following an impact with the water.
