AVIATION INVESTIGATION REPORT

A09Q0003

CONTROLLED FLIGHT INTO TREES

PIPER PA-28-140 C-FRZH

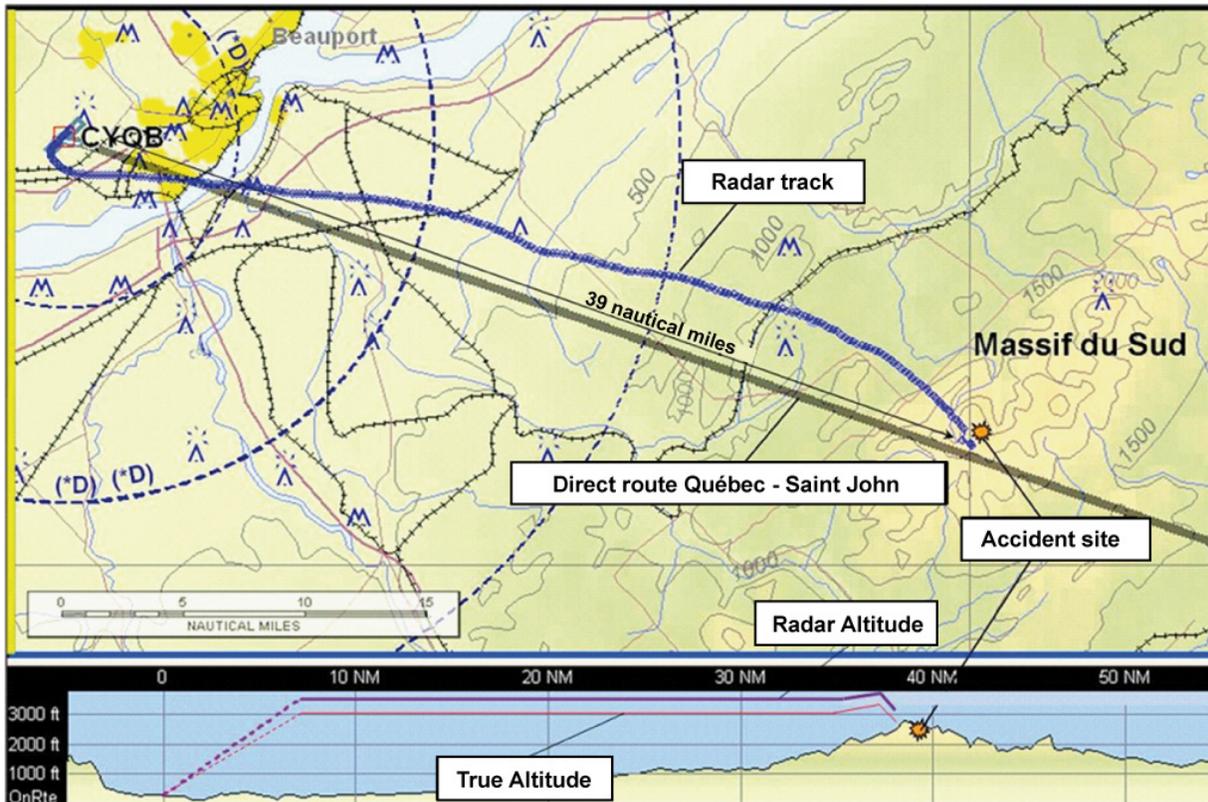
Figure 1. Aircraft trajectory.

Québec radar tracked the aircraft almost all the way to the crash site (see Figure 1). Shortly after takeoff, the aircraft deviated from the direct route. Upon leaving class D airspace, the aircraft turned onto an intercept heading of approximately 10° towards the direct route. Two minutes before the aircraft vanished from the radar screen, its ground speed decreased from 140 knots to 100 knots, then increased to 170 knots, and finally dropped to 50 knots. At the same time, the aircraft turned south and then entered a left turn to a final heading of 111°M. The aircraft's altitude went from 3800 feet asl to 3100 feet asl, then to 3400 feet asl. The aircraft disappeared from the radar screen at 0509:04.
