Transportation Safety Board
of Canada

**AVIATION INVESTIGATION REPORT
A10Q0087**

**COLLISION WITH WATER
LAKE BUCCANEER LA-4-200 (PRIVATE), C-GGFK
LAC BERTÉ, QUEBEC
03 JUNE 2010**

Report Number A10Q0087

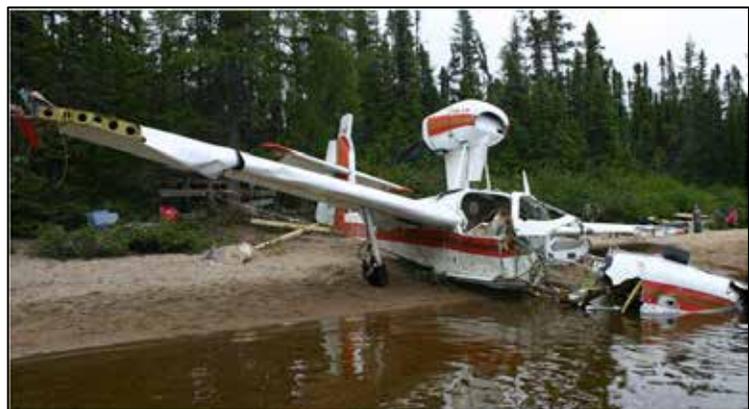
Photo 1. Lake Buccaneer C-GGFK

The aircraft collided with the water at an approximate 20° nose-down attitude, right lateral movement and right wing low attitude. The right wing tip collided with the water first, tearing away the right wing sponson and the outboard portion of the right wing leading edge and wing tip cover (Photo 1). The nose section, from the instrument panel to the nose cone of the aircraft, was torn open from right to left. It

remained attached to the rest of the fuselage by the front left side skin, electrical wires and hydraulic lines. The cabin floor was torn apart as the nose section separated from the rest of the aircraft. The seat rails failed in overload as the floor was torn open allowing the seats to come free of the aircraft. The left wing outboard leading edge was flattened as it whipped around to

hit the surface of the water after the right wing and nose struck the water. The tail section and top vertical fin of the aircraft also showed kinks in the aircraft skin indicating the aircraft struck the water while rotating around the right wing. The aircraft was found upside down, resting on the top of the engine, at the bottom of the lake. There were no signs of pre-impact fire or bird strike.

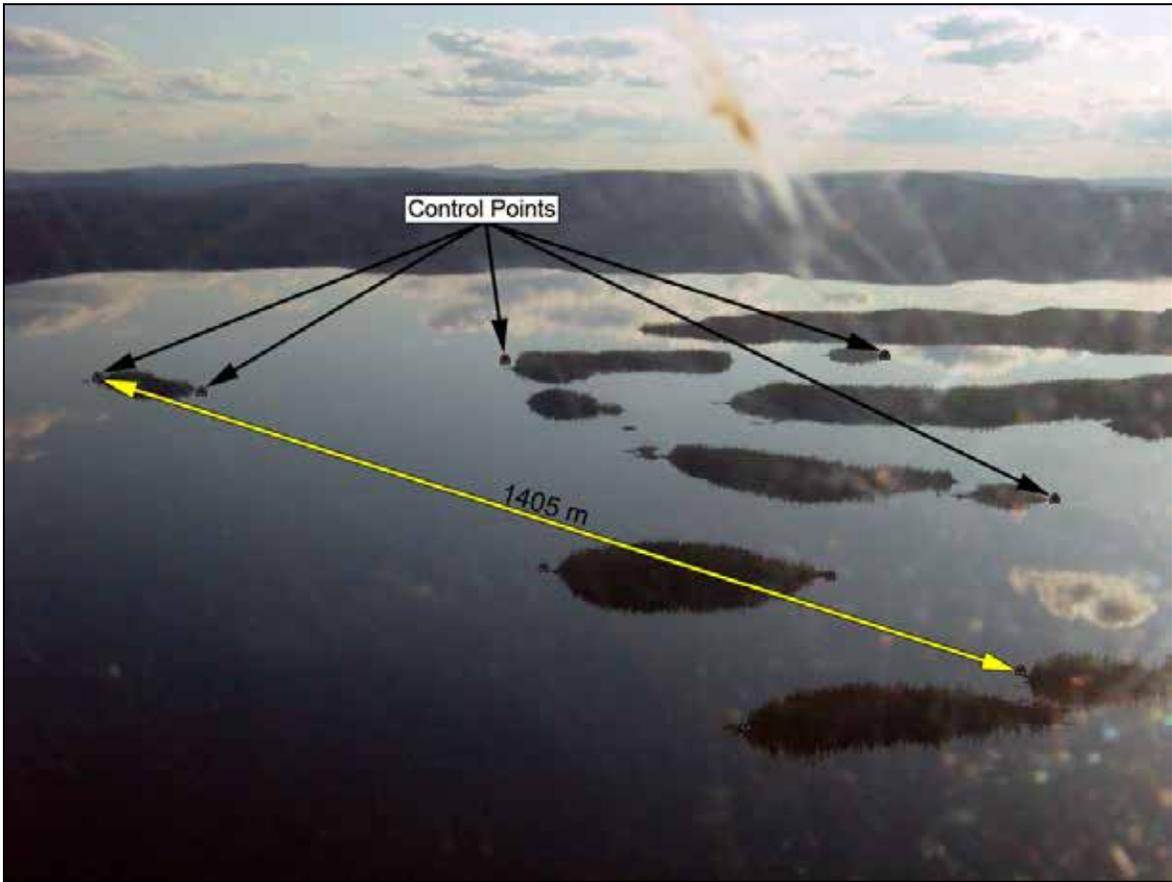
Photo 2. Last photo taken with passenger's camera

The passenger's camera was found in the wreckage. Photos extracted from the camera were taken over a 3-day period coinciding with the 3 days the pilot and passenger spent at the pilot's cottage. The last group of photos shows the aircraft on take-off, heading south from Lac de la Marmotte II towards Lac Berté, and in cruise flight over the tip of the northeast bay of Lac Berté heading south. It was determined that the pictures were taken in the evening because photos show the sun setting to the right, while the aircraft is flying in a southerly direction. This information helped confirm that the occurrence flight took place on the evening of 03 June 2010. The aircraft's altitude as shown on the last photo (Appendix B) was estimated to be approximately 876 feet above the surface of the lake (2073 feet above sea level). The exact time of the occurrence is unknown.

The retrieved photos also helped determine the weather conditions at the approximate time of the occurrence flight. The reflection of the sky and clouds on the surface of Lac Berté, revealed that weather was conducive to VFR flight; it was sunny with scattered clouds, winds were light to nil giving glassy water conditions for the lake surface; no thunderstorm activity or precipitation was visible in the area at the time the photos were taken.
