AVIATION INVESTIGATION REPORT A10C0104

INSUFFICIENT FUEL

**PERIMETER AVIATION
DEHAVILLAND DHC-8-102 C-GWPS
WINNIPEG, MANITOBA
29 JUNE 2010**

Report Number A10C0104

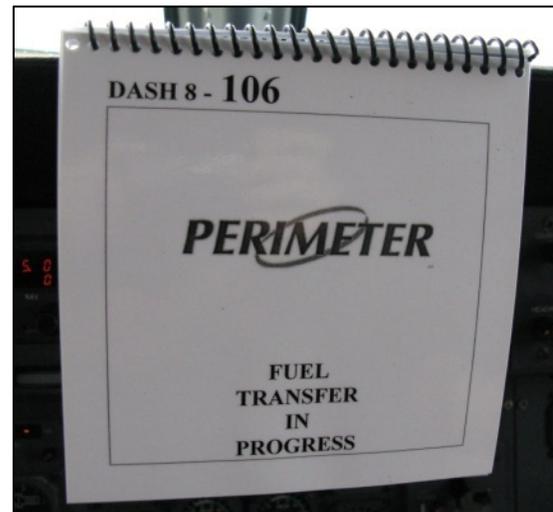
Photo 1. Fuel Transfer Card

The crew placed the fuel transfer card ³ (see Photo 1) on the glare shield to remind them of the 2 deferred checklist items to be completed before initiating the engine start. Subsequently, they opened the cockpit escape hatch to the vent position, and the fuel transfer card also served as a reminder to close the hatch.

3. Using the adaptation that had become accepted practice, the PAG107 pilots completed the BEFORE START - ENROUTE checklist to the line, and placed the fuel transfer card on the glare shield as a reminder that the fuel quantity check had been deferred.

4. The PAG107 pilots subsequently opened the cockpit hatch for ventilation, and also used the fuel transfer card as a reminder to close the hatch before engine start. Consequently, the card served as a reminder for two unrelated purposes, the incomplete fuel quantity check and the open hatch.

6. The crew subsequently closed the cockpit escape hatch and removed the fuel transfer card from the glare shield. Both pilots forgot their intent to use the fuel transfer card as a reminder that the fuel quantity check had been deferred. The fuel quantity was not verified and the flight departed with insufficient fuel.

Short-term corrective action was implemented immediately after the occurrence. On 29 June 2010, the chief pilot issued Perimeter Dash 8 Operation Memo #05-10 to all company DHC-8 pilots. The memo indicated that “doing the ‘Before Start Checklist’ while passengers were deplaning from the inbound flight and then the crew leaving the aircraft” had led to a serious flight irregularity. The memo directed all pilots to cease the practice, and stated that, “effective immediately, the ‘Before Start Checklist’ will only be done when the captain and first officer are in their respective seats and ready for the start.”
