**AVIATION INVESTIGATION REPORT
A10O0240**

**LOSS OF CONTROL AND COLLISION WITH TERRAIN
SENECA COLLEGE OF APPLIED ARTS AND
TECHNOLOGY
BONANZA F33A C-GSCZ
TORONTO/BUTTONVILLE MUNICIPAL AIRPORT,
ONTARIO
10 NM E
18 NOVEMBER 2010**

Report Number A10O0240

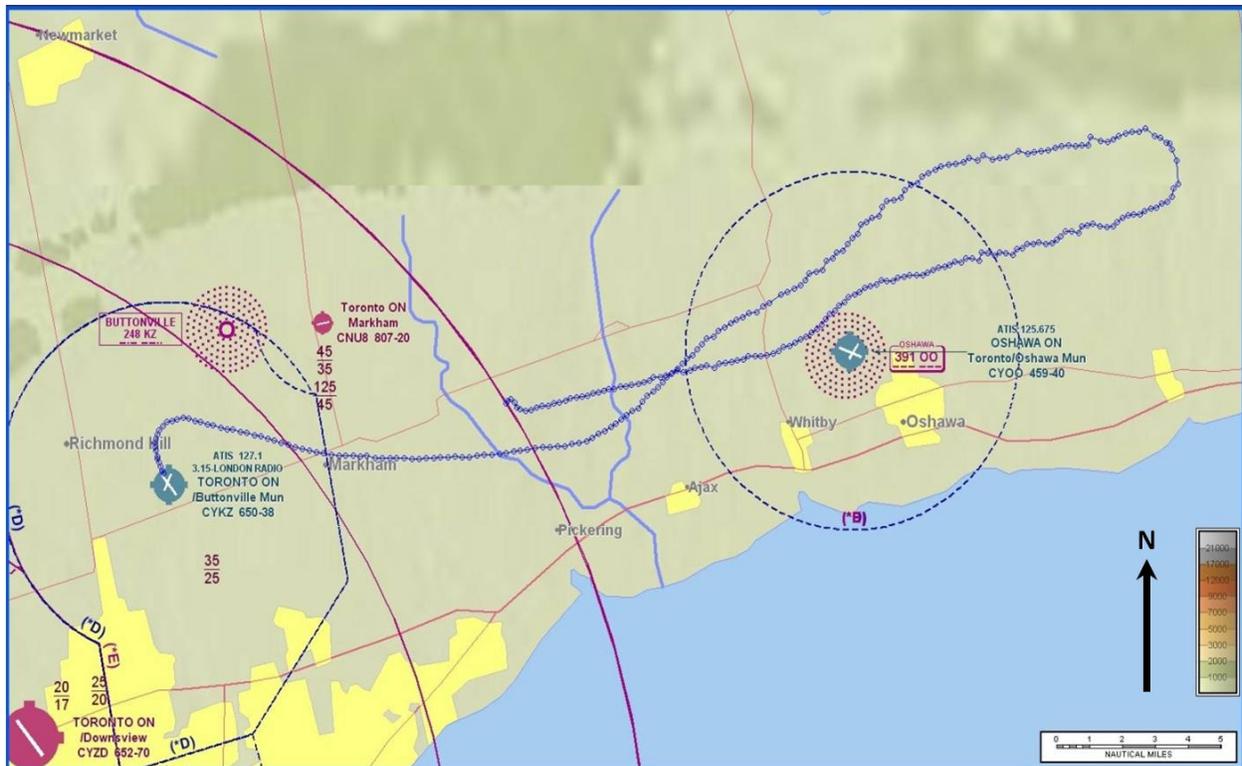
Figure 1. Actual flight path

Immediately after this last communication, the radar indicated the aircraft began a climbing right turn to a track of 330°. The airspeed reduced to approximately 90 knots IAS during the climb. The second last radar contact showed the aircraft climbing through an altitude of 2800 feet asl, and turning westbound to a track of 277° with a further reduction to 50 knots IAS. The last radar contact at about 1843 indicated the aircraft was tracking 211°, descending rapidly through 2100 feet asl with the IAS at 90 knots and increasing (see Figure 1).

Radar data indicates that after receiving the clearance from the tower, the aircraft was in a climbing right turn toward the north. As the aircraft climbed from approximately 2300 up to 2800 feet asl the IAS dropped from 115 knots to 60 knots. The aircraft then started rolling to the left but the airspeed dropped further to 50 knots. This was followed by a rapid loss of altitude and a correspondingly rapid increase in airspeed. The last radar contact showed the aircraft at an altitude of approximately 2100 feet asl descending rapidly at 9600 feet per minute and accelerating through 140 knots.

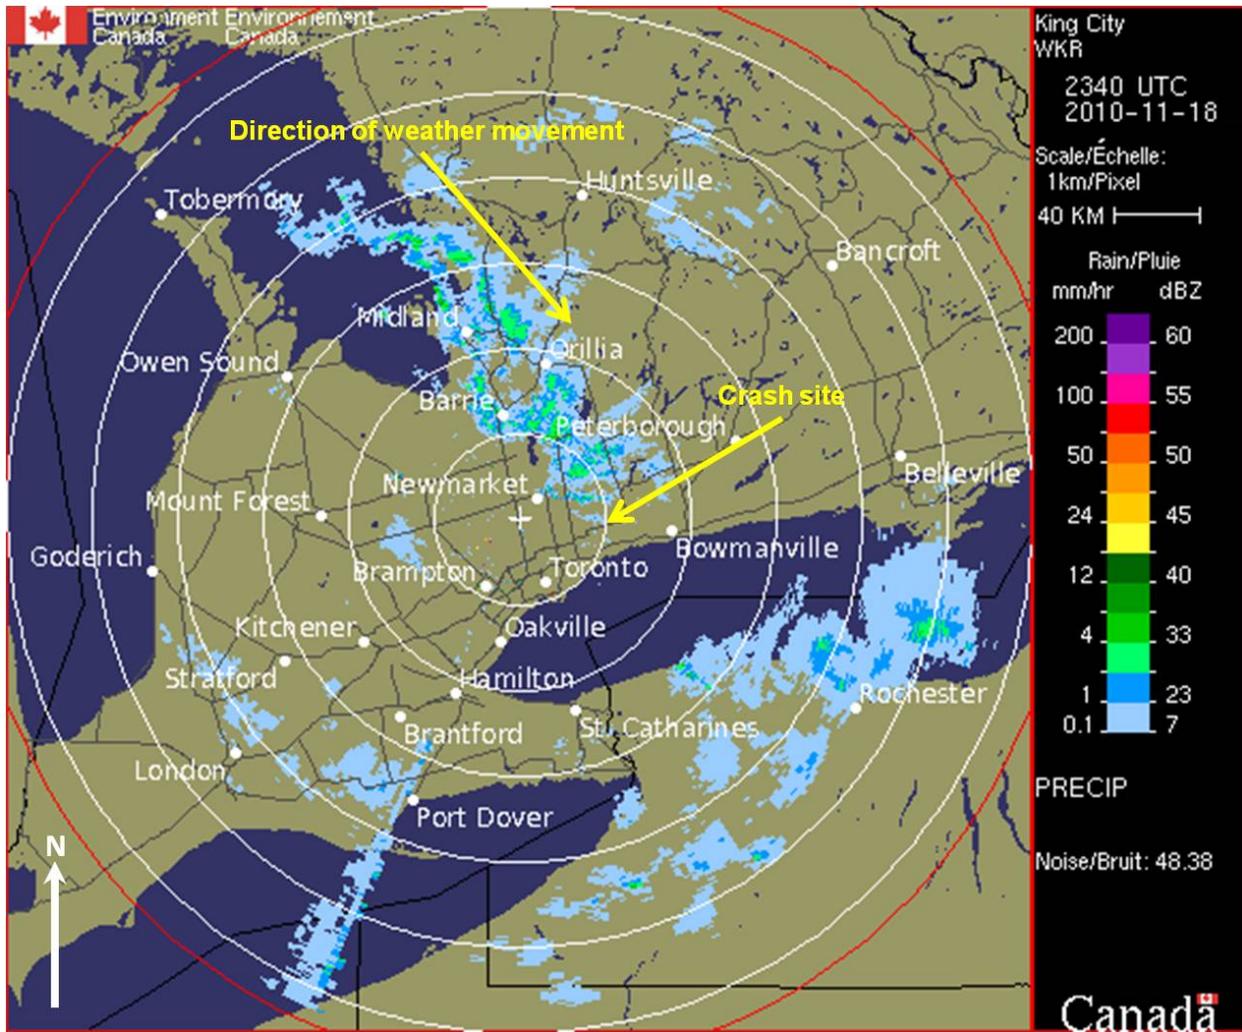
Figure 2. Location of Accident Site and Weather Conditions

Environment Canada radar indicated precipitation in the form of rain moving in a southerly direction towards Lake Ontario from Lake Huron. The graphical area forecast (GFA) clouds and weather forecast for Ontario region valid at 1900 hours, forecasted isolated towering cumulus clouds, 2 statute miles visibility in light snow showers with a ceiling of 1000 feet agl over and off Lake Huron. The GFA icing turbulence and freezing forecast issued at 1242 and valid at 1900 showed no icing being forecast with a freezing level at 2500 feet asl. A second GFA issued at 1832 and valid at 1900 showed moderate mixed icing between 3000 to 9000 feet asl. This forecast was not available prior to the aircraft departing CYKZ. Although no PIREPS were received prior to the occurrence, aircraft in the vicinity and at an altitude of 2500 agl, were encountering light icing conditions with mixed precipitation, and a temperature of approximately -2°C.

Although CYKZ and CYOO airports were reporting VFR weather conditions, at the mid-point between the two, there were ground reports of rain mixed with snow with temperatures suitable to icing.
