TSB Aviation Investigation Report A12Q0216

Executive Summary

Collision with terrain of Perimeter Aviation Metro III in Sanikiluaq, Nunavut, on 22 December 2012

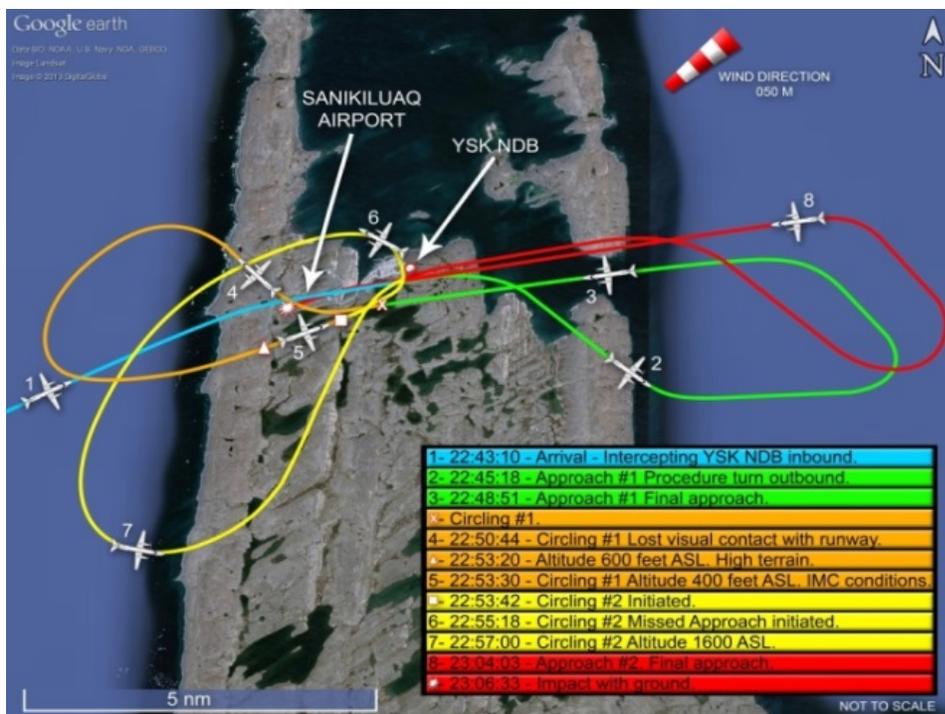
Figure 1. Flightpath of the aircraft

The crew's initial plan was to come in on a straight-in visual approach to land eastbound, into the wind on Runway 09 at Sanikiluaq (Figure 1). Weather conditions, however, did not permit this. As there was no published instrument approach procedure for Runway 09, they used the published procedure for Runway 27 and circled around visually to land on Runway 09, as wind favored landing in that direction. But visibility was insufficient, so they circled a second time, only to once more lose sight of the runway.

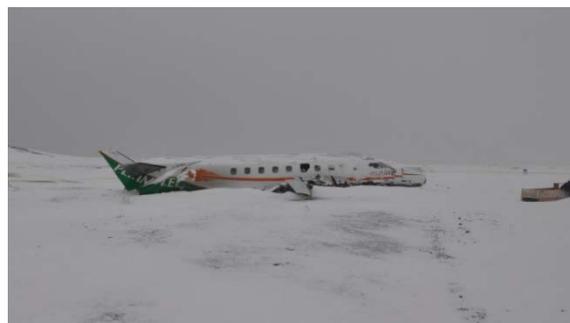
Photo 1. Aircraft wreckage

technically acceptable for landing, the crew decided to continue¹ attempting to land at Sanikiluaq. With the crew feeling increasing pressure to land, there was an increase in stress, workload, frustration and fatigue, resulting in attentional narrowing and a breakdown in crew communication. They made a second attempt, this time to land westbound on Runway 27. A tailwind, however, increased the aircraft's groundspeed, and they came in too high, too steep, and too fast, sighting the runway later than expected. By the time the captain decided to reject the landing it was too late, and the aircraft struck the ground. This is considered an approach-and-landing accident.

The 2 crew and the 6 adult passengers, secured by their seat belts, suffered injuries ranging from minor to serious. A lap-held infant, not restrained by any device or seatbelt, was fatally injured.
