**AVIATION INVESTIGATION REPORT
A14O0164**

RISK OF COLLISION

JAZZ AVIATION LP DHC-8-102 C-GJMI

**SAULT COLLEGE OF APPLIED ARTS AND TECHNOLOGY ZLIN
Z242L C-FANU**

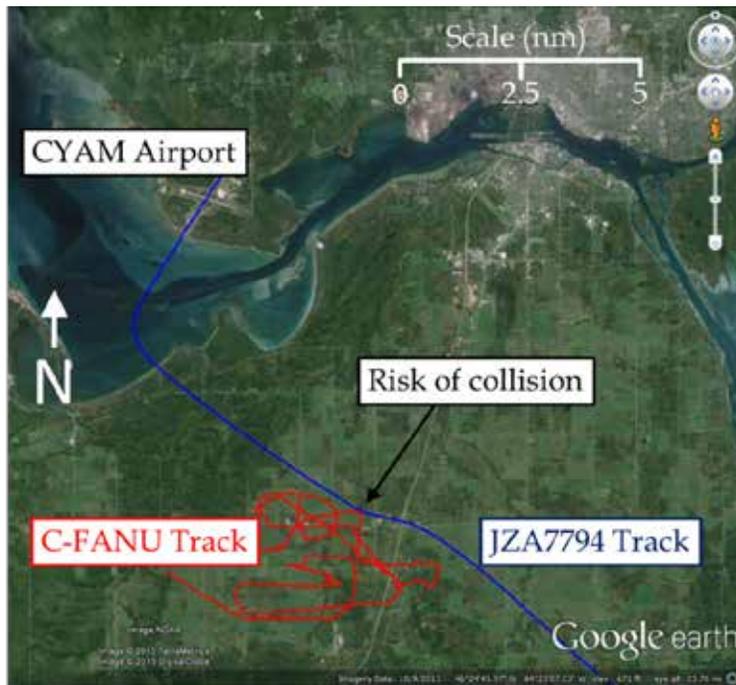
Figure 1. Depiction of the aircraft tracks leading to the risk of collision
(Source: Google Earth, with TSB annotations)

The large aircraft (JZA7794) passed to the right of C-FANU at the same altitude, separated laterally by approximately 350–450 feet (Figure 1).

Shortly after JZA7794 levelled off at 4500 feet, the flight crew noticed the right wing of the light aircraft drop and the aircraft enter a rapid descending turn. The flight path of this rapid manoeuvre was diagonally right to left from the perspective of JZA7794 and put the 2 aircraft on a collision course. Almost instantly, the TCAS issued a resolution advisory (RA), aurally instructing the flight crew to descend. The PF assessed that, due to the flight path of the descending aircraft, a descent would not be sufficient.

Without delay, the JZA7794 PF banked the aircraft 30° to the left. While in the turn, the flight crew noticed that the light aircraft had recovered from its rapid descending turn and passed to their right at the same altitude, separated by approximately 350–450 feet.

The irregular flight path of the spin put the 2 aircraft on a collision course before an evasive turn by JZA7794 caused the aircraft to pass each other, separated by 350–450 feet laterally.

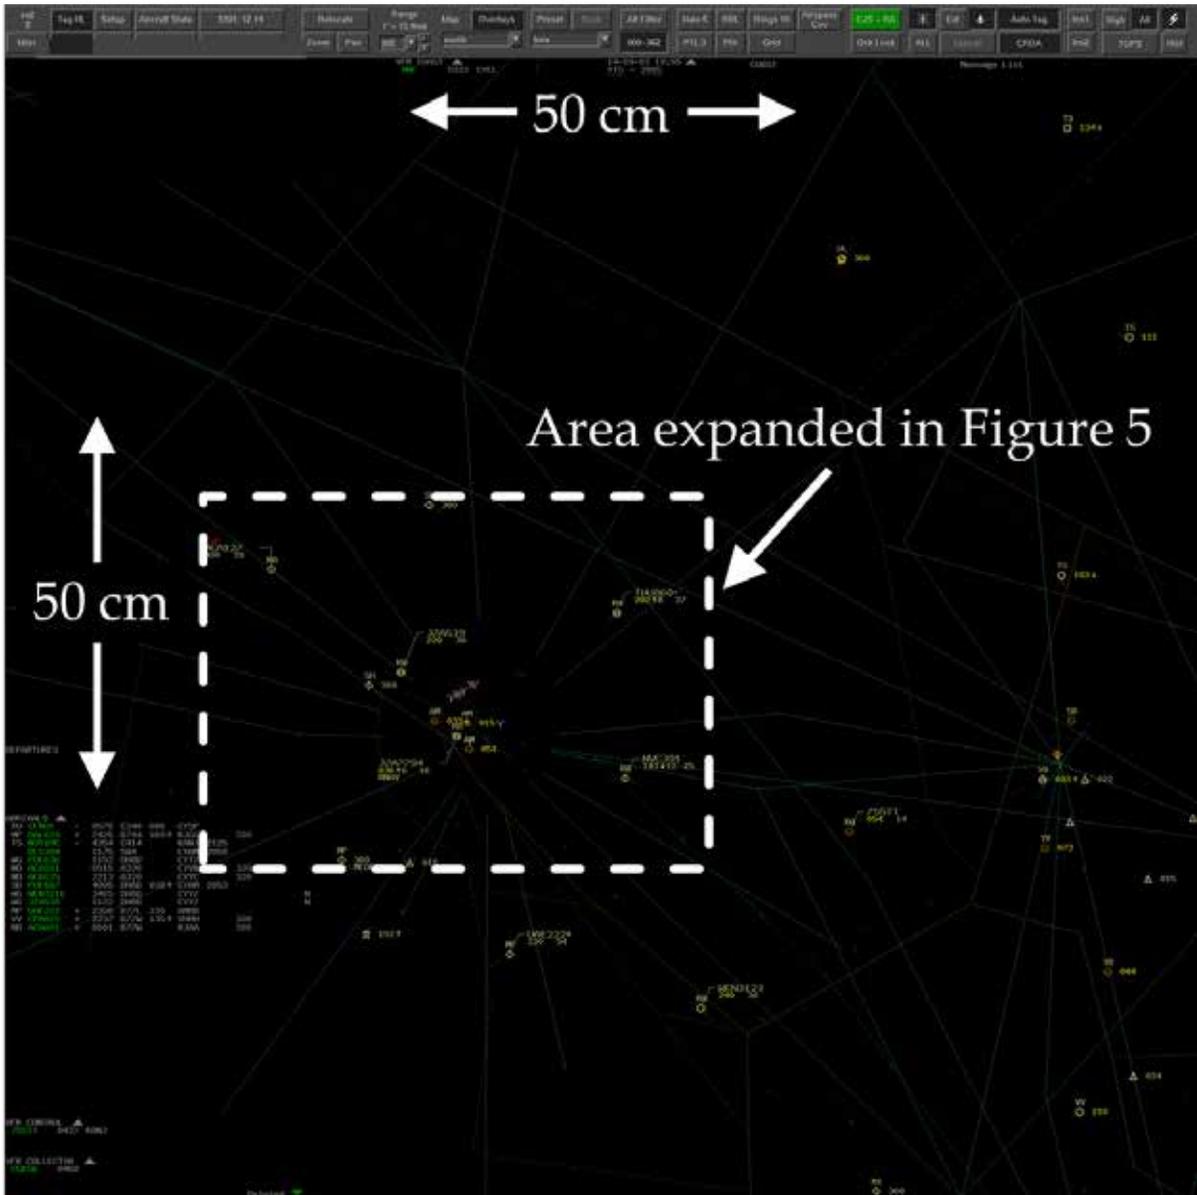
Figure 3. The CAATS situational display (CSit) at the time of the occurrence (Source: NAV CANADA, with TSB annotations)

Given the large size of the Sault Low Sector, the radar range is normally set to 305 nm, a setting that enables the controller to see the entire sector (Figure 3). With the range set to this scale, 1 cm of screen resolution equals 6 nm.

The CZYZ controller was used to seeing VFR targets surrounding CYAM and preferred to have the PPSs associated with these targets dimmed to the lowest available setting to ensure that the IFR PPSs stood out. In the controller's experience, these VFR targets were most often at low altitudes (less than 5000 feet) and generally didn't conflict with IFR traffic.

The controller was familiar with seeing VFR targets in the area of CYAM, and was aware of the busy flight school in the area. In the controller's experience, the targets in close proximity to the airport were much lower than 5000 feet. This expectation may have resulted in the aircraft target's altitude going unnoticed. This may also have occurred due to the fact that the brightness of the target—and all other VFR targets—was set to the minimum setting, or potentially due to the clutter of the targets in the CYAM area, given the large scale of the display for the Sault Low sector.

Therefore, the target's altitude went unnoticed when the CZZY controller cleared JZA7794 direct to the DARID intersection, possibly due to a combination of clutter between radar targets, dimness of display, and expectation of a lower altitude for the training aircraft.

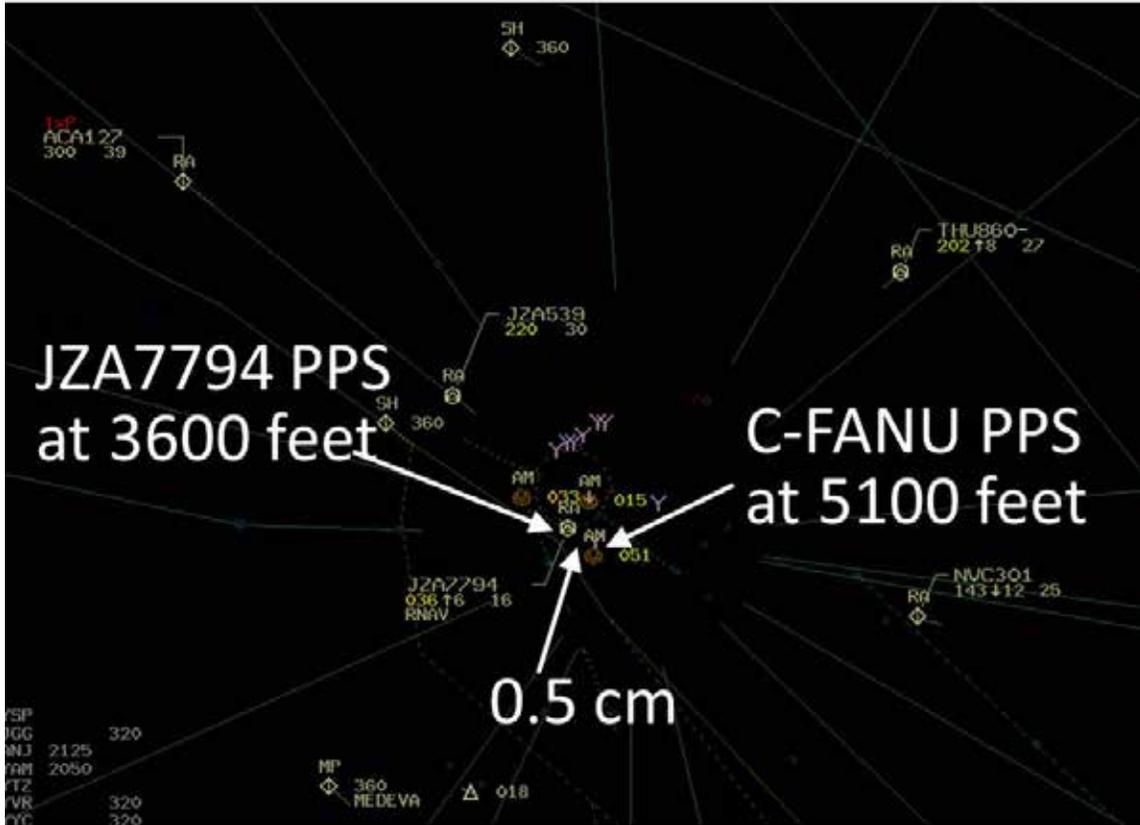
Figure 4. Expanded portion of the CSit in Figure 3, as it appeared shortly before the traffic alert and collision avoidance system (TCAS) traffic advisory (TA) (Source: NAV CANADA, with TSB annotations)

When the clearance direct to DARID was issued to JZA7794, the 2 occurrence targets were separated by 8 nm, or 1.3 cm on the screen. Just before the JZA7794 flight crew received the TCAS TA, the targets were separated by 3 nm, or 0.5 cm (Figure 4).

As the aircraft passed each other, their PPSs overlapped.

When the controller issued the clearance to JZA7794, the radar target on the controller's screen associated with C-FANU was directly in line between JZA7794 and DARID, and displayed an altitude of 5600 feet.

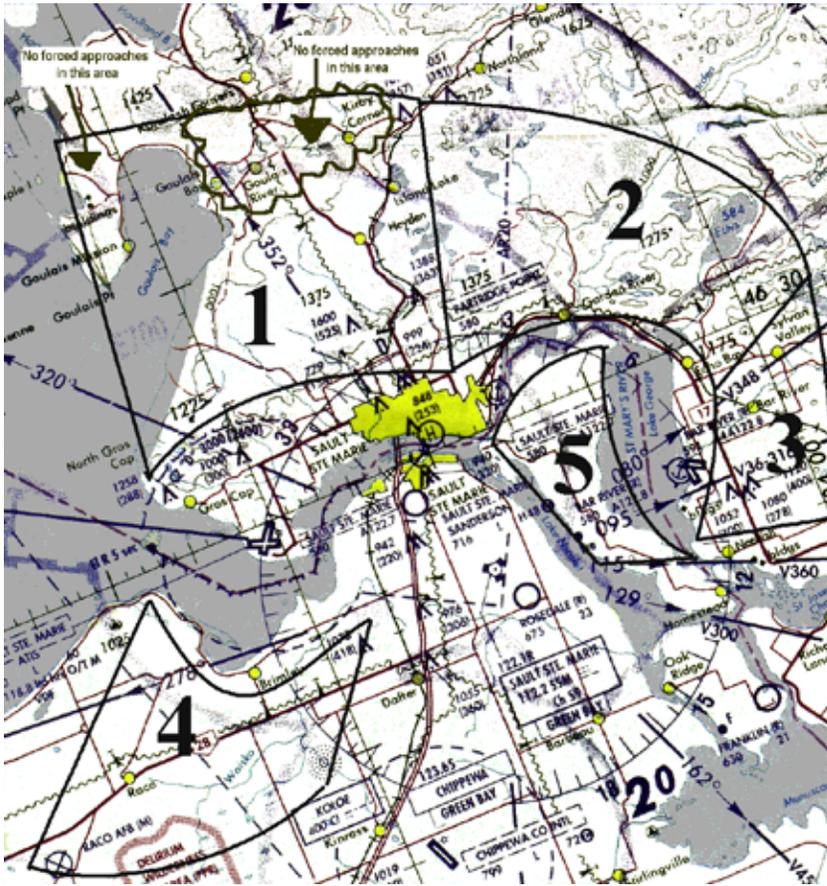
Figure 8. Sault College designated practice areas (Source: Sault College of Applied Arts and Technology)

Prior to the occurrence, in part to address the risk of conflicts, Sault College had published specific designated practice areas within its SOPs (Figure 8). The purpose of the areas was to keep Sault College aircraft somewhat separated as students and instructors discussed their planned areas of operation before departure and during flight on the company dispatch frequency. Additionally, the areas served to detail where some specific training manoeuvres could and could not take place. However, no guidance was provided regarding the use of the areas for upper airwork.

At the time of the occurrence, the instructor and student were somewhat familiar with the practice area designations. As the areas were published only in the Sault College manuals, the CYAM control tower and CZYZ were not aware of their existence.
