MARINE OCCURRENCE REPORT

M97W0236

SINKING

“PACIFIC CHARMER”

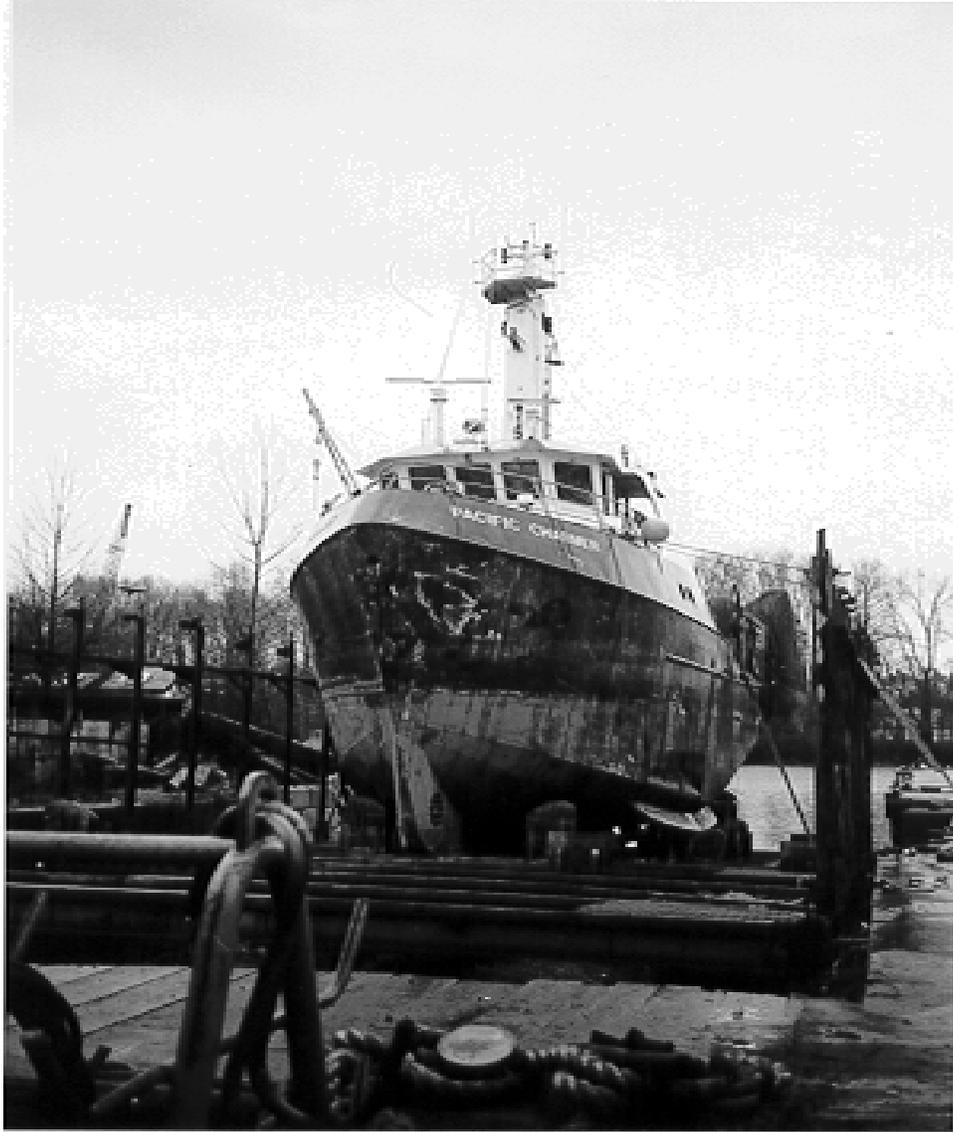
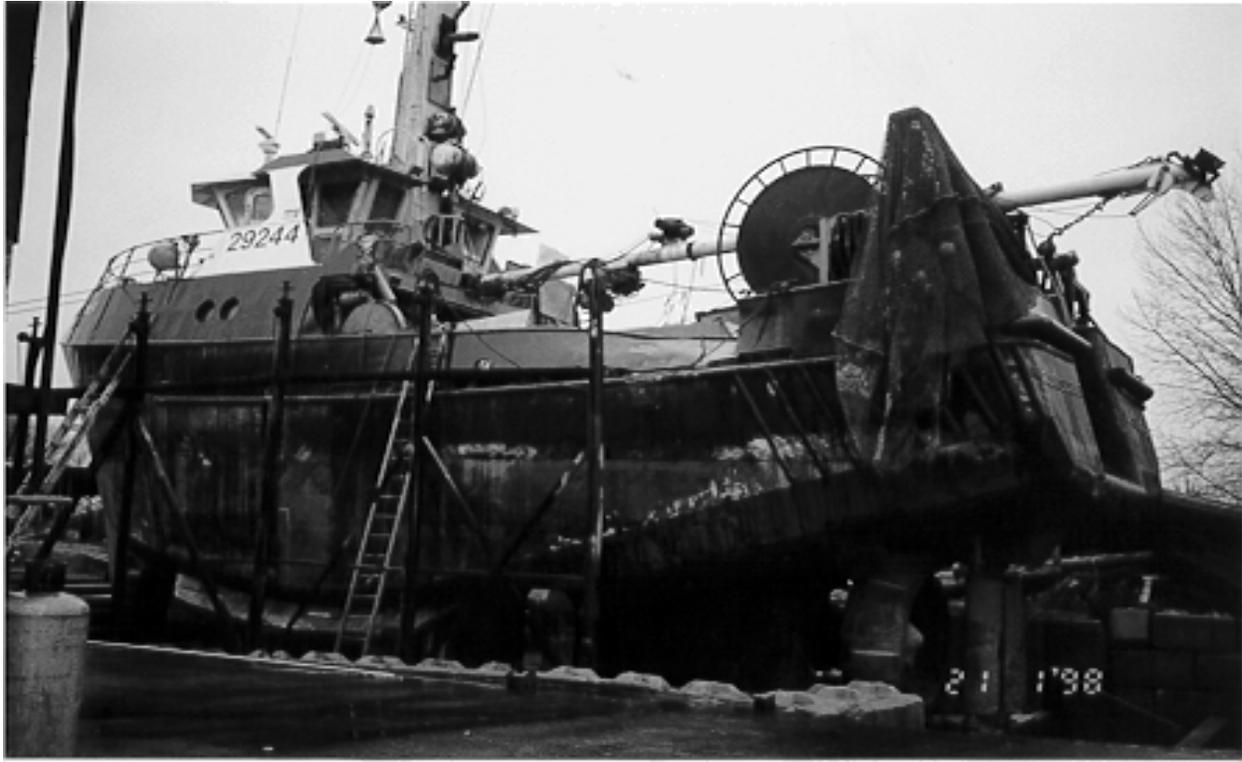
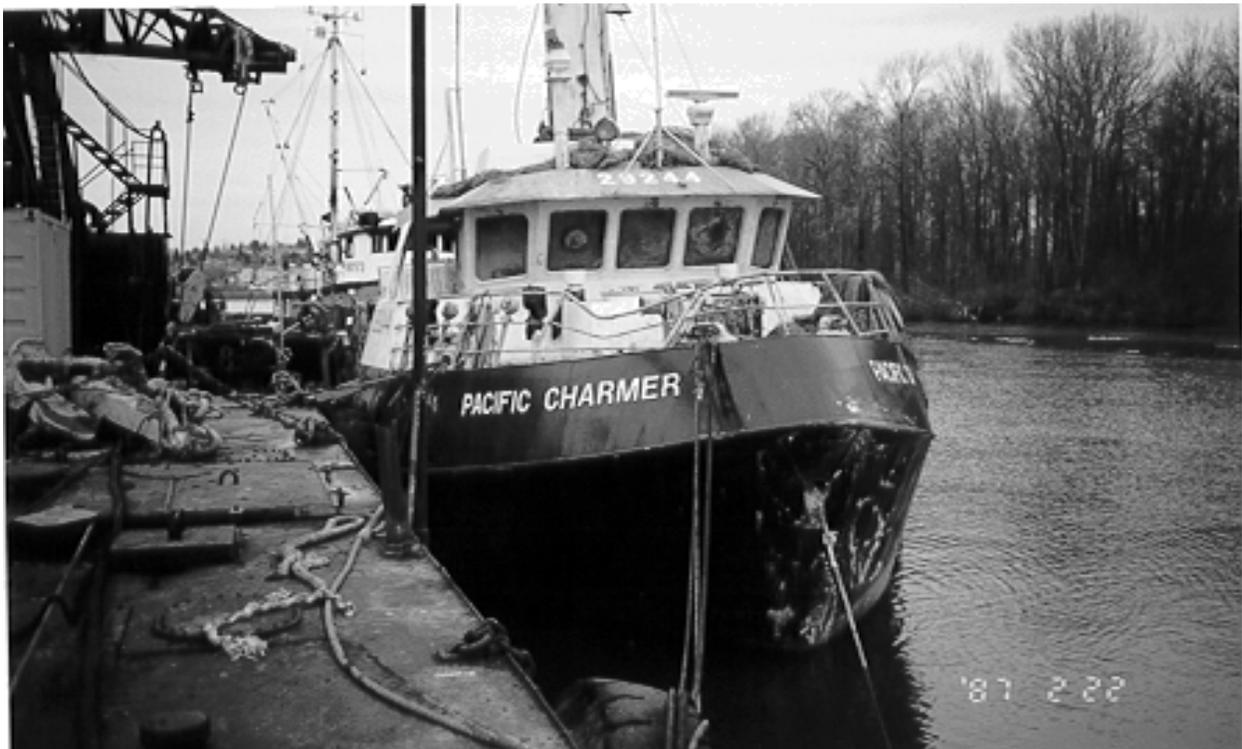
Appendix B - Photographs

- a) The sunken vessel was initially found lying bow down and partially buried in the sea bed, listed to starboard, and resting on the bottom shell and chine at the starboard turn of bilge.
- b) The watertight integrity of the hull shell, stern-tube bearing, rudder trunk bearing, sea-suctions and transducer penetrations, etc., were intact, and revealed no source of ingress for flood-water prior to the occurrence.
- c) The electrically operated triple-rudder angle indicator located at the wheel-house control station showed 19 degrees port helm was applied when power was lost as the vessel was sinking.
- d) The ship's electric clock in the wheel-house was found to have stopped at 0130.

- h) The engine-room and crew accommodation weathertight access doors located above the main deck were found hooked in the open position.
- i) The watertight door at the after end of the shaft tunnel giving access to the lazaret and steering gear compartment was found to be secured open with a synthetic rope lashing.
