MARINE INVESTIGATION REPORT
M99C0005

GROUNDING AND HULL DAMAGE

THE BULK CARRIER "ALGONTARIO"
AT JOHNSON POINT, ST. MARYS RIVER, ONTARIO
5 APRIL 1999

Report Number M99C0005

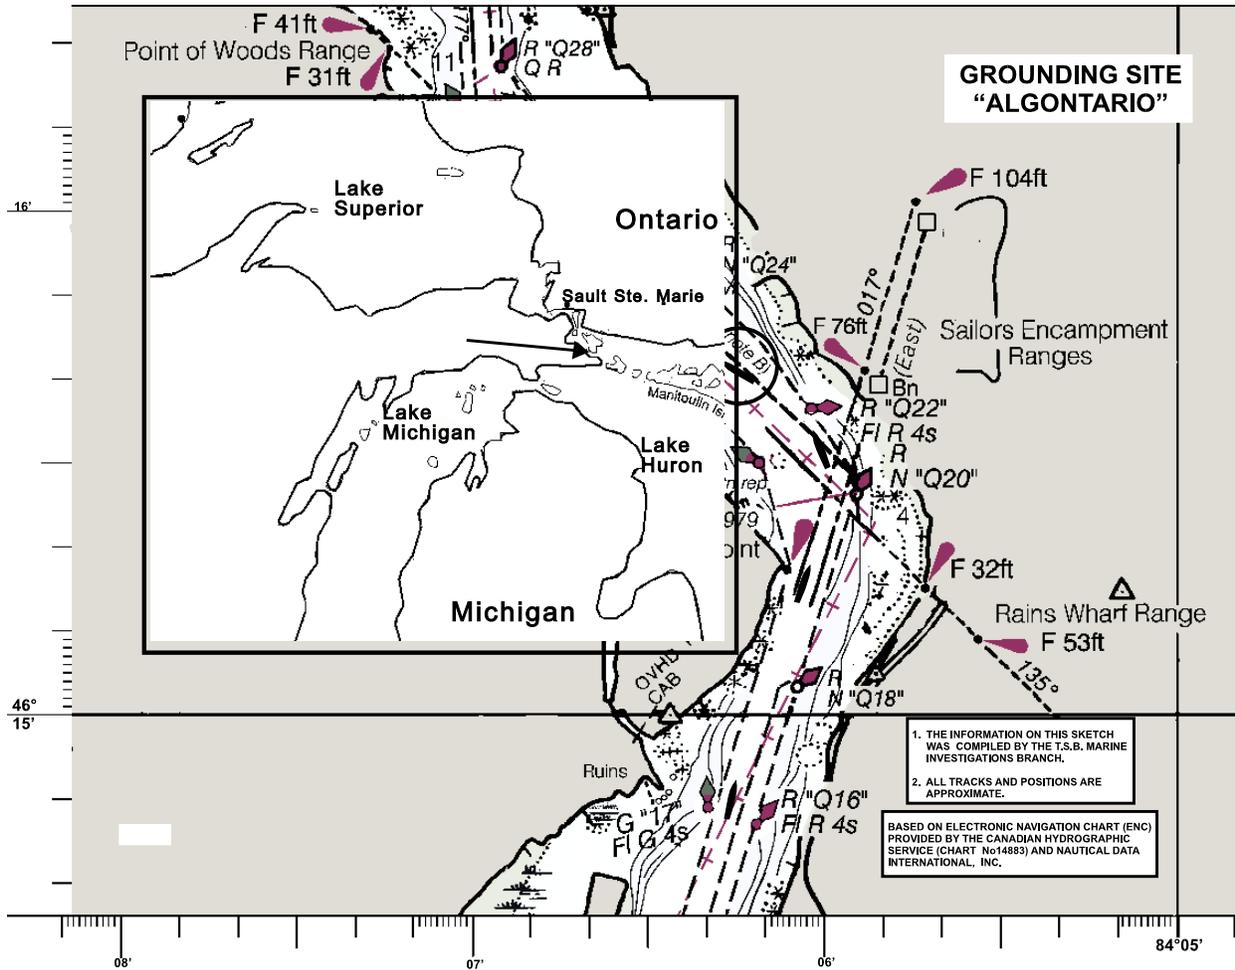
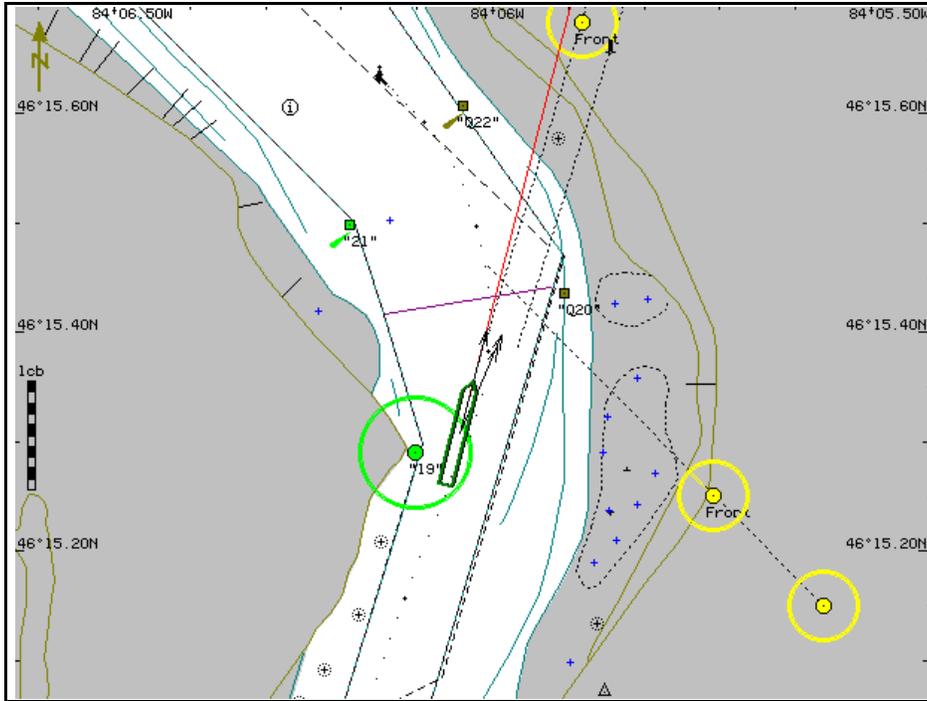
Appendix A - Occurrence Area with Track of the Vessel

There is conflicting information as to when the order to turn was given. Information retrieved from the ECDIS suggests that there is a discrepancy between the location where the order “Come to Port” was reportedly given and the position of the vessel when the bow started to swing to port. In fact, two thirds of the ship’s length had passed Johnson Point light when the first change of heading was recorded (see Appendix A).

The trace on the ECDIS shows that the vessel stayed in the deep water channel all the way on Course 9 with a minor adjustment for set near buoy Q18 at 0836. The bow of the vessel was well past Johnson Point light when it started to swing to port at 0840. A current of approximately 2 knots acting on the port side would have reduced the rate of turn, causing the turning circle to be larger than anticipated.

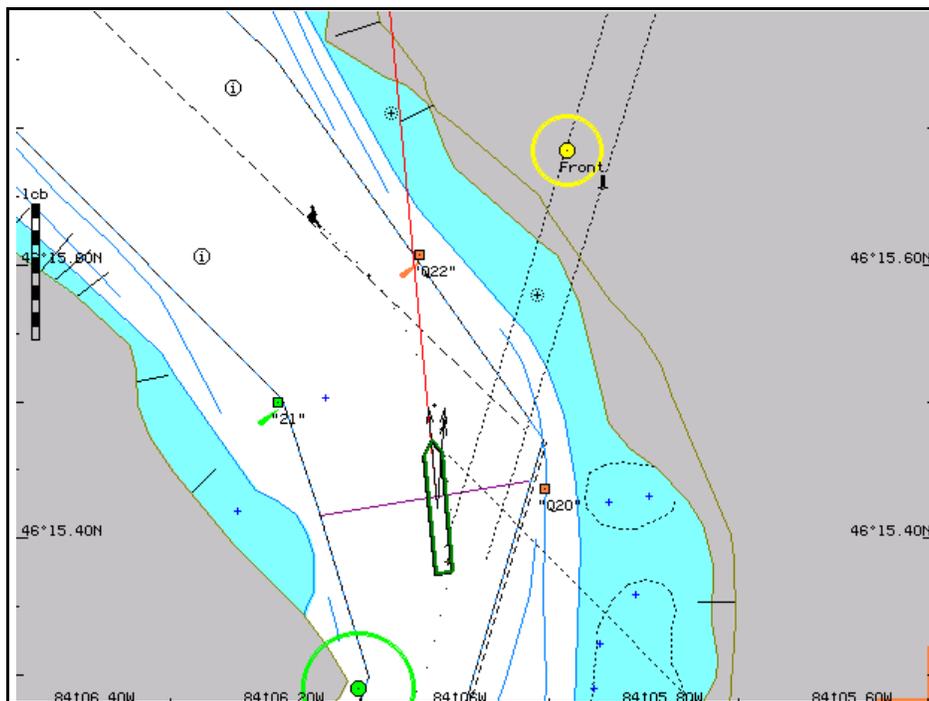
At 0434 the vessel passed buoy Q16 with an SOG of 7.5 knots. The helmsman steered the vessel using the Sailor's Encampment range lights, 017°T, using the left-hand-side range. At 0436 the speed had decreased to 7.4 knots at buoy Q18 and to 7.1 knots at 0438. At 0439, more than half the ship's length had passed Johnson Point light, which was approximately 60 m to port. The ship's heading was 015°T, and the SOG was 7.2 knots. The master called Soo Control at the winter calling-in point near Johnson Point. The mate noted the position in the log book. The engine speed was then increased to Position 6 on the throttle. At 0440, after the master ordered "Come to Port" when Johnson Point light was abreast of the bridge window, the helmsman immediately put the helm hard to port and the rudder angle indicator followed. The bow started to swing to port, as confirmed by an ECDIS heading of 354°T (see Appendix B, Figure 1).

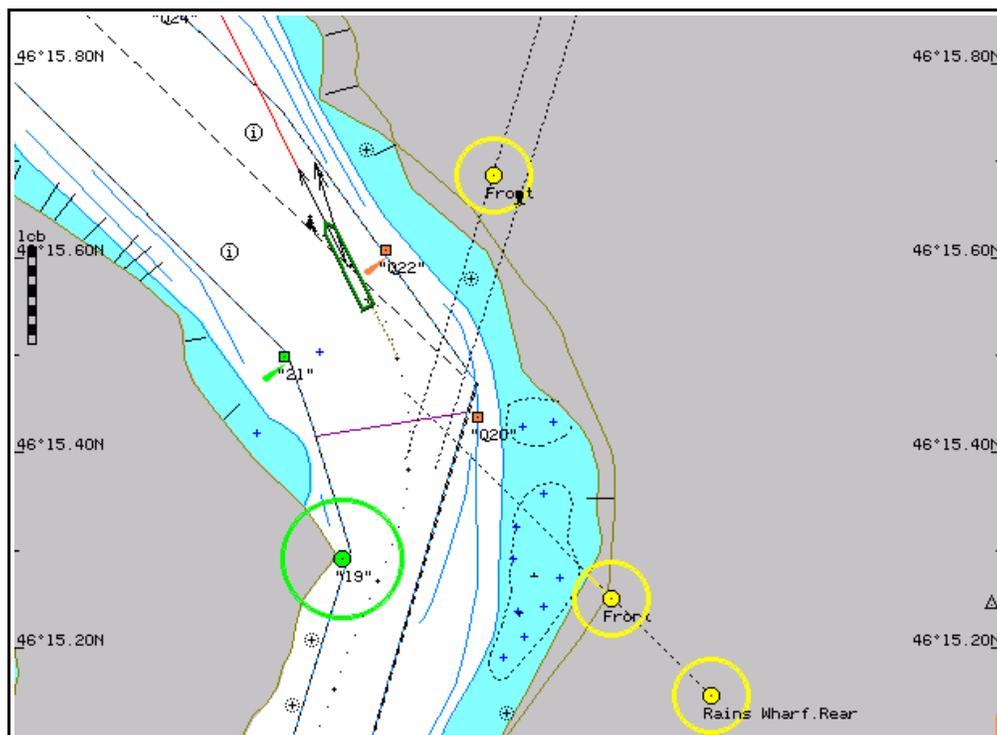
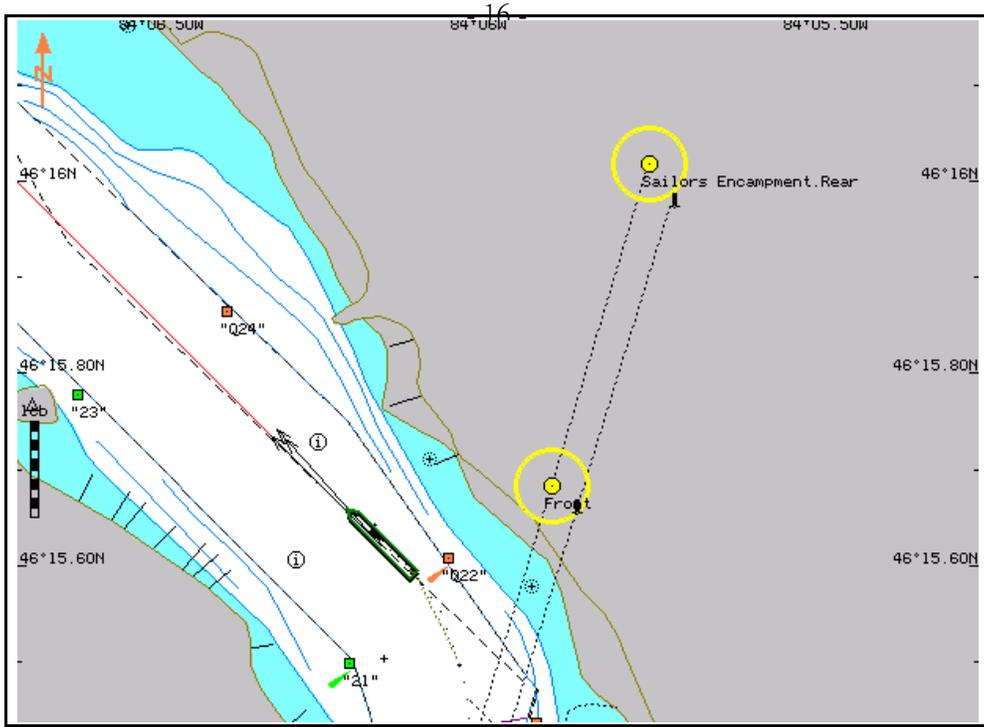
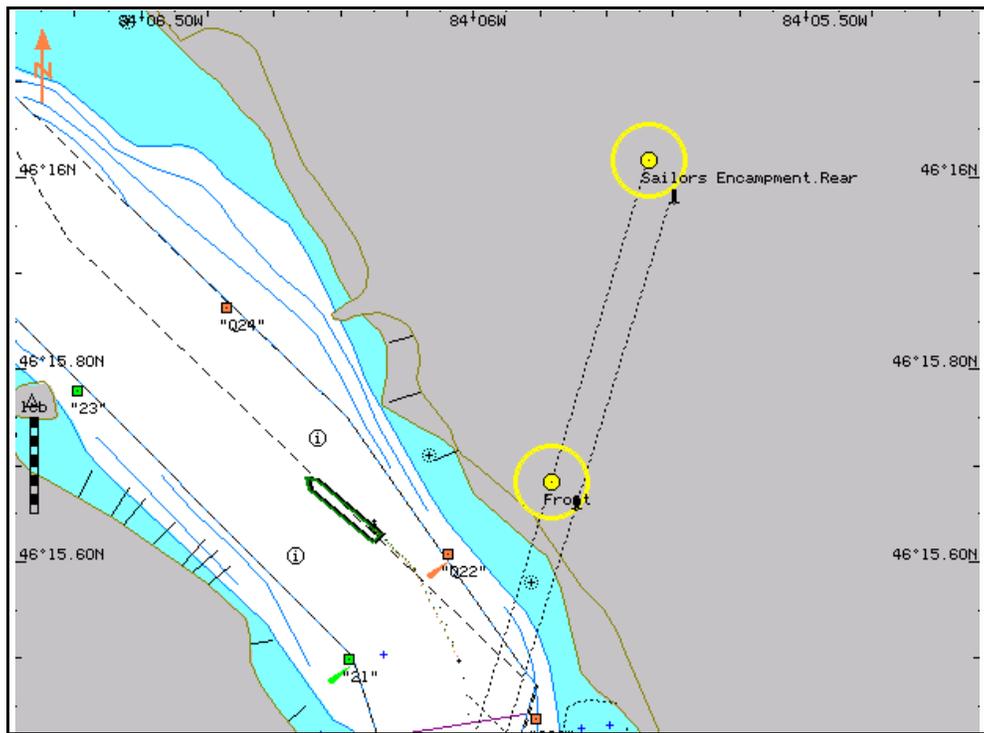
The vessel continued to turn to port but also drifted to starboard into the shallow channel. When the mate felt the vessel shudder, he left the chart table to go to the bridge front window. There was no reported discrepancy between ship time and ECDIS time (see Appendix B, Figures 4, 5, and 6).

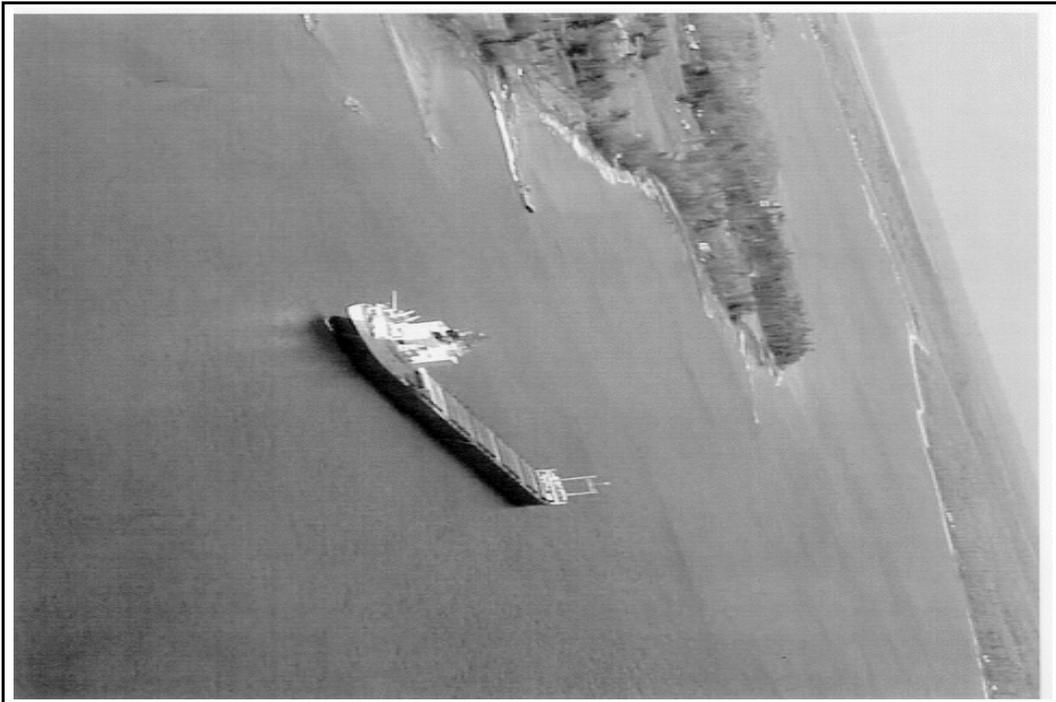
Appendix C - Photographs

A diving inspection revealed that the ship was resting on a mud, gravel, and rock bottom, the stern frame skeg was resting on boulders, and the rudder was clear. The diving inspection and subsequent dry-dock survey indicated that the vessel had sustained extensive bottom shell plating damage. Starboard double bottom water ballast tanks Nos. 4, 5, and 6 and the feed water tank and cofferdams in way of the engine room were breached.
