MARINE INVESTIGATION REPORT

M99W0133

COLLISION

BETWEEN THE PLEASURE CRAFT *SUNBOY* AND THE  
TUG *JOSE NARVAEZ* TOWING THE

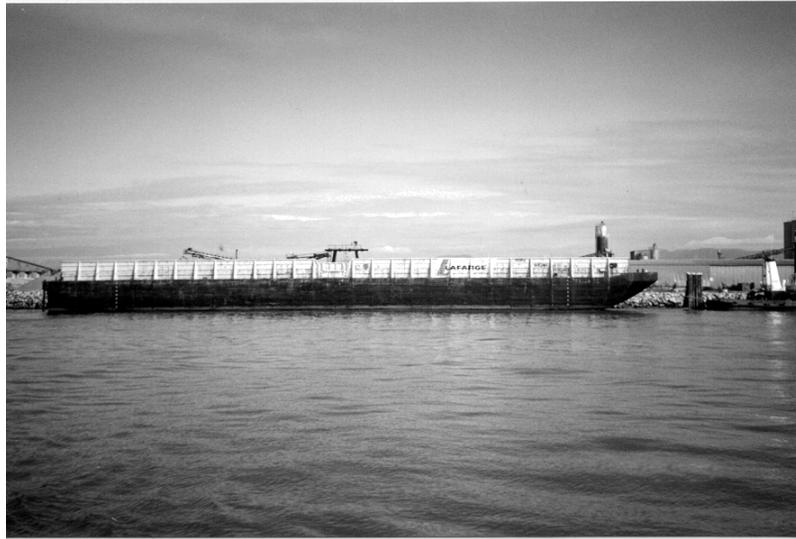
The barge had three minor abrasions on the port side of the forward rake 1 m below the main deck. Abrasion marks were found approximately 4 m from the towing eyes on the port bridle of the *Texada B.C.* The abrasions were consistent over an area of approximately 4.5 m.

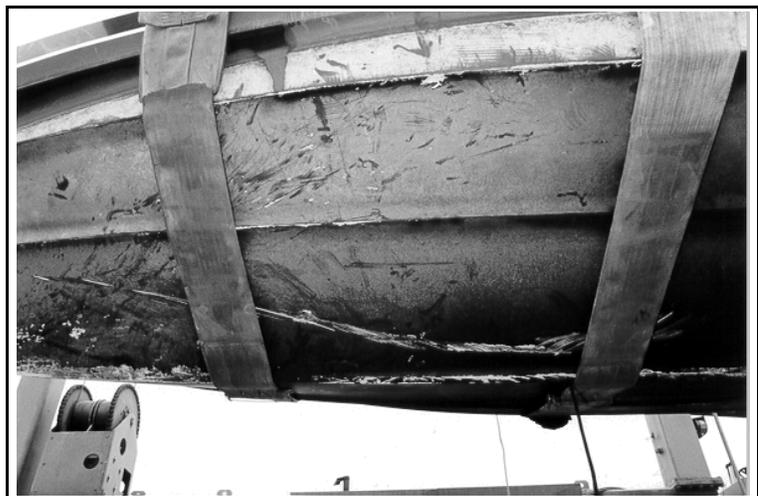
The pleasure craft was extensively damaged, particularly on her port side. The significant structural damage was identified as follows:

- port propeller blades were bent and fractured
- starboard propeller blades were bent, fractured or missing

- port rudder was bent back and upward sufficient to puncture the hull
- port portion of the underwater hull, keel and chine were heavily scarred
- port lifeline stanchions were torn away from their main deck fittings
- entire bridge superstructure was dislodged and broken in many places
- port salon window was dislodged and missing
- forward window directly ahead of the interior helm was missing.

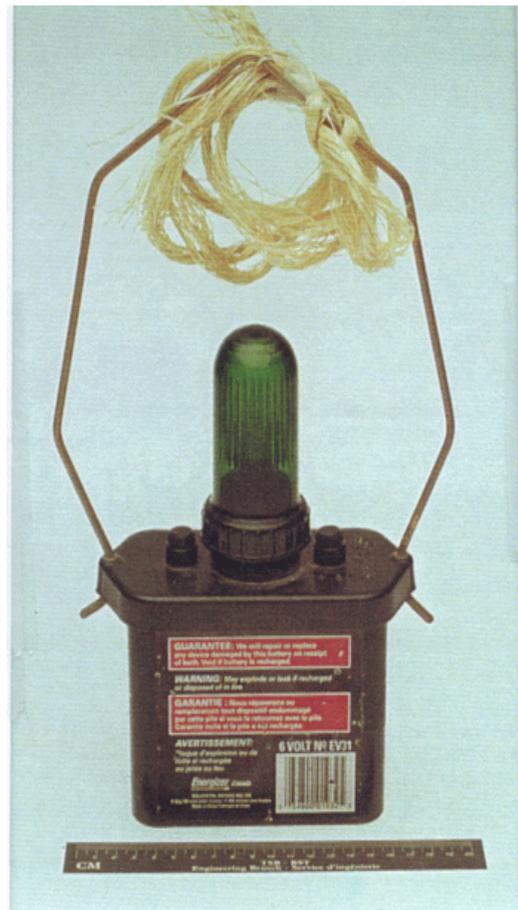
#### 1.9.1 *Portable Navigation Lights*

The substitute light in use aboard the *Texada B.C.* on the night of August 7 is commonly referred to as a "Scotty" lantern. It was a 6-volt lantern battery atop which was secured a light assembly with a green lens cap over a clear light bulb. The height of the combined battery and light assembly was approximately 25 cm. Attached to the battery was a wire carrying-handle rising approximately 25 cm above the battery. Tied to the top of the handle of the lantern was a coiled length of twine. The lantern weighed approximately 2.5 kg. Its type is catalogued in the manufacturer's sales material as a barge, boom or portable anchor light designed to be used with a clear lens. It is identified in its packaging as a "Barge and Boom Lantern". (The manufacturer indicated that, with a clear lens, the visibility range is approximately 1 nm.) However, the design permits the clear lenses to be replaced with coloured lenses. The TSB had the lantern tested in an independent laboratory five weeks after the collision, in the presence of representatives of both the owner and the TSB. With a green (starboard) lens, the lantern was found to have a maximum visibility range of less than four cables (0.4 nm). International regulations required the sidelight to have a minimum visibility range of 3 nm. The owners of the tug and barge maintained an inventory of these lanterns and occasionally used them on barges as temporary sidelights.

This investigation revealed the widespread use of portable kerosene- and battery-operated navigation lights in the West Coast towing industry, particularly on barges and log booms. The visibility range of these lights—most frequently used as navigation lights—is substantially below that required for safety as specified in the COLREGS, which in this instance was 3 miles. These navigation lights have not been tested in accordance with the Transport Canada publication entitled *Standards for Navigation Lights, Shapes, Sound Signal Appliances and Radar Reflectors 1991 - TP1861*.

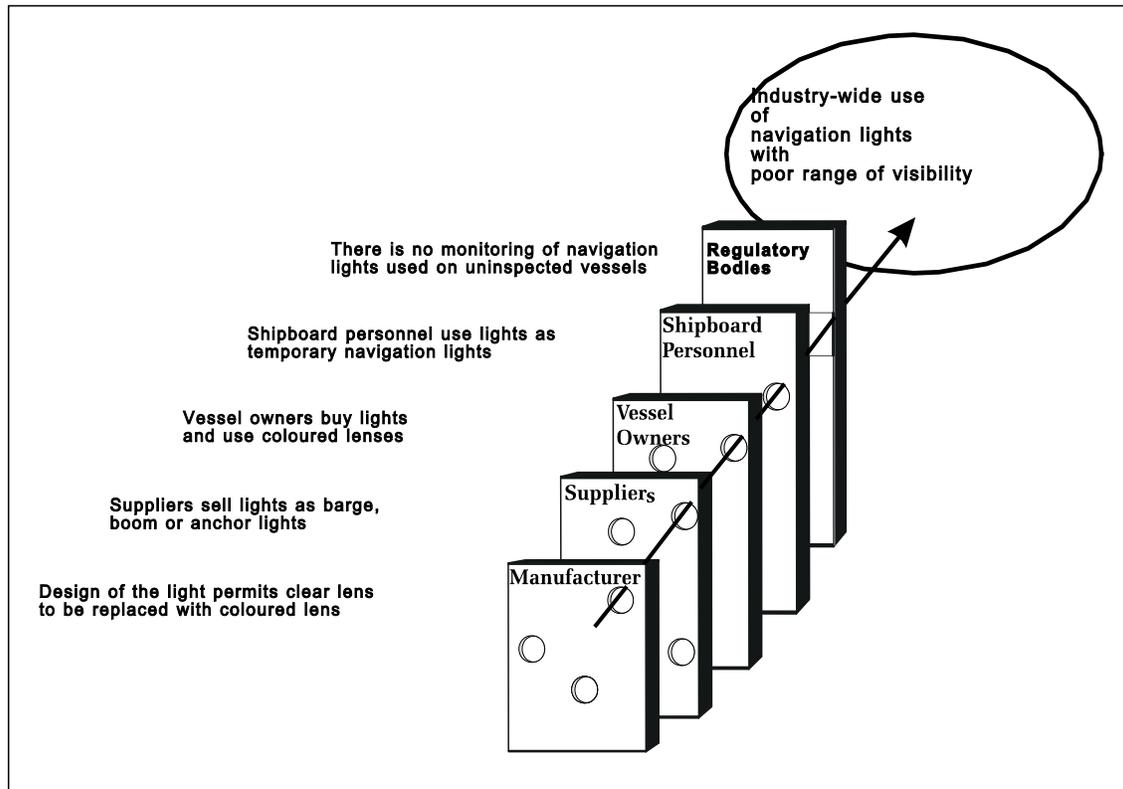
Given the long history of the use of these navigation lights within the industry, and given that these lights are supplied by the company for use as navigation lights, the ship's complement had no reason not to accept them as such. Consequently, the risk associated with the use of these lights was unrecognized and the safety threshold was thus lowered. Reason's model of accident causation is used to illustrate, from a systemic perspective, a number of safety defences that had been breached. The result is the widespread use of lights for navigation purposes that do not meet the safety range of visibility (see Figure 1).

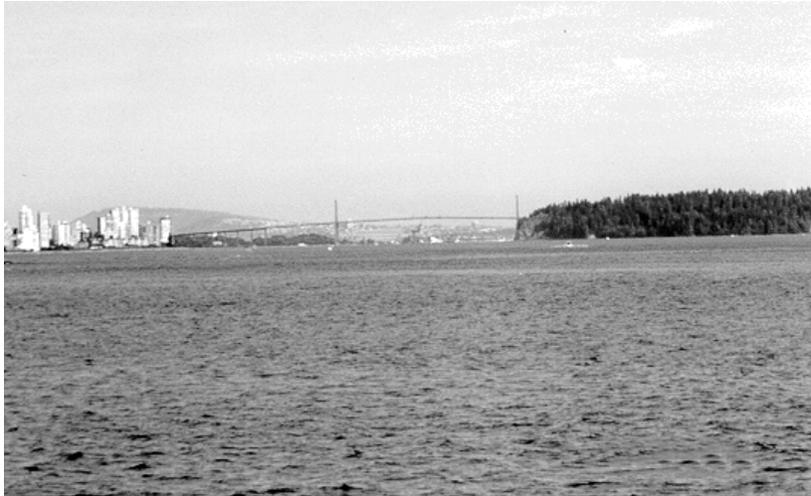
An observation of the view that would have been seen from the flying bridge of the *Sunboy*, as it made its way between its West Vancouver moorage and Burrard Inlet, was carried out on the night of August 11 (the next fireworks night). The observation revealed that from the command bridge one could see, from left to right, the north shore of Burrard Inlet, buoy "QB", the unlit area of Stanley Park, a large group of boats assembled around the fireworks barge and, behind them, the shore lights along English Bay beach towards False Creek. As the *Texada B.C.* and the *Sunboy* were on a near-collision course, the bearing of the barge from the *Sunboy* would have remained constant. Hence, the predominately dark barge

moving in front of Stanley Park would have been difficult to discern. Given the visibility range of the barge's starboard sidelight, the sighting of the barge from the *Sunboy* would have been made all the more difficult. This is consistent with the operator's perception that the barge was an island.
