## MARINE INVESTIGATION REPORT

M02L0061

### CREW MEMBER LOST OVERBOARD

BULK CARRIER *KENT*  
NEAR VERCHÈRES, QUEBEC

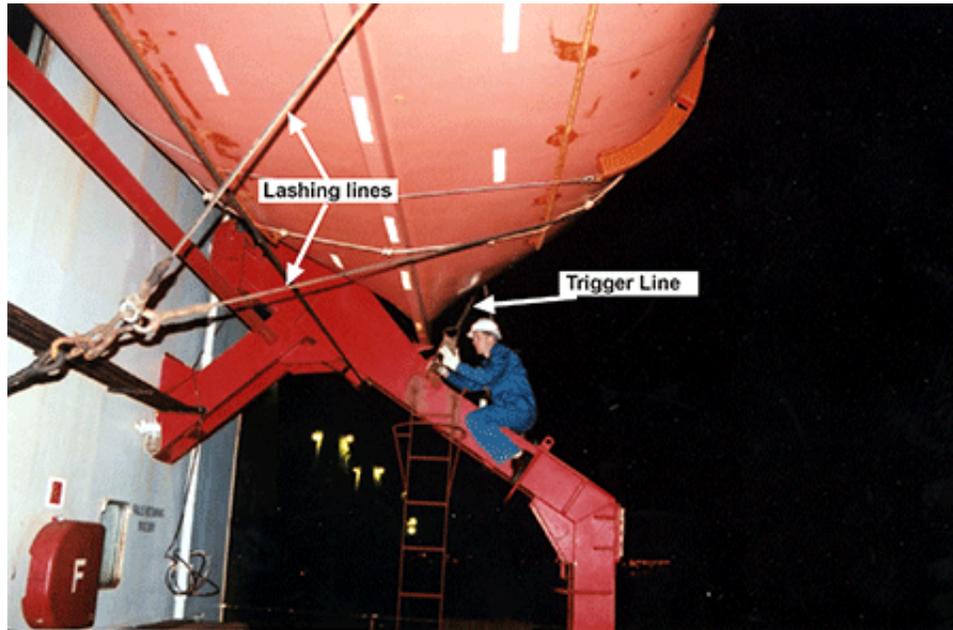
after reaching the deck he heard a noise, and turned to see the roller gravity davits with the suspended lifeboat, sliding down the cradle.

The noise also alerted the ship's electrician who was nearby. Both the electrician and the seaman rushed to the lifeboat davit winch and applied the brake. The lifeboat stopped descending but not before hitting the bosun, sending him backwards. He clung to the trigger line momentarily, but lost his grip and fell overboard into the water 15 m below. The time was approximately 1825.

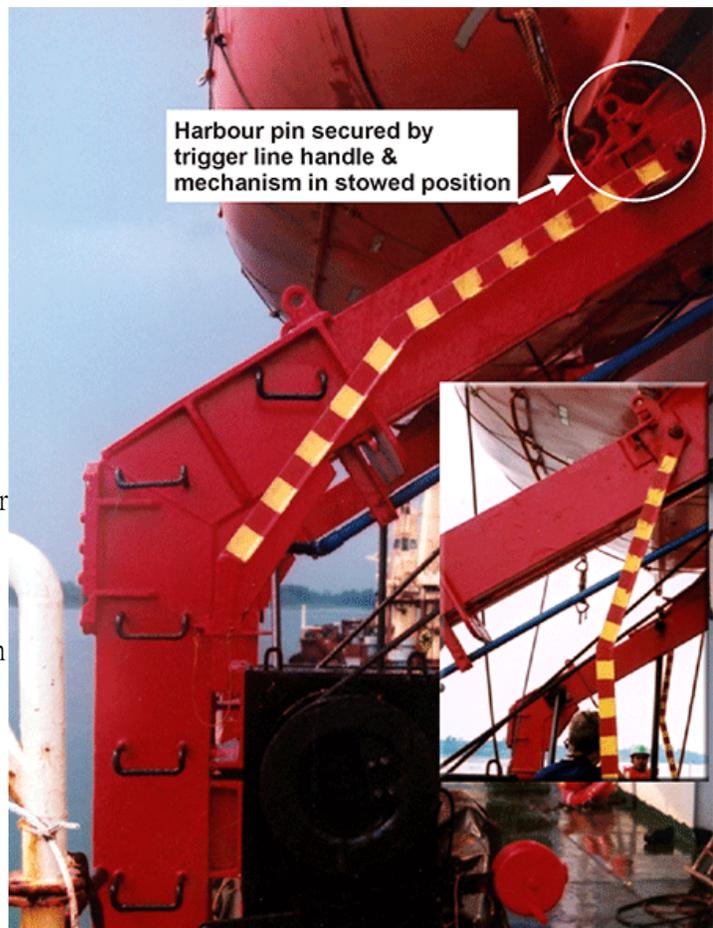
With a lifeboat on its roller gravity davits in the stowed position, the trigger line release handles are in line with the davit cradles (see Photo 2 ). In this "locked" position, the harbour pins are secured across the roller track to prevent the descent of the gravity davits holding the lifeboat. In the released position, the trigger line release handles are pulled down to the vertical, simultaneously releasing the trigger line and allowing the harbour pin to be swept aside as the gravity davits, with the suspended lifeboat, descend the davit cradle roller tracks (see inset in Photo 2).

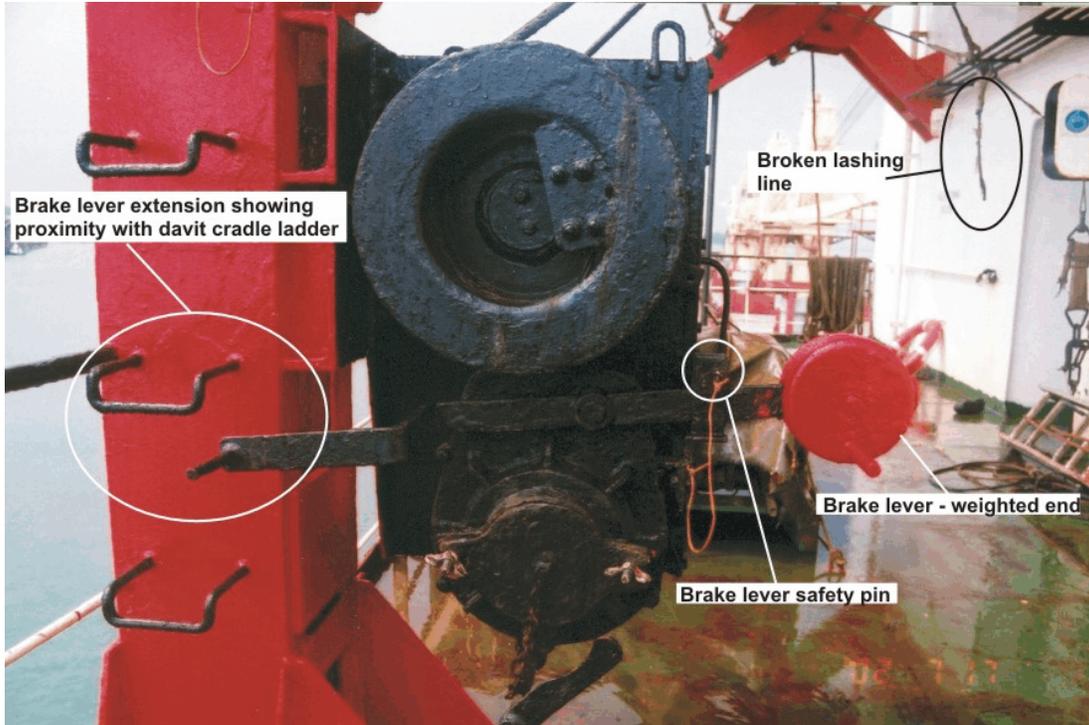
- When the weighted inboard end of the brake lever mechanism was lifted into the “brake off” position, it remained stuck in the off position after the lever was released, instead of falling into place to reset the brake.

- With the safety pin on the brake lever mechanism in place to avoid accidental release, a gap of 12 mm existed between the safety pin and the lever. This gap allowed the lever to be lifted sufficiently to disengage the brake and release the lifeboat.

- Parted ends of a broken lashing line showed signs of advanced corrosion and wear. Close examination by the TSB Engineering Branch established that the number of wires within the port lashing line had been reduced to 37 per cent of the original wire count (from 144 to 54).<sup>4</sup>

- The outboard end of the brake lever (opposite the weighted end) was extended such that the handle was near the vessel’s side to control, within view, the lowering of the lifeboat down the ship’s side to the waterline. The handle was in very close proximity to (6 cm below and 5 cm out from) the second rung of the aft cradle ladder (see Photo 3). It was further noted that if this handle was pushed down, it would have the same effect as lifting the brake lever at the inboard (weighted) end, that is, to disengage the brake.

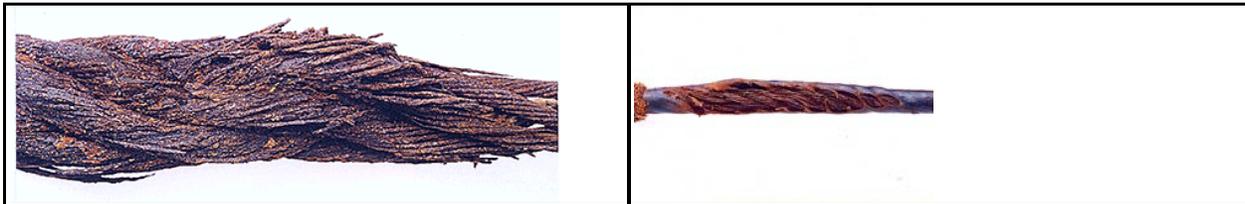
The steel wire cable lashing line was corroded well beyond its serviceable life. Although plastic protected wire cable can hide the condition of a steel wire, in this case, even a cursory inspection would have revealed the deteriorated condition of the cable. The failed cable, together with a similar piece of lashing from the starboard lifeboat davits, was examined by the TSB Engineering Branch<sup>8</sup> (see photos 4 and 5). It was concluded that only 37 per cent of the steel wires within the port cable were carrying the load and 55 per cent were effective in the starboard cable. Severe corrosion caused the starboard cable to fail under testing at a load of 1638 kg, and the port side would have likely failed at a load of approximately 1119 kg.
