MARINE INVESTIGATION REPORT
M04L0099

COLLISION

BETWEEN THE PLEASURE CRAFT *MONDISY*
AND THE CONTAINER SHIP *CANADA SENATOR*
OFF SAINT-NICOLAS, QUEBEC
11 AUGUST 2004

Report Number M04L0099

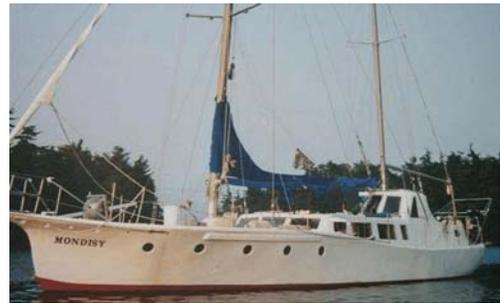
Photo 2. The *Mondisy*

The wreck of the *Mondisy* was salvaged from the river bottom 22 days after the collision in position latitude 46°42'54" N, longitude 071°25'42" W. Damage was extreme as the entire hull had collapsed under the force of the impact with the *Canada Senator*. The laptop computer used for navigation was recovered, but information pertaining to the last voyage was not retrievable from the hard disc because of water damage.

Although reports of pleasure craft hindering large vessels in the main shipping channel is a common occurrence, collisions are rare. In 1986, a 12 m fibreglass sailboat and a laker were involved in a collision in the main shipping channel near Chippewa Point, New York, United States.⁸ The sailboat remained perched on the bulbous bow of the laker for several minutes and, when way was taken off the laker, the sailboat slipped off and remained afloat. The sailboat sustained only minor hull damage and the occupants sustained some bruises. The *Mondisy*, of ferro-cement construction, was made of materials without inherent buoyancy and relatively unresilient. Upon impact with the steel bow of the *Canada Senator*, the ferro-cement hull was breached and the sailboat quickly sank.

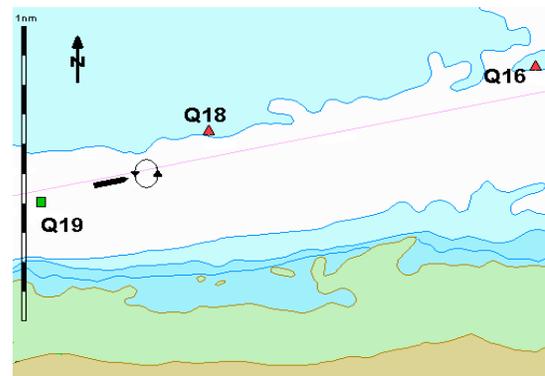
Figure 1. *Mondisy* track (not to scale)

The movement of the sailboat was reported as being unusual, but many pilots report similar experiences with pleasure boats. To the bridge team who observed the *Mondisy* on board the *Canada Senator*, the sailboat was moving back and forth across the river. A shore-based observer very close to the collision site and high on the overlooking cliffs indicated that the sailboat had in fact been circling to port (counterclockwise) for at least 15 minutes before the collision. The *Mondisy* was also drifting down river with the ebbing tidal current at between 2 and 3 knots.

From the nearby cliffs and looking down at the *Mondisy*, the sailboat's true movement could be observed, that is circling. However, from a distance such as on board the *Canada Senator*, the circular movements of the *Mondisy* appeared as a zigzag manoeuvre. Repeatedly turning in circles is consistent with either a mechanical malfunction related to the steering, or the helm simply being left unattended for some time before the collision. There was no sign of activity on deck during the 15-minute period before the collision.
