MARINE INVESTIGATION REPORT
M06L0063

ACCIDENTAL RELEASE OF LIFEBOAT AND LOSS OF LIFE

BULK CARRIER *SEA URCHIN*
BAY OF SEPT-ÎLES, QUEBEC
22 MAY 2006

Report Number M06L0063

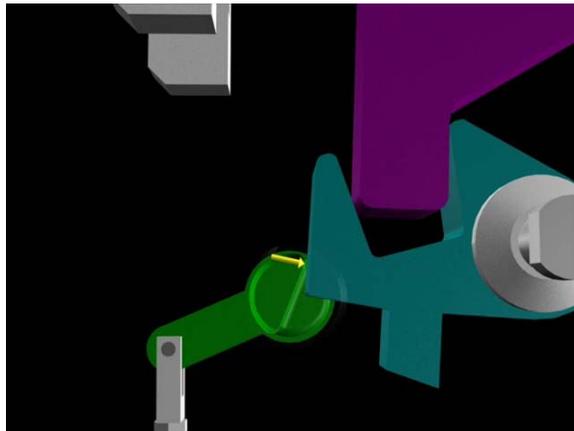
If the reset has been done properly, clearance (yellow lines) is visible between the cam and lock piece (see Figure 5). Note that this clearance must be maintained using constant pressure on the hook to keep the lock piece in place. If this clearance is not maintained, the lock piece will pivot back down and interfere with the cam, preventing the resetting of the cam into its final position (see Figure 6).

Figure 6. Interference between lock piece and cam

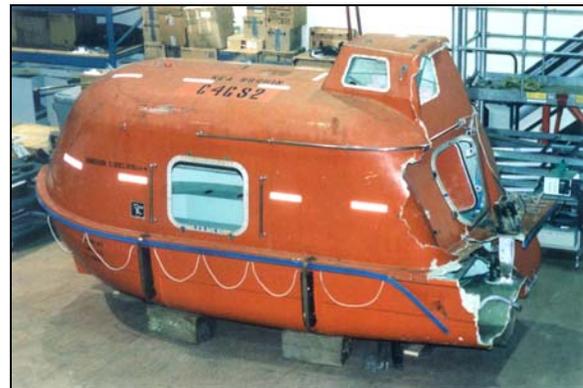
The starboard lifeboat was transported to the TSB Engineering Laboratory for examination and testing (see Photo 3).

Photo 3. The 25-person lifeboat, as received at the TSB Engineering Laboratory

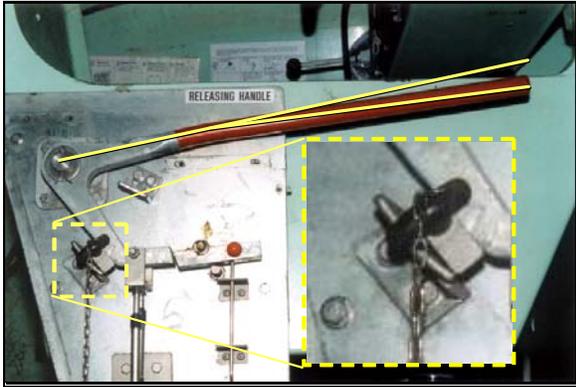
Before the recovery of the starboard lifeboat, the crew had difficulties lowering the release handle to its final position. Additional force by two crew members was applied in order to lower the release handle to a position where the safety pin could be inserted. In this instance, the release handle and the cable attachment bracket were found deformed and the safety pin inserted, but not rotated into its locked position (see Photos 4 and 5).

Photo 4. Deformation of release handle, with safety pin not rotated into locked position

When the release handle is lowered with the lock piece in an intermediate position, the lock piece interferes with the cam rotation. Any additional force applied on the release handle will translate into the release cable attachment bracket being deformed. The greater the deformation, the closer the release handle will be to its reset (final) position. With each subsequent deformation, and closer to final positioning of the reset handle, it becomes more likely that, given the short distance needed to achieve the goal of inserting the safety pin, an operator will attempt to force the system.

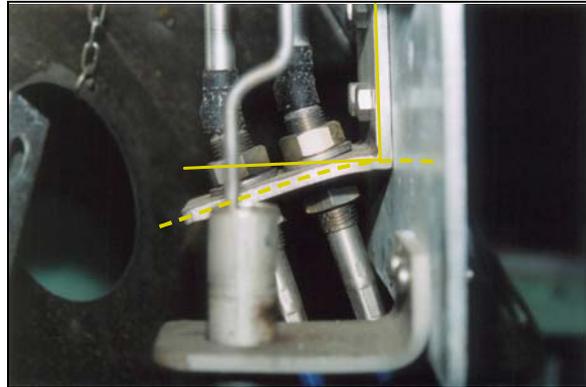
Photo 5. Deformation of release cable attachment bracket

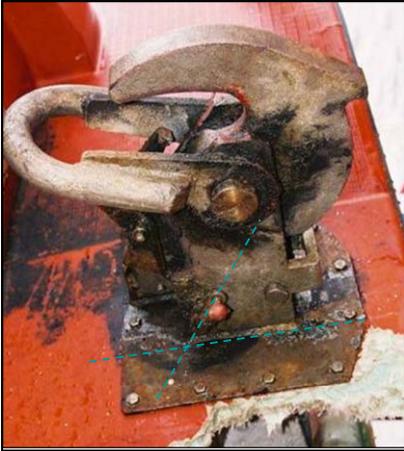
During the post-occurrence salvage, as the starboard lifeboat was being raised from the water, the cam lever on the aft hook assembly was observed as not being in the horizontal reset position (see Photos 6 and 7); hence, the hooks were not locked in place before the recovery.

Photo 6. Aft hook cam lever (red knob) not in horizontal reset position in situ

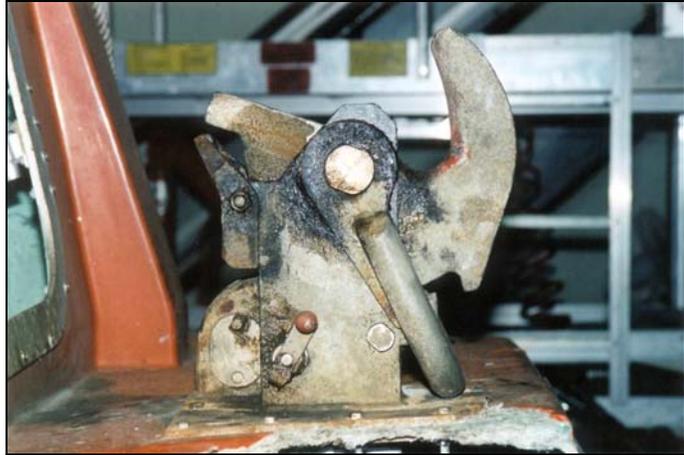
Photo 7. Aft hook as received at the TSB Engineering Laboratory

Although the release handle was locked by the safety pin, the cams (both fore and aft) were not fully rotated under their respective lock pieces. The interference resulting from the incorrect re-setting of the hooks, combined with the force required to insert the safety pin, accounted for the subsequent residual compression force in the release cables/cam lever assembly.⁴

This in turn generated sufficient friction between the cam edge and the lock piece to hold the hook in place and bear the load of the lifeboat. While the lifeboat was being hoisted, it was in a quasi-static state – at least until the floating blocks reached the davit arms, at which point the shock resulting from impact overcame the friction that held the aft hook in place. This released the davit fall long link. As the lifeboat's aft end began to fall, the load was transferred to the improperly reset forward hook, which could not absorb the additional load and released, allowing the lifeboat to fall.

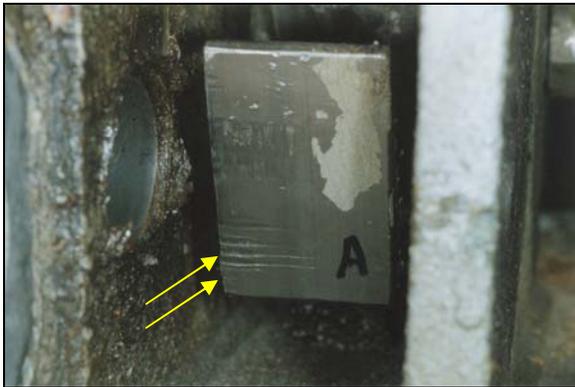
The interference or lack of clearance can be seen in Photos 8 and 9. These photos show multiple indentations where the cam previously interfered with the lock piece of the starboard lifeboat.

Photo 8. Indentations on aft hook lock piece caused by contact with top edge of cam

The multiple indentations on the lock piece, caused by contact with the cam edge, suggest that this scenario had taken place before – a repeated pattern of improper resetting that put the safety of crew and equipment at risk.

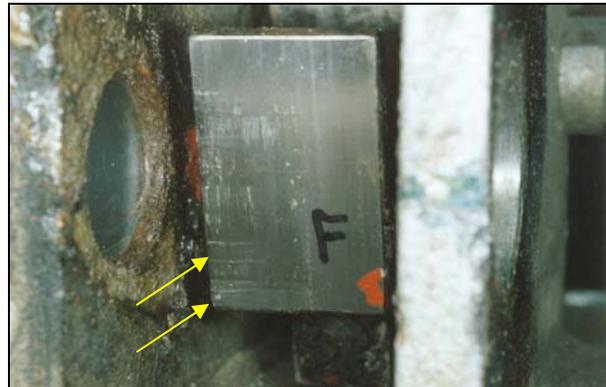
Photo 9. Indentations on forward hook lock piece caused by contact with top edge of cam
