## MARINE INVESTIGATION REPORT

M07N0117

### CAPSIZING AND LOSS OF LIFE

SMALL FISHING VESSEL *SEA URCHIN*  
NEWMAN SOUND, NEWFOUNDLAND AND LABRADOR  
04 NOVEMBER 2007

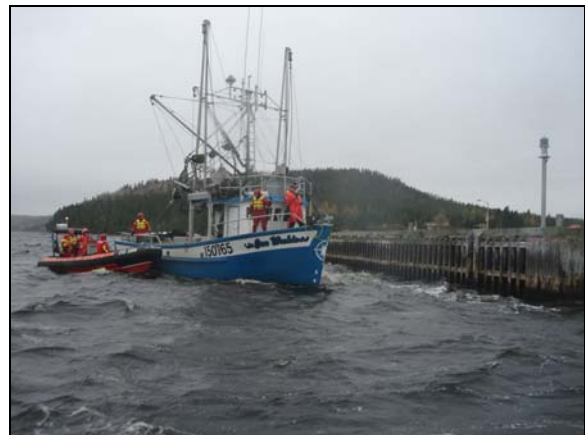
**Photo 1.** The *Sea Urchin* on the day of the occurrence

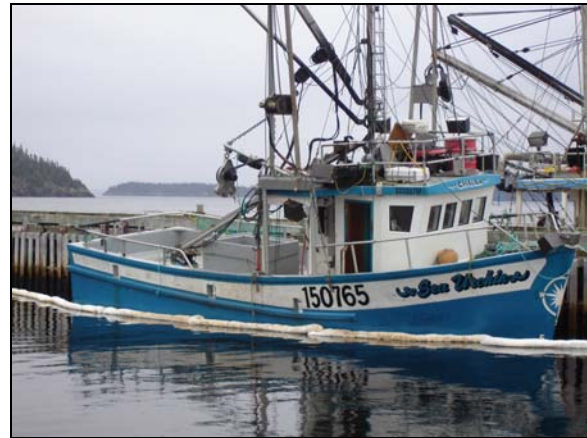
**Photo 2.** The *Sea Urchin* after recovery

In this occurrence, the effects of the wind gusts and quartering seas, combined with the already deficient stability, caused the vessel to roll until it exceeded the angle of vanishing stability and capsized.
