MARINE INVESTIGATION REPORT
M07L0158

STRIKING

PASSENGER VESSEL *NORDIK EXPRESS*
ENTRÉE ISLAND, HARRINGTON HARBOUR, QUEBEC
16 AUGUST 2007

Report Number M07L0158

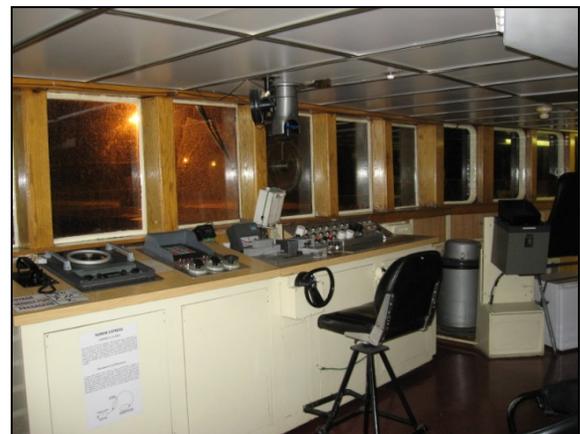
The bridge was equipped with several consoles. One was located approximately on the centreline and forward against the front bridge windows, and contained the autopilot and helm. A console in each wing contained engine, rudder, and bow thruster controls. Two radars and the electronic chart system (ECS) were located between the port and centreline consoles. A third radar was to starboard of the centreline console (see Photo 2).

Neither the radars nor the ECS could be monitored without leaving the helm.

Photo 2. Bridge centre console showing the starboard radar. The other radars and ECS are out of view to the left (port).

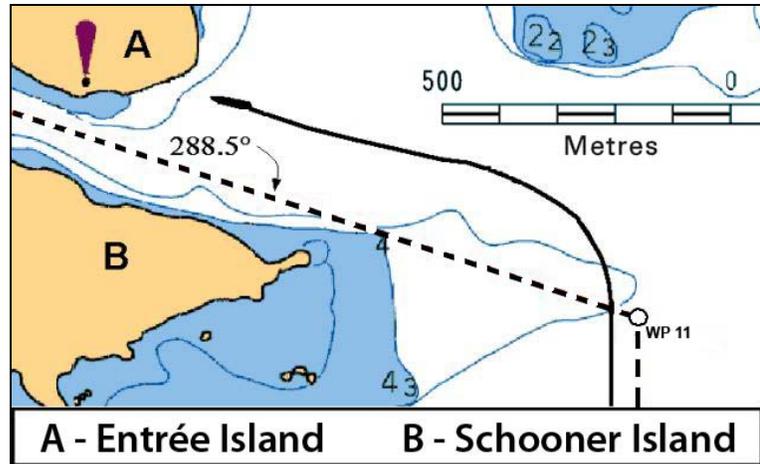
At about 2303, or approximately two minutes after leaving, the helmsman returned to the bridge. The vessel, back on its heading of 288°, was still full ahead and making way at 11.7 knots;¹⁰ its actual track, however, was offset to the northeast, parallel to the intended track (see Figure 1).

Figure 1. Screen capture of the vessel's ECS at 2303:13, showing the vessel's actual track and position (solid line) compared with the intended track (dashed line).

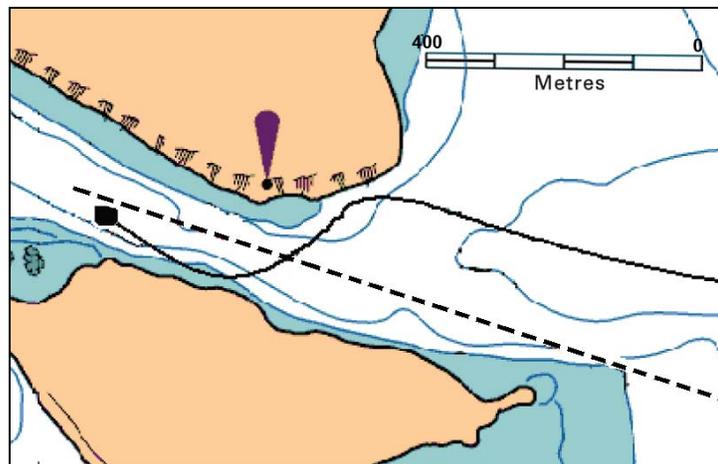
After striking Entrée Island, the vessel crossed the narrow passage, almost grounding on Schooner Island. The helmsman then saw the harbour's leading lights ahead and began to steer the vessel into the middle of the passage (see Figure 2).

Figure 2. Track showing vessel striking Entrée Island and rebounding toward Schooner Island (solid line).
