MARINE INVESTIGATION REPORT
M08M0062

CAPSIZING

FIREBOAT 08-448B
HALIFAX HARBOUR, NOVA SCOTIA
17 SEPTEMBER 2008

Report Number M08M0062

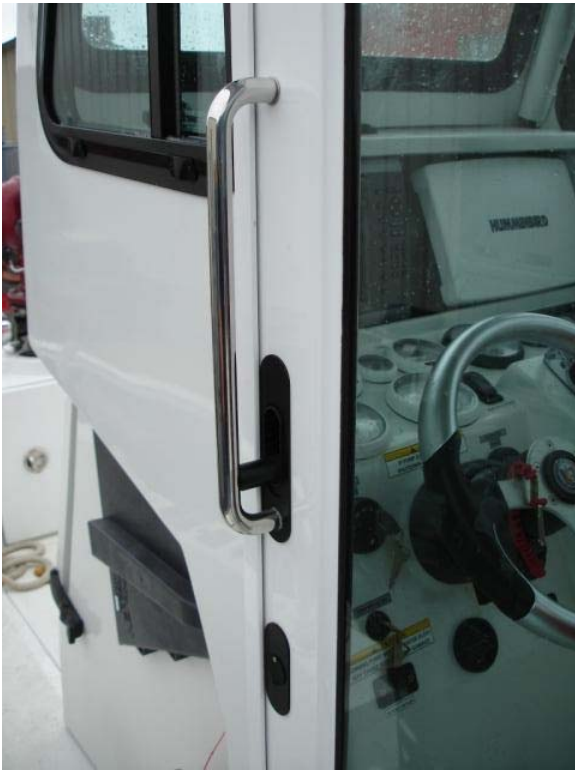
Photo 2. Looking forward at the port door handle and latch

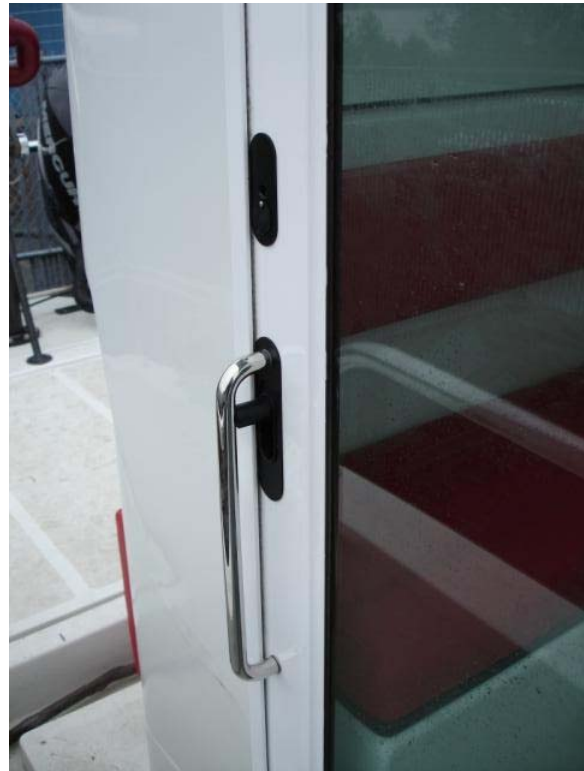
During the pre-departure orientation session, crew members were not instructed on the use of the door latch system nor notified that the starboard door had been installed upside down.

Photo 3. Looking aft at the starboard door handle and latch (installed upside down)

Following the capsizing, crew members within the pilot house found it difficult to locate the door latch and open the starboard door. Whether this was due to the upside-down installation, difficulty in locating the relatively tiny finger slot, a lack of familiarity with its use, or because the door had been inadvertently locked is impossible to ascertain.

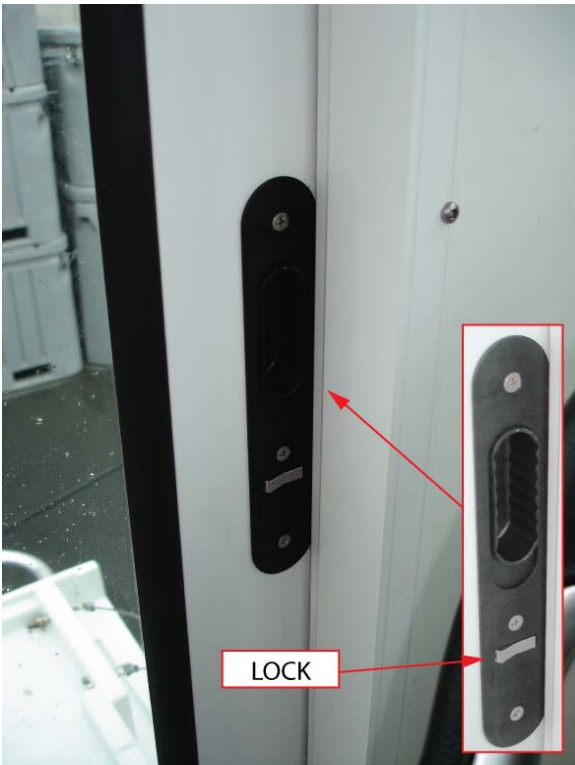
Photo 4. Port door interior latch

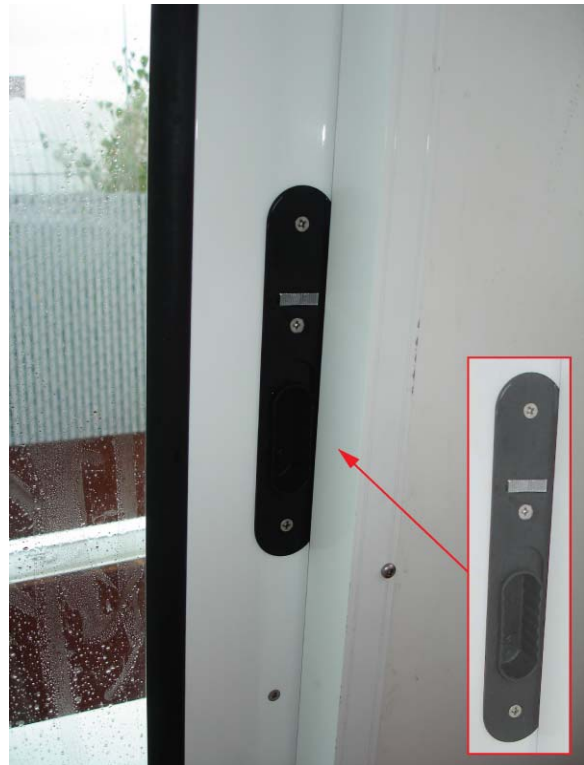
Photo 5. Starboard door interior latch (note position difference from port door latch)

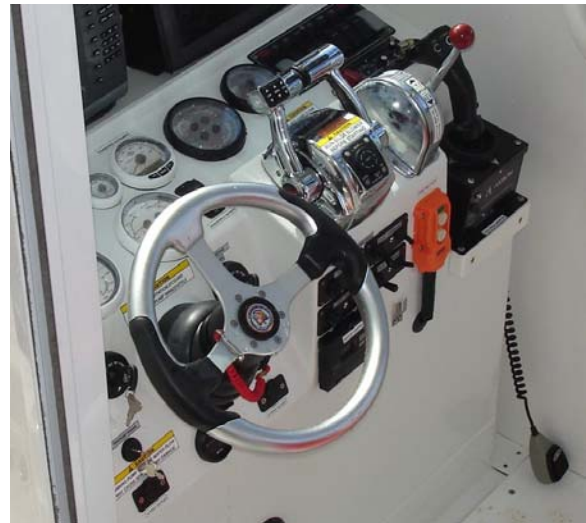
The engine kill switch (also known as the “dead man’s lanyard”) was not attached to the operator (see Photo 6). The purpose of such a lanyard is to stop the engines if the operator leaves the controls. Although the lanyard had been used during the training sessions earlier in the week, because the seas were calm on the morning of the accident, it was not used. Moreover, although in this occurrence both engines stopped immediately upon capsizing, not using this safety device could lead to a situation where engines continue to run with no operator.

Photo 6. Kill switch and throttle position (note lanyard draped over steering wheel)

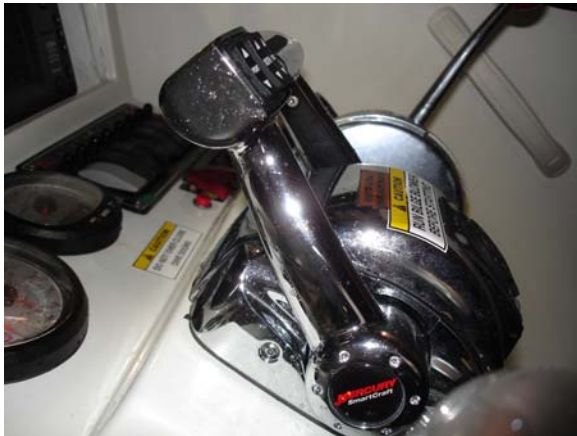
When the vessel began to heel to port, the instructor told the operator to increase throttle. This may explain why the three-quarter throttle setting (see Photo 7) and the amidships motor position conflict with reports that the vessel was in the midst of a slow, relatively tight turn at the time of the capsizing. It is also possible that the throttles were inadvertently pushed forward as the vessel decelerated while capsizing. The clutches were electrically controlled, and the investigation concluded that the port engine disengaged during the capsizing.

Photo 7. Throttle position (after capsizing) at three-quarters ahead

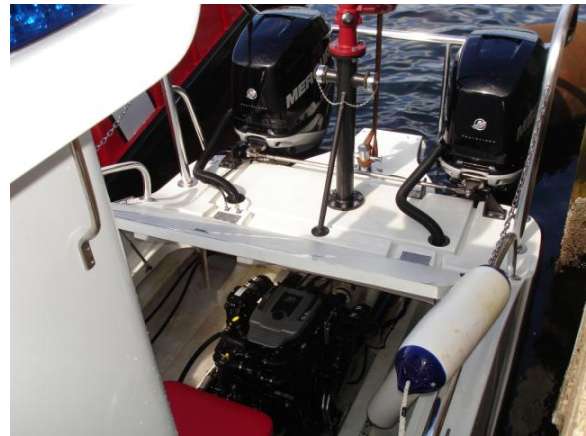
Photo 8. Engine compartment hatch

Upon recovery of the vessel, the inboard engine compartment, which had been closed but not properly secured (see Photo 8), was observed to be open. Such a practice can compromise the watertight integrity of the hull as water is shipped on board during heavy weather or aggressive manoeuvring.
