MARINE INVESTIGATION REPORT

M11M0017

CREW MEMBER LOST OVERBOARD

SMALL FISHING VESSEL *SILVER ANGEL*
5.5 NAUTICAL MILES SW OF CAPE SABLE ISLAND
NOVA SCOTIA
03 MAY 2011

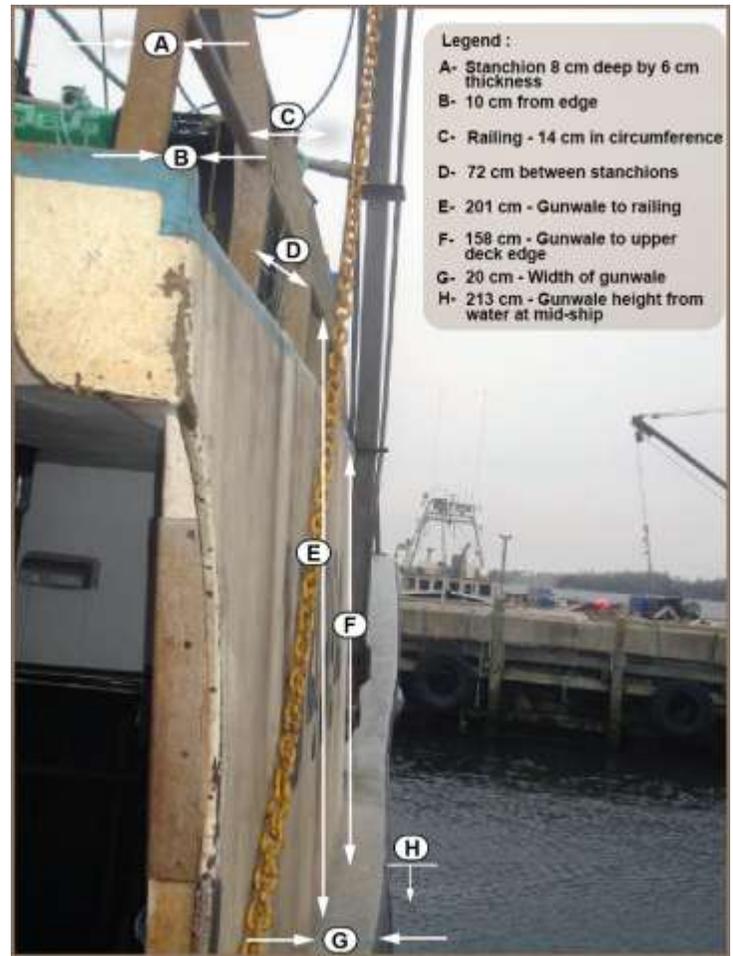
Photo 2. Vessel starboard side

A shelter deck covers the forward half of the work deck on both sides. Measurements of the starboard side are given in Photo 2. There are no specific handholds to assist in walking along the gunwale. A crew member can use hands along the upper edge, grab the bottom of the stanchions or reach the railing between the stanchions. While standing on the gunwale, a vertical hand grip reach of the railing is possible for 75 to 80% of males.²

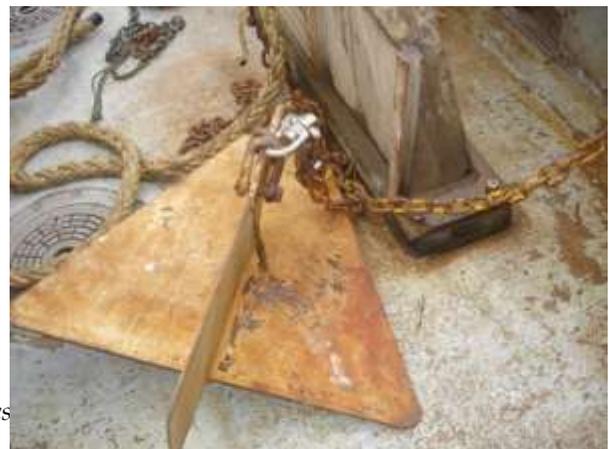
Photo 3. Paravane

Just before midnight, the captain and deckhand deployed the paravane stabilizers⁴ (Photo 3) as the northeast wind had increased to about 30 knots and the vessel was rolling about 25°. At midnight, the captain handed the watch over to the deckhand and gave the order to be called about 5 nautical miles south of Cape Sable Island,

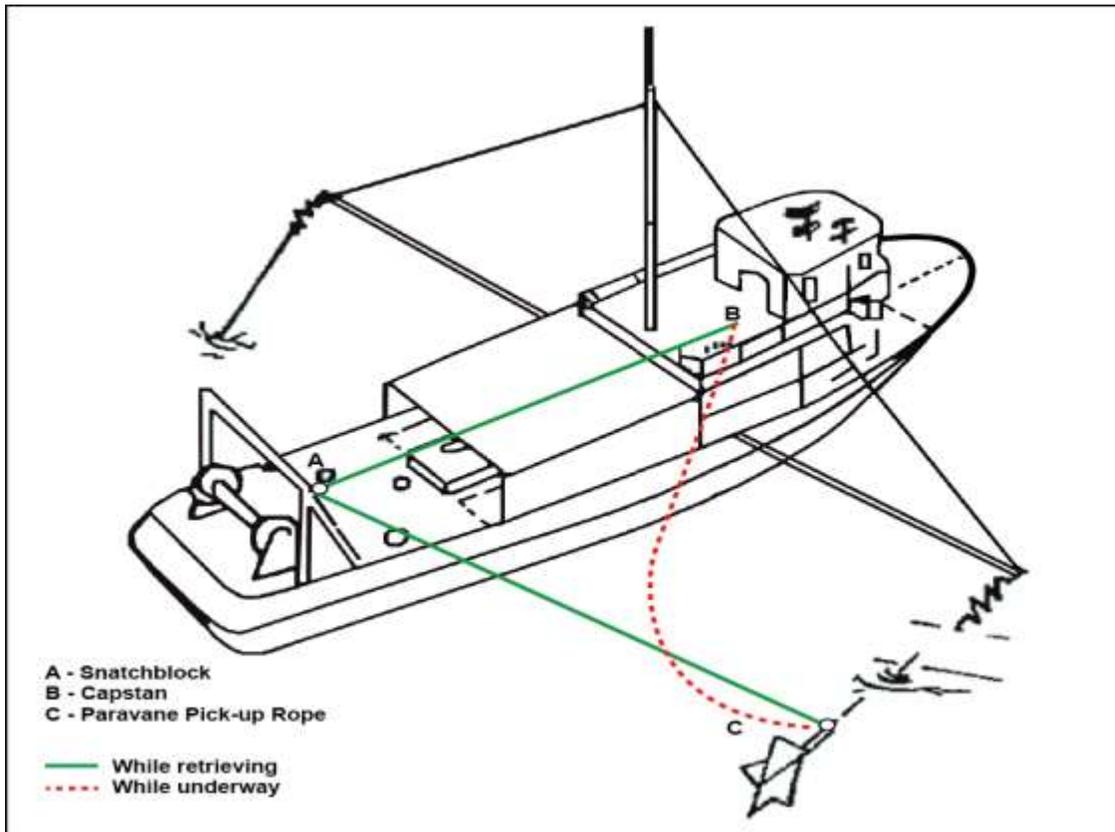
Figure 1. Arrangement of paravane stabilizers on the *Silver Angel*

When retrieving a paravane (Figure 1), a crew member on the upper deck would remove the haul-up rope from the cleat and walk it aft, passing it down to a deckhand waiting on the after deck. If nested tote boxes remained between the cleat and after end of the upper deck (Photo 4), the crew member would walk or crawl aft on the boxes, passing the rope to the waiting deckhand, who would climb the gantry and put it in the snatch block. On the *Silver Angel*, it was not necessary to walk on the gunwale to retrieve the paravane haul-up ropes when following this procedure.

The retrieval arrangement on the *Silver Angel* increased the risk of falling overboard during the retrieval of the paravane stabilizers, as it did not preclude a crew member from walking along the gunwale. Furthermore, the placement of the tote boxes made the alternative method of paravane retrieval hazardous because crew members would have to make their way across these boxes while being close to the side of the vessel without the protection of the railing.

- The arrangement of retrieval gear on board the vessel allowed for the retrieval of the paravane pick-up rope via walking along the gunwale.
- The deckhand's practice of walking on the gunwale was never addressed and continued unchecked.

- The company has re-rigged the paravane stabilizer haul-up ropes to ensure crew members cannot access it by walking on the gunwale and will remain on deck when retrieving the paravane stabilizers.

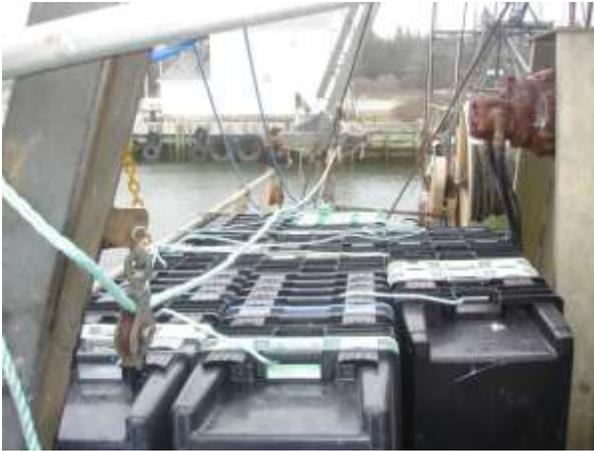
Photo 4. Nested tote boxes on upper deck against the starboard rail.

- the practice of walking along the gunwale to retrieve the paravane went unchecked;
- the arrangement of tote boxes posed a hazard to the crew if they retrieved the paravane by not going along the gunwale;
- the rigging of the gear used to retrieve the paravanes allowed for the option to walk along the gunwale;
- there was a lack of dedicated safety meetings and emergency drills;
- the operating level that was not adequate to address emergency situations;
- PFDs or safety harnesses were not provided or worn by crew members when working on deck; and
- the lifering was not easily accessible.

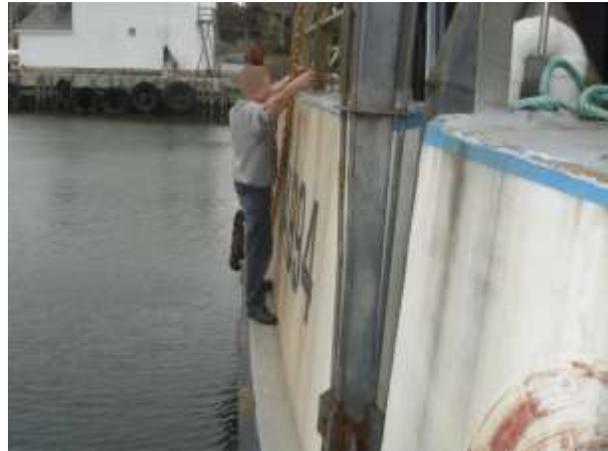
Photo 5. Demonstration of walking along the gunwale while holding onto the stanchions.

When retrieving the starboard paravane, the deckhand on the *Silver Angel* normally walked along the gunwale (Photo 5), taking the haul-up rope and bringing it to the snatch block on his own. When arriving at the starboard cleat, the crew member on the upper deck gave slack if necessary. The deckhand had performed this task successfully hundreds of times in the past, and displayed a great agility in doing so. No other crew member walked on the gunwale, choosing instead to wait on deck until the haul-up rope was passed down to them. Company management was not aware of the deckhand's practice.

The deckhand worked in the fishing industry most of his life, and he was known for his agility when moving around the vessel, including his practice of walking along the gunwale to retrieve the starboard paravane. Other crew members perceived this skill to be an asset. He probably started this practice to save time while waiting for the other crew member to finish his task on the port side. This practice, however, represented a clear risk of falling into the water, given that the small width of the gunwale did not provide for a balanced foothold, and that the deckhand had to grab either the stanchions or the railing while pulling the paravane rope along the gunwale. After completing this task successfully hundreds of times, it had become his normal practice. Despite the other option available to retrieve the paravanes, the deckhand's practice of walking on the gunwale was never addressed and continued unchecked.

- The deckhand probably fell from the vessel's gunwale while attempting to retrieve the starboard paravane pick-up rope, losing his footing and/or handhold as the vessel rolled in the seas.

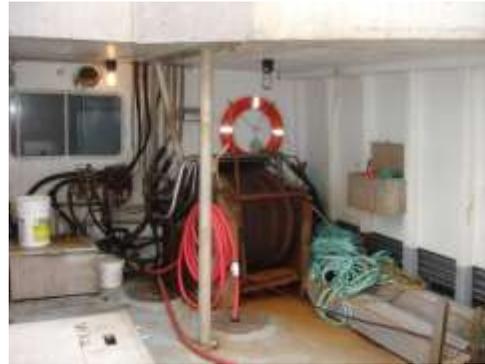
Photo 6. Lifering with line
