MARINE INVESTIGATION REPORT

M12N0017

STRIKING OF WHARF

PASSENGER VESSEL *BEAUMONT HAMEL*
PORTUGAL COVE, NEWFOUNDLAND AND LABRADOR
30 MAY 2012

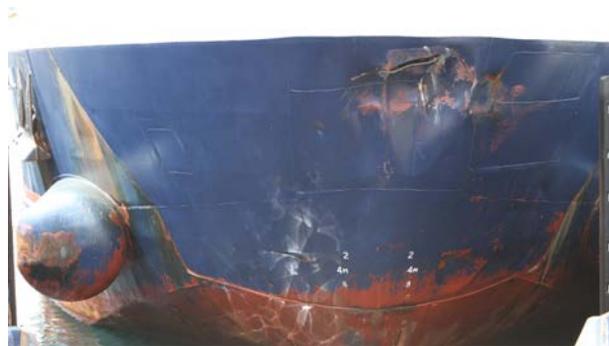
Photo 2. Damage to bow visor

- A section of hull plating, approximately 2 m², was dented and sheared at the top of the indentation, 100 cm below the forecastle deck elevation (Photo 2).
- The centreline girder of the visor was deformed at the stem, and was buckled for approximately 1 m aft (Photo 3).
- The hull stringer, several deck beams, and flange brackets were also deformed in the area of the indentation (Photo 3).

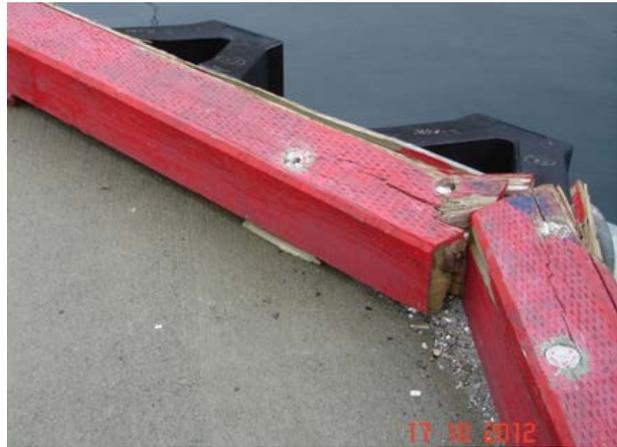
Photo 4. Damage to wooden cap rail

The damage to the Portugal Cove terminal was limited to the wooden cap rail around the edge of the concrete wharf (Photo 4). The damage had no effect on the ferry services.
