**MARINE INVESTIGATION REPORT
M14A0348**

COLLISION

**PILOT BOAT *CAPTAIN A.G. SOPPITT* AND
PASSENGER VESSEL *BAYLINER*
MAIN CHANNEL INTO THE PORT OF SAINT JOHN
SAINT JOHN, NEW BRUNSWICK
01 AUGUST 2014**

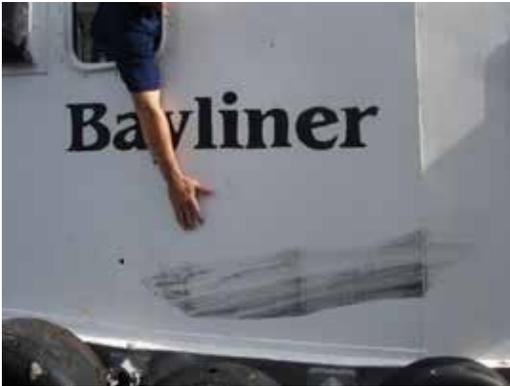
Photo 3. *Bayliner's* port side

Damage to both vessels was limited to black scuff marks where the rubber fenders had made contact (Photo 3 and Photo 4).

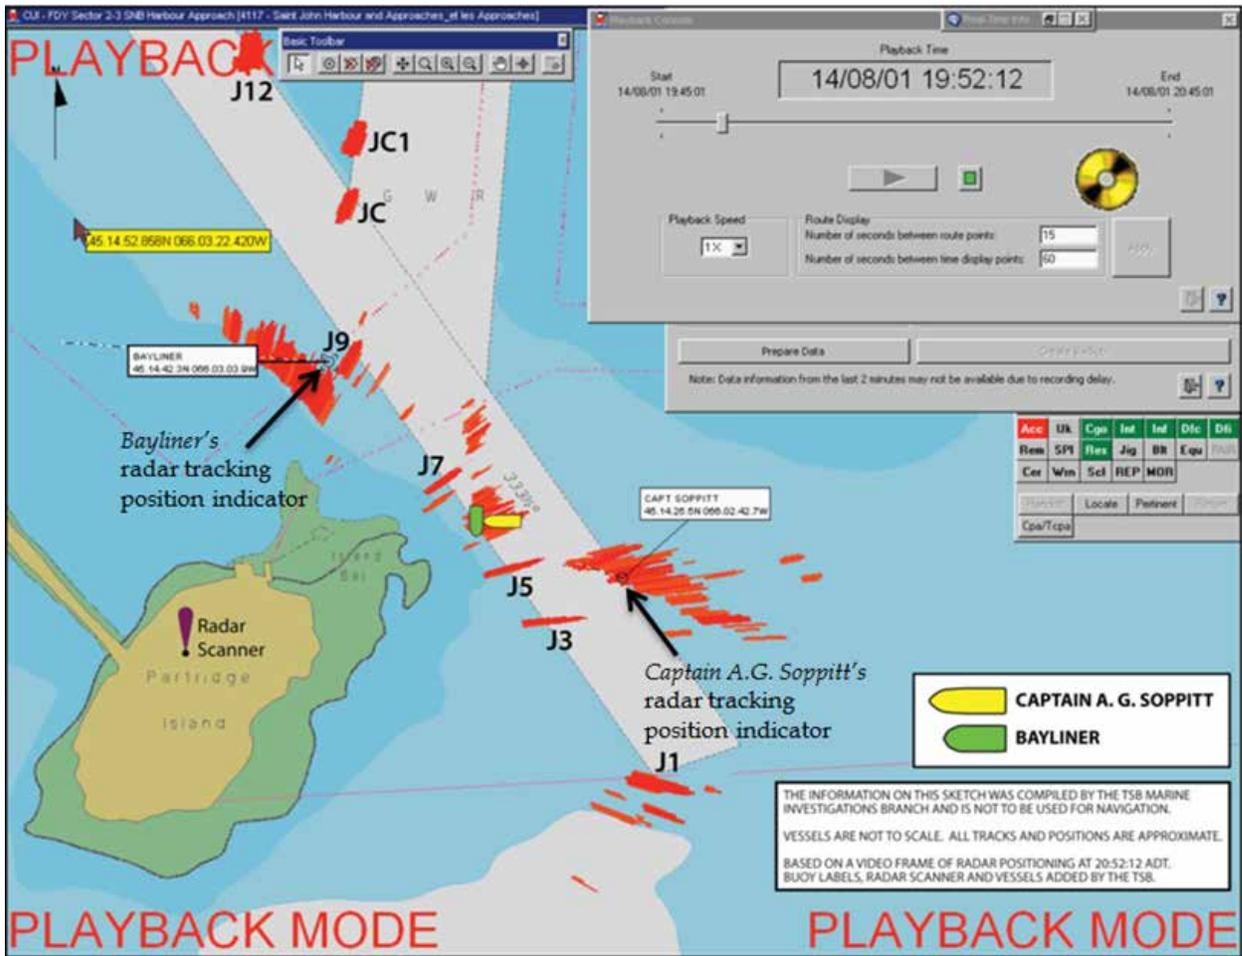
Appendix E – Screenshot of Fundy Traffic radar

Meanwhile, at the Saint John MCTS centre, one of the Fundy Traffic officers on duty was using radar to monitor vessels in the main channel. However, at 2051:31, the radar tracking position indicator for the *Captain A.G. Soppitt* swapped¹⁸ to clutter on the radar, so the radar was no longer depicting the vessel's position accurately (Appendix E). Thirteen seconds later, the radar tracking position indicator for the *Bayliner* swapped to the J9 buoy radar echo, so the depiction of the *Bayliner*'s position was now also inaccurate. At the time, the Fundy Traffic officer was not aware that these target swaps had occurred.

¹⁸ A target swap occurs when incoming radar data for a tracked target become incorrectly associated with another tracked target or a non-tracked radar echo. Target swapping is known to occur regularly in this area of the Saint John main channel.
