**MARINE INVESTIGATION REPORT**  
**M15A0009**

**BOTTOM CONTACT**  
**ROLL-ON ROLL-OFF PASSENGER FERRY *GRACE SPARKES***  
**BURNSIDE, NEWFOUNDLAND AND LABRADOR**  
**21 JANUARY 2015**

### **Bottom contact**

Roll-on roll-off passenger ferry *Grace Sparkes*

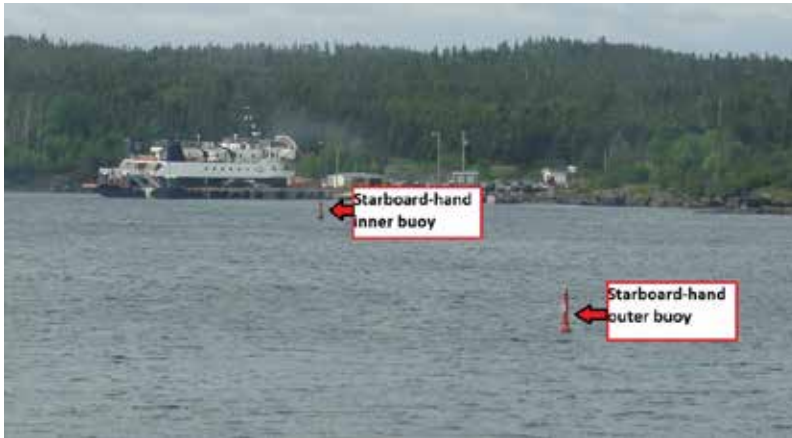
There were 2 starboard-hand buoys and 1 port-hand marker in the area of the occurrence (Photo 2 and Photo 3). The 2 buoys indicated the starboard boundary of the channel. The marker indicated the location of Burnside Rock, but did not indicate the port boundary of the channel.

Photo 2. Starboard-hand buoys designating the Burnside channel

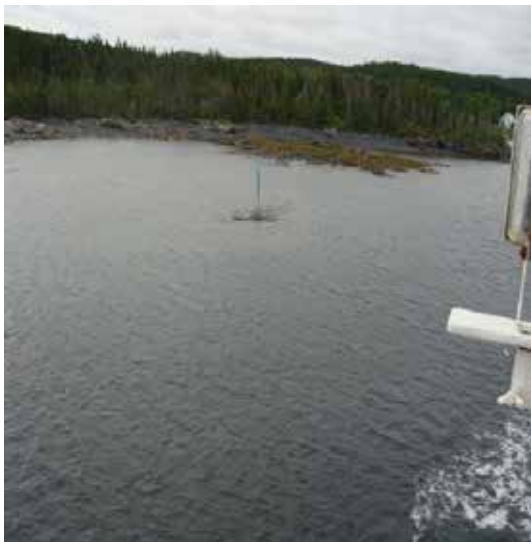
Photo 3. Port-hand marker on Burnside Rock

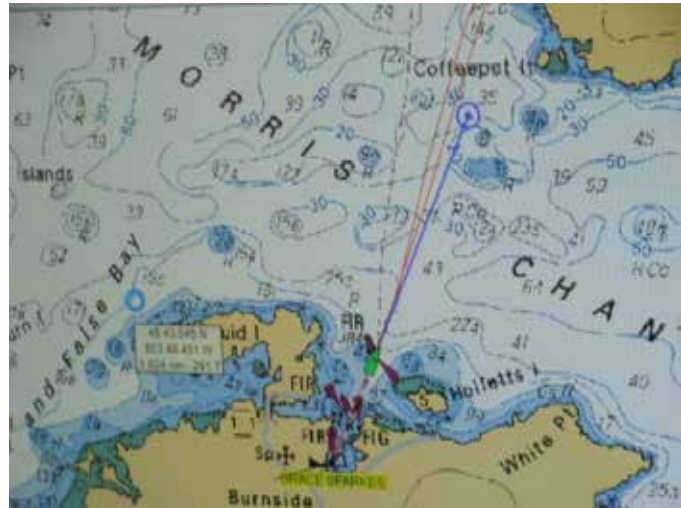
Photo 4. Raster chart of area of occurrence

The raster chart in use at the time of the occurrence did not have any courses or waypoints entered for the voyage.

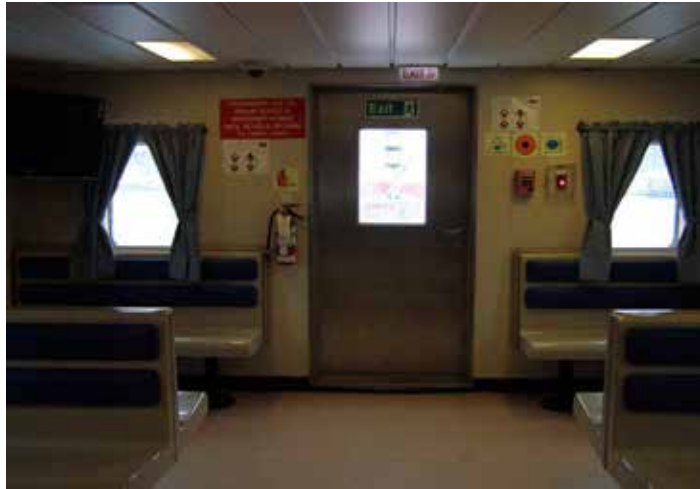
The lifejackets on board the *Grace Sparkes* were stowed on deck, aft of the passenger lounge, in labelled orange stowage crates. The crates were visible from inside the lounge, but only to a person standing by the aft exit door looking out (Photo 5) in the direction of where they were stowed. The lounge had signage indicating donning instructions for the lifejackets. However, there was no signage indicating where the lifejackets or lifejacket containers were located, nor was there any regulatory requirement to indicate, by signage, the directions to the lifejackets.

Photo 5. Aft exit of passenger lounge (lifejackets outside door on deck but no signage)

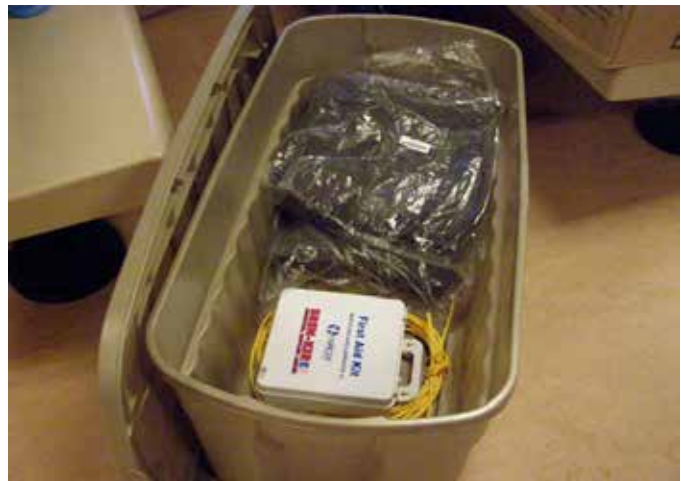
The *Grace Sparkes* was equipped with first aid kits, defibrillators, and other first aid equipment, but not all of this equipment was readily visible. The first aid kit in the passenger lounge was stowed in an unmarked container (Photo 6), and other first aid equipment, such as a defibrillator and an eye wash station, was stowed on the wall of a corridor on the boat deck forward of the passenger lounge. The equipment in the corridor was not visible from the seating area in the lounge, and there was no signage to indicate its location. Other lifesaving equipment, such as a loud hailer and smoke signals, was stowed in unmarked cupboards.

Photo 6. First-aid kit stowed in unmarked container

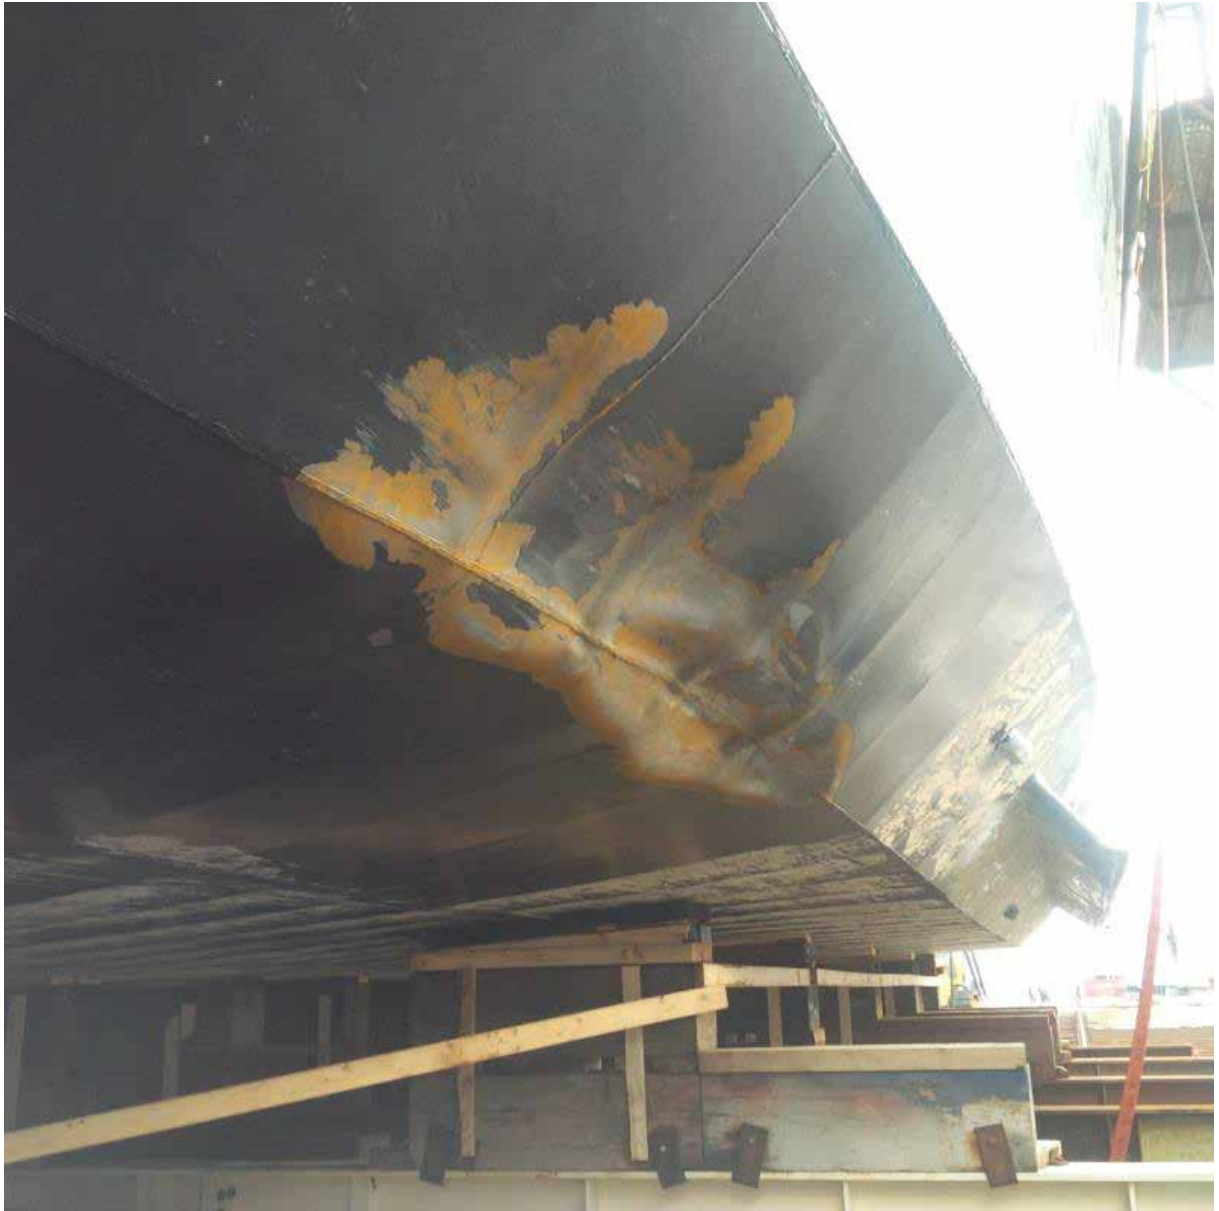
*Appendix C – Shell plating damage*

The *Grace Sparkes* sustained damage to an area of the hull measuring 3 m<sup>2</sup> from frames 51 to 56. The damaged area was at the lower chine,<sup>4</sup> measured 300 mm wide, and included several internal framing members (Appendix C).

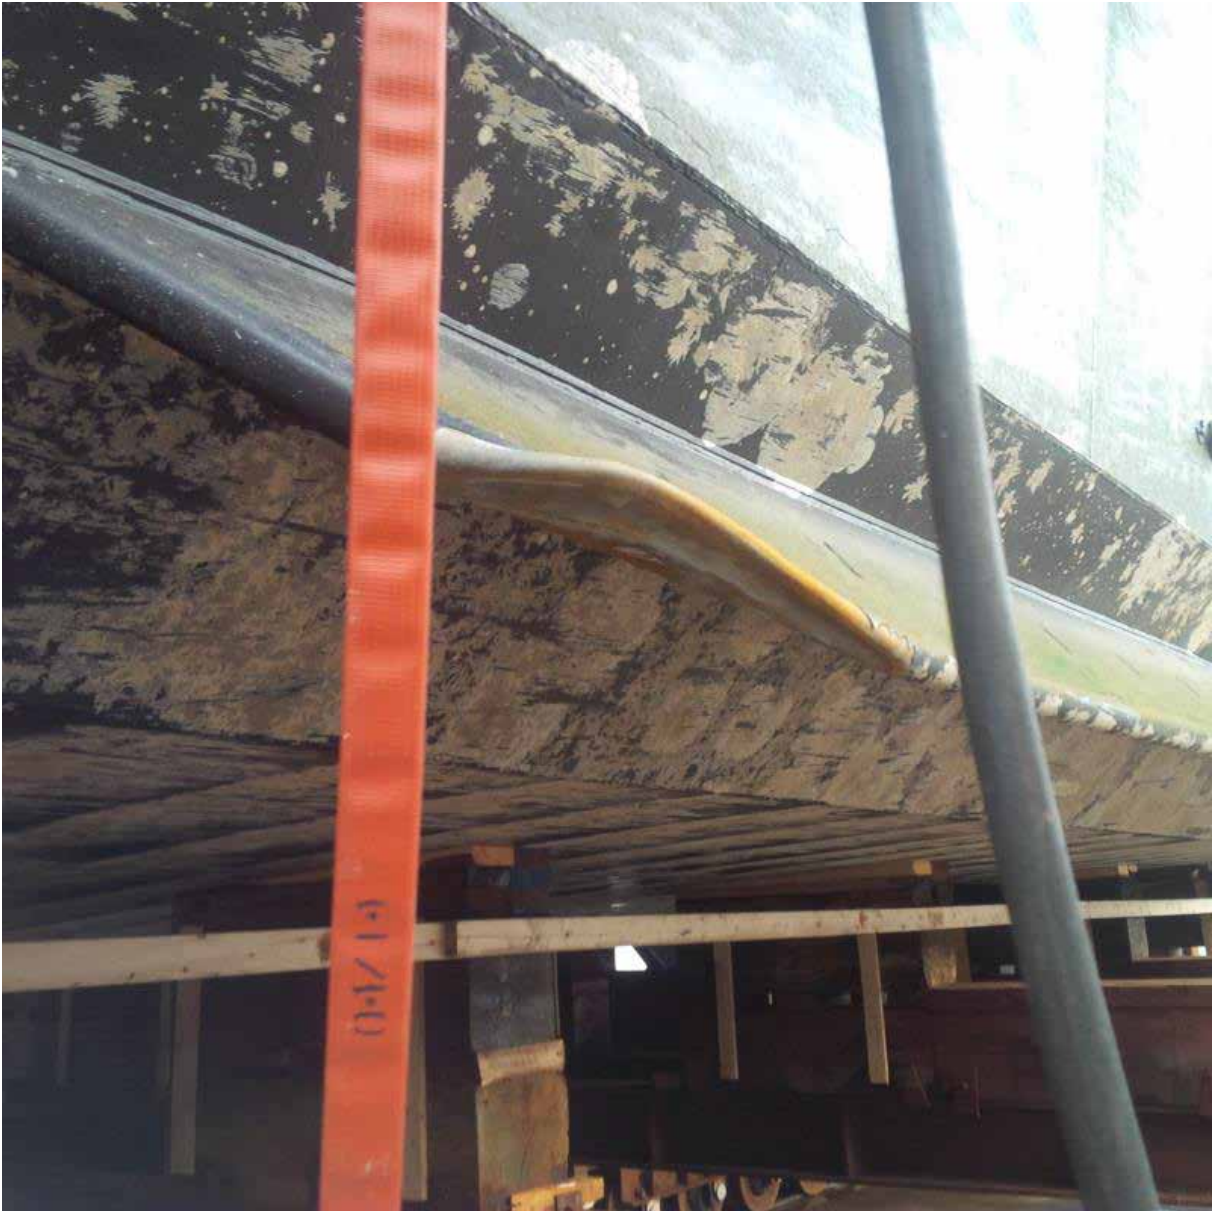
*Appendix D – Bilge keel damage*

In addition, the forward end of the bilge keel was damaged on the outer edge from frames 44 to 47 (Appendix D).
