MARINE TRANSPORTATION SAFETY INVESTIGATION REPORT M18C0018

ON-BOARD FATALITY

Bulk carrier *Sage Amazon*
Port-Daniel–Gascons, Quebec
17 March 2018

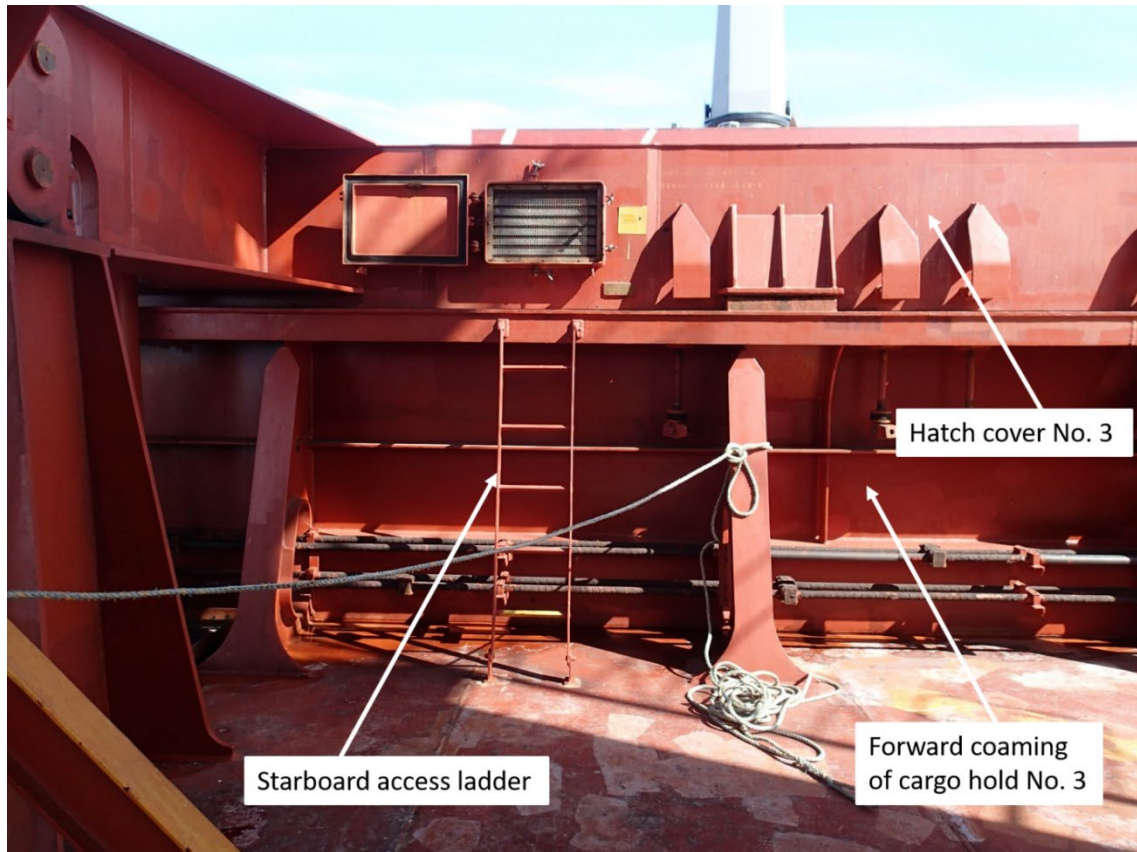
At the front of cargo hold No. 3, there are 3 access ladders 1.76 m high. The ladders are bolted to the main deck and to the top of the hatch coaming. Two are positioned near the port and starboard hydraulic cylinders, and one is positioned on the centreline of the vessel (Figure 2).

Figure 2. Access ladder on the starboard-forward section of cargo hold No. 3

1. The master experienced an acute myocardial infarction while standing on an access ladder for the No. 3 cargo hold and fell onto the main deck, receiving serious head injuries. First aid initially focused on his head injuries.
2. When the possibility of a cardiac event was raised, with no automated external defibrillator (AED) on board the vessel, it was not possible to confirm the master's cardiac condition.
3. Various search-and-rescue resources were dispatched, but it took approximately 3 hours for first responders to reach the vessel, at which point it was too late for medical assistance.
4. The master was pronounced dead about 4 hours after the cardiac event and subsequent fall.

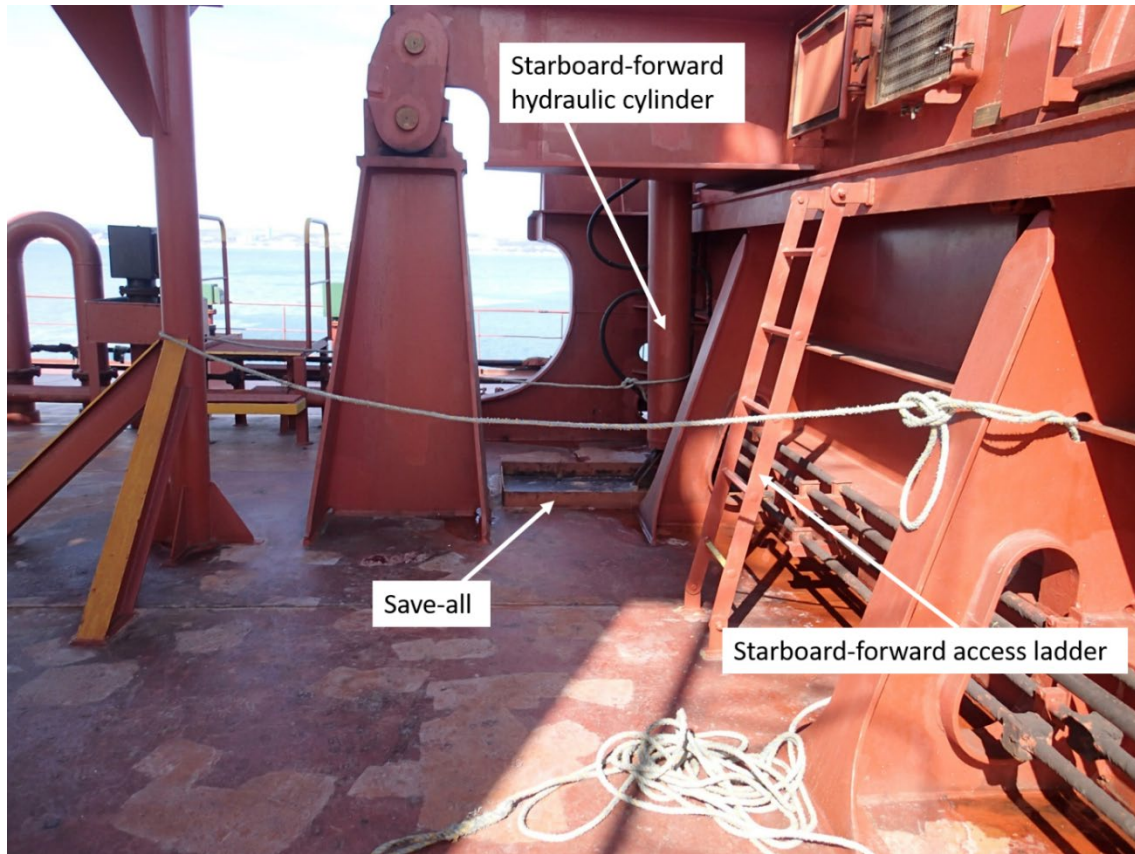
Near each hydraulic cylinder, a save-all¹ 9.5 cm high is welded to the main deck (Figure 3).

Figure 3. Location of save-all in relation to the starboard-forward hydraulic cylinder and access ladder

At 0735, a muffled sound was heard and the master was seen lying unconscious on the main deck. The back of the master's head was resting on the save-all, and his hard hat was lying on the main deck beside him. The chief officer immediately called for help using his portable radio. The crew mustered at the accident site at 0740 and established that the master's

The examination, conducted at the hospital in Chandler, showed that the master had received a deep laceration of the scalp 6 cm long over the occipital bone, after falling and hitting his head on the edge of the save-all. Consequently, the master's cause of death was initially established as severe cranial trauma causing a cerebral hemorrhage and culminating in cardiopulmonary arrest.
