RAILWAY INVESTIGATION REPORT

R98M0020

MAIN TRACK RUNAWAY AND COLLISION

VIA RAIL CANADA INC. PASSENGER TRAIN NO. 14  
AND AN UNCONTROLLED FIVE-PAK MOVEMENT

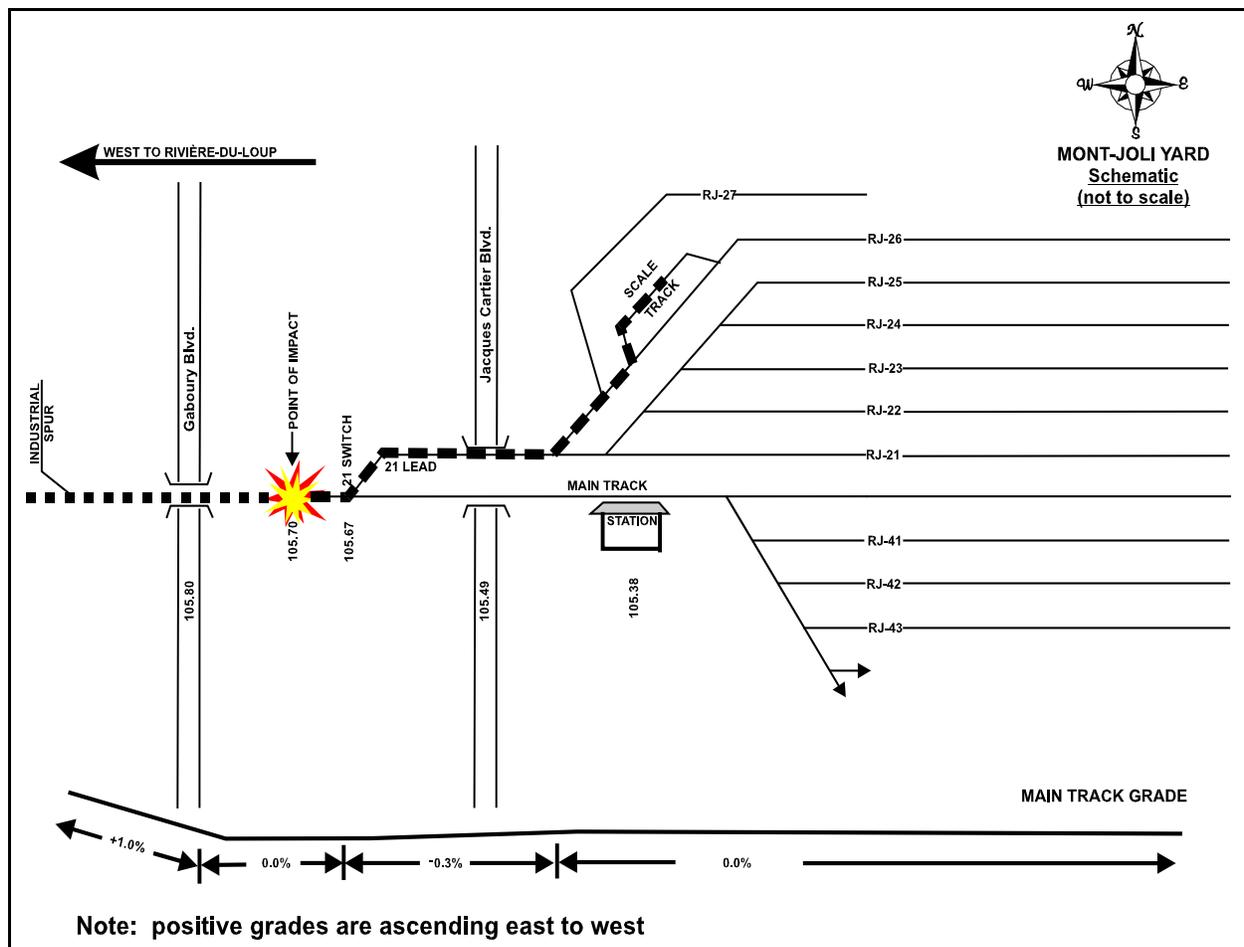
The MRC Mont-Joli Yard trackage extends west to Mile 105.67 and east to Mile 104.3. Mont-Joli Station is located at Mile 105.38. It supports VIA passenger ticketing and baggage services and provides an office and employee facilities for MRC and Canadian National (CN) (see Figure 1).

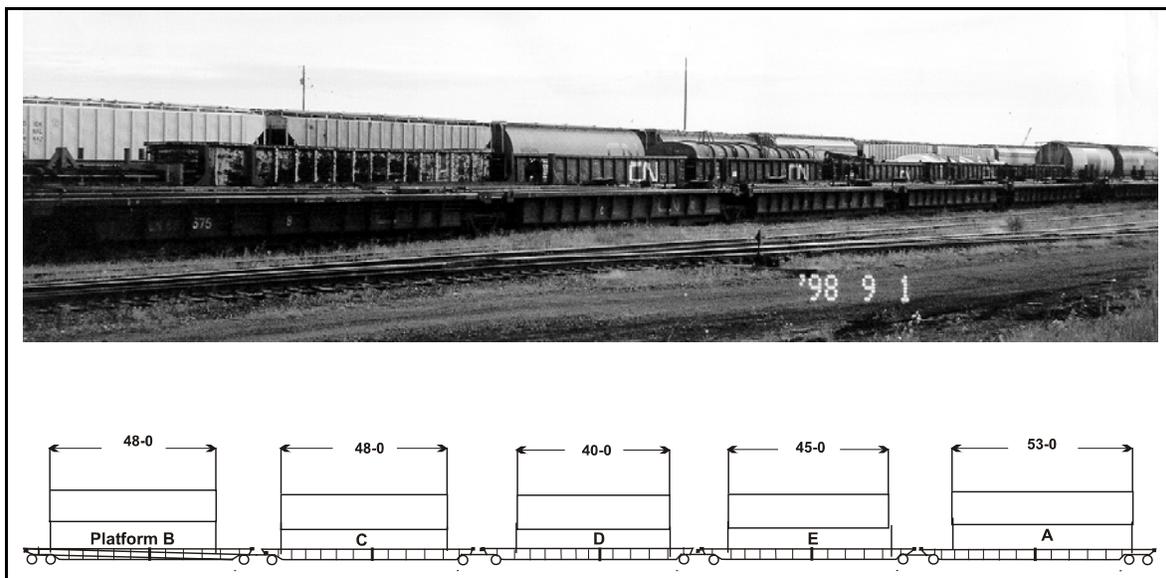
The five-pak, CN 683656, was owned by CN and was built in 1985 by National Steel Car in Hamilton, Ontario. The CN 683 series five-paks are articulated five-platform intermodal cars, with a 175,000-pound tare (unloaded) weight and a length of approximately 240 feet. There were 82 CN 683 series five-paks in service and they were used for transporting intermodal containers and highway trailers. This equipment has been usually operated in trains comprised of a large proportion of multi-platform cars or in intermodal unit trains

(see Figure 2).
