RAILWAY INVESTIGATION REPORT

R98T0042

MAIN TRACK DERAILMENT

MILE 127.54, KINGSTON SUBDIVISION

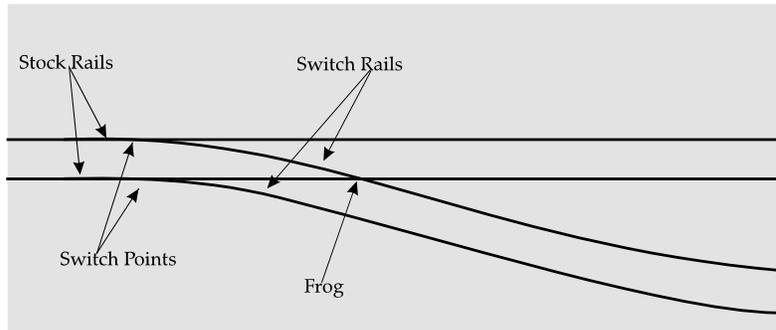
The crossover at Mile 127.54 was designed to permit a maximum speed of 45 mph for diverging movements. It was built with No. 20 turnouts equipped with Samson switches. Figure 1 illustrates a turnout and some of its major components.
