RAILWAY INVESTIGATION REPORT

R02C0054

MAIN-TRACK DERAILMENT

CANADIAN PACIFIC RAILWAY

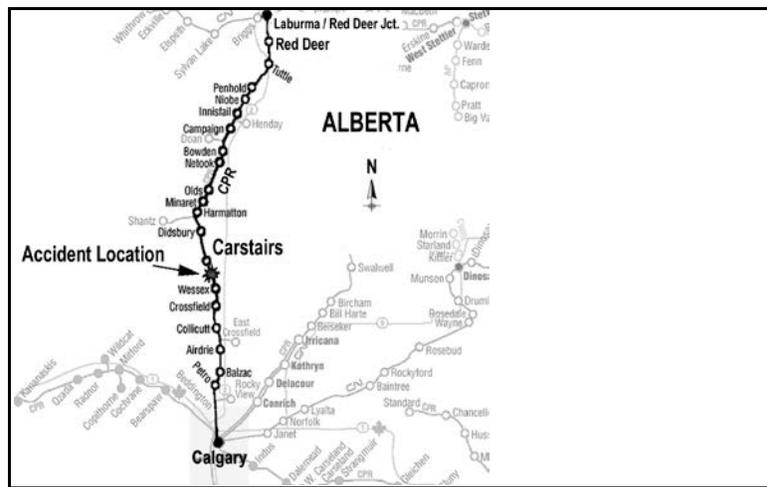
At 1722, as the train passed over Mile 36.6 on the Red Deer Subdivision, a train-initiated emergency brake application occurred. The track reportedly moved upward and then outward under the middle of the train and cars derailed. After conducting the necessary emergency procedures, the crew determined that 15 tank cars, the 50th car to the 64th car from the head end, had derailed.
