RAILWAY INVESTIGATION REPORT

R02E0114

MAIN-TRACK DERAILMENT

CANADIAN PACIFIC RAILWAY

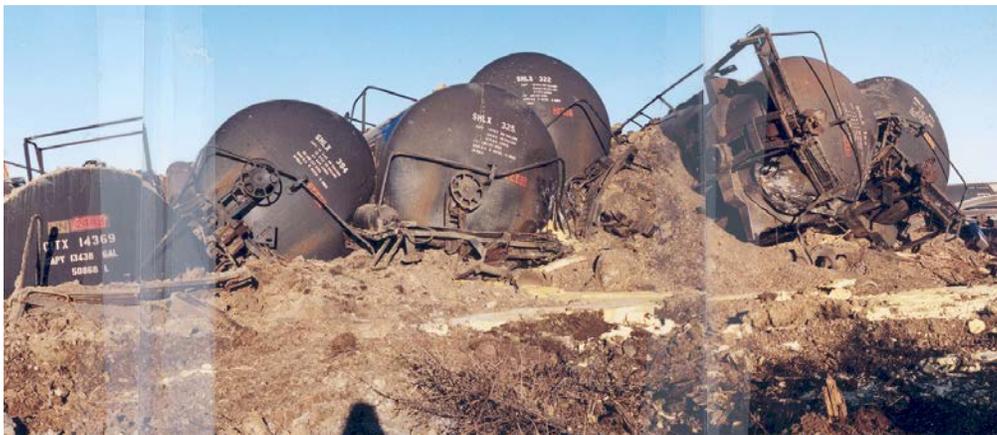
At 0055 mountain standard time¹ on 04 December 2002, Canadian Pacific Railway (CPR) freight train 614-046, proceeding eastward on the CPR Taber Subdivision at approximately 38 mph, derailed at Mile 11.8 after a train-initiated emergency brake application. The crew immediately contacted the rail traffic controller (RTC), who advised the Medicine Hat Fire Department, Seven Persons Fire Department, Ambulance, and the Royal Canadian Mounted Police (RCMP). Inspection of the train revealed that 42 tank cars loaded with liquid sulphur, commencing behind the seventh car, had derailed, 10 of which were on fire. The rear wheels on the eighth car in the consist had derailed. The locomotives and the first eight cars continued approximately 1/4 mile east of the main pile-up. The following 40 cars were jackknifed perpendicular to the track, one beside the other, within 400 feet of the last derailed car, which had derailed leading wheels. About 440 feet of track was

Forty tank cars were severely damaged and ultimately scrapped. Nine SHLX tank cars and one PROX tank car were breached by dents and punctures to the tank shell heads and sides. Six cars, including the PROX car, were breached with four SHLX cars badly damaged with safety vents sheared off and torn side jackets. None of the tank cars was equipped with head shields; however, a nine per cent increase in puncture resistance was incorporated into the SHLX cars design, as required by Transport Canada's (TC) Equivalent Level of Safety Permit SR 5206. The bottom fitting protection and skid plates on these cars did not prevent the loss of product from some of the cars involved in the derailment. Four cars had the bottom outlet valves sheared off but did not open. All tank cars involved in the derailment were general purpose, insulated, non-pressurized tank cars built without head shields to specification DOT 111A100W2 or 211A100W1 design.

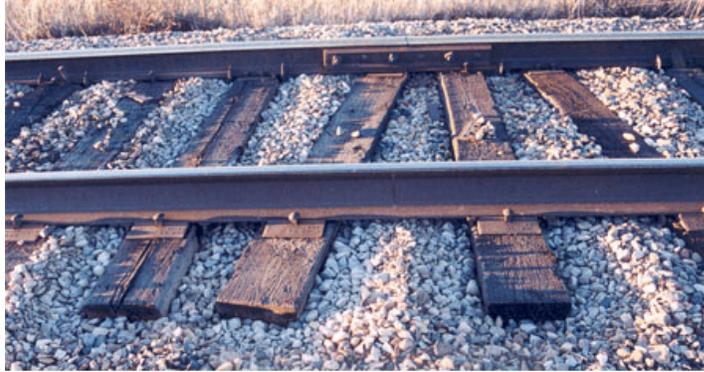
The area of the derailment was tangent track on a 0.61 per cent descending grade into a sag vertical curve at the POD. The railway subgrade in the vicinity of the derailment was constructed of local materials consisting of silty, sandy clays, and sand on a six- to eight-foot fill. The terrain in the area of the derailment is flat and generally well drained.

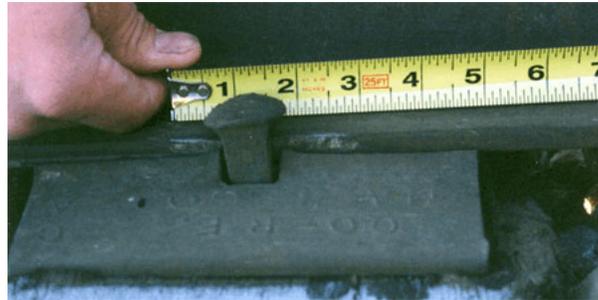
The rail is box-anchored every second tie. At the time of the occurrence, rail anchors were in fair condition, but many were two to three inches away from the ties, indicating rail movement. In some areas of the subdivision, where there is soft track, additional anchors were installed every tie (beyond Standard Practice Circular (SPC) standards) to prevent rail creep.
