RAILWAY INVESTIGATION REPORT

R03Q0003

COLLISION

BETWEEN CANADIAN NATIONAL TRAIN Q-148-91-18

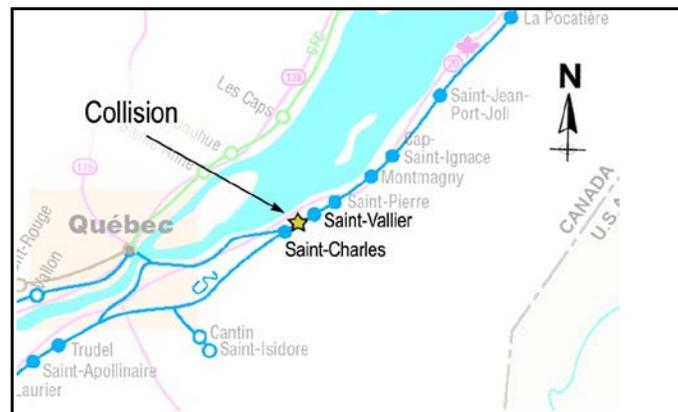
The foreman placed his Hi-rail vehicle on the main track at a public level crossing at Saint-Charles, then proceeded to the bridge over the Boyer River at Mile 97.60 (see Figure 1) to weld some rail joints. The foreman switched on his portable radio and the Hi-rail vehicle radio to the designated monitoring frequency, and switched on the exterior loudspeaker.
