RAILWAY INVESTIGATION REPORT

R03T0080

DERAILMENT/COLLISION

CANADIAN PACIFIC RAILWAY

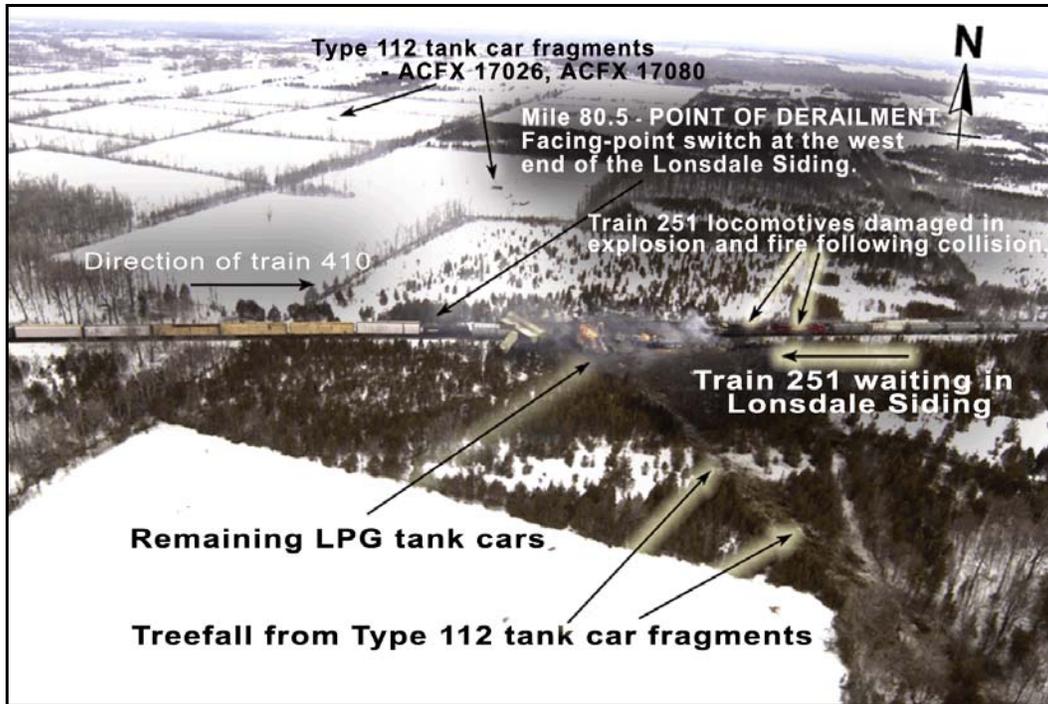
At approximately 0540, a wheel set on the 27th car of train 410 derailed to the south side of the main track at Mile 80.9. The derailed car continued eastward towards the switch point at Mile 80.5, where it took the diverging route into the Lonsdale Siding. The 27th car (SOO 18748, a loaded box car of lentils) then struck the side of the first locomotive (CP 8654) on train 251. The following two cars from train 410, the 28th and 29th cars, which were loaded with agricultural products, ran in behind and derailed to the north side of the track. The next seven cars of train 410, the 30th to 36th cars, were tank cars loaded with liquefied petroleum gas (LPG). The first loaded tank car derailed and struck the right front corner of the first locomotive of train 251 and exploded on impact. The second tank car also derailed and then exploded after heavy impact damage. This sequence was followed by explosions of the third and fifth LPG tank cars within 15 minutes of sustaining severe damage from derailed cars piling in from behind. Shortly after, the remaining three loaded LPG tank cars ruptured as a result of impact damage, failed safety appliances, and intense heat from the fire. The contents of the seven LPG tank cars were consumed in the fire (see Photo 1).

Photo 1. Aerial view of accident site on the day of occurrence (Source: Ontario Provincial Police)

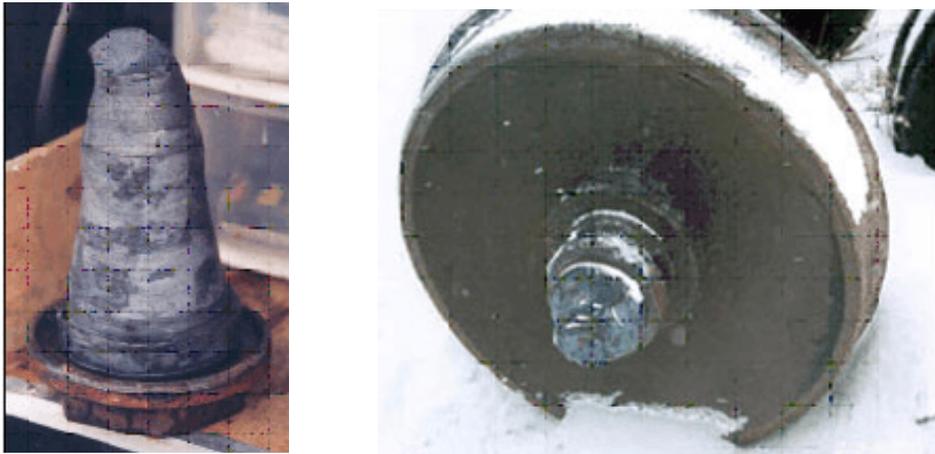
The wheels, axle, and recovered components from the burnt-off journal on axle 122 of the 27th car (see Photo 2) were sent to the TSB Engineering Laboratory for analysis. Both wheels were CJ33 type and had been manufactured in February 1985. No significant grease spatter was observed on either wheel plate. The wheel set “back to back” measurement was within specified limits. There were no significant shelling defects or other tread defects on either wheel.

The bearings were Class E BRENCO 6X11. The burnt-off bearing had experienced significant heat damage, and the outer seal and ring were missing. No grease remnants remained. The cause of the bearing failure could not be determined due to extensive heat damage, which changed the material microstructure and hardness.

Photo 2. Burnt-off journal and wheel assembly from car SOO 18748

An examination of the derailed rolling stock determined that a burnt-off journal at the No. 2 wheel on the 27th car (SOO 18748) of train 410 had occurred. Just prior to the derailment, the roller bearing overheated and seized. The axle then extruded, resulting in a reduction in cross-sectional thickness. After sufficient thinning, the overheated axle could no longer support the weight of the car, leading to a complete axle fracture.

The cause of the overheated bearing could not be determined due to the extensive damage to the axle journal and roller bearing. An examination of car SOO 18748 after the accident determined that there was grease spatter on the floor underframe, immediately above the failed roller bearing location. However, it could not be determined whether the grease spatter resulted from this overheated condition or was residue from a previously failed bearing, as there is no requirement to remove grease from the undercarriage of a car body from previously failed bearings.

Subsequent to this occurrence, CPR modified the software on all wayside detectors such that, while passing the detector, the alarm tone is immediately followed by a radio announcement identifying the nature of the defect (e.g. dragging equipment, hot box or hot wheel).
