RAILWAY INVESTIGATION REPORT
R03T0158

MAIN-TRACK DERAILMENT

CANADIAN PACIFIC RAILWAY

MILE 48.30, WINCHESTER SUBDIVISION

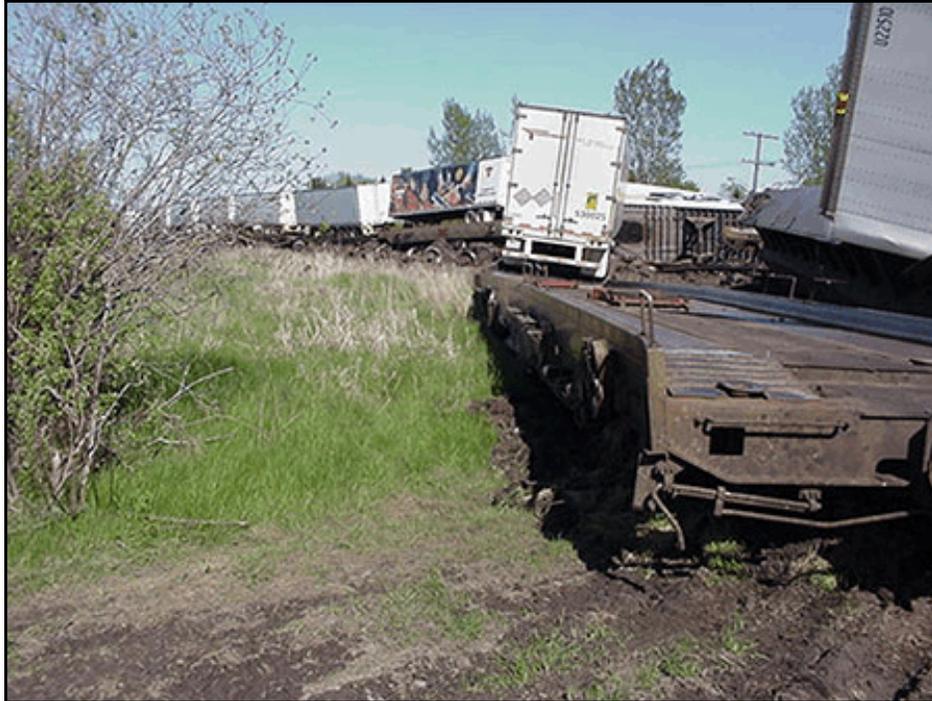
Photo 1. Derailed rolling stock west of crossing with Highway 34, Mile 48.3 of the Winchester Subdivision

The stub of a burnt-off roller bearing was found approximately 800 feet east of the crossing on the north side of the track.

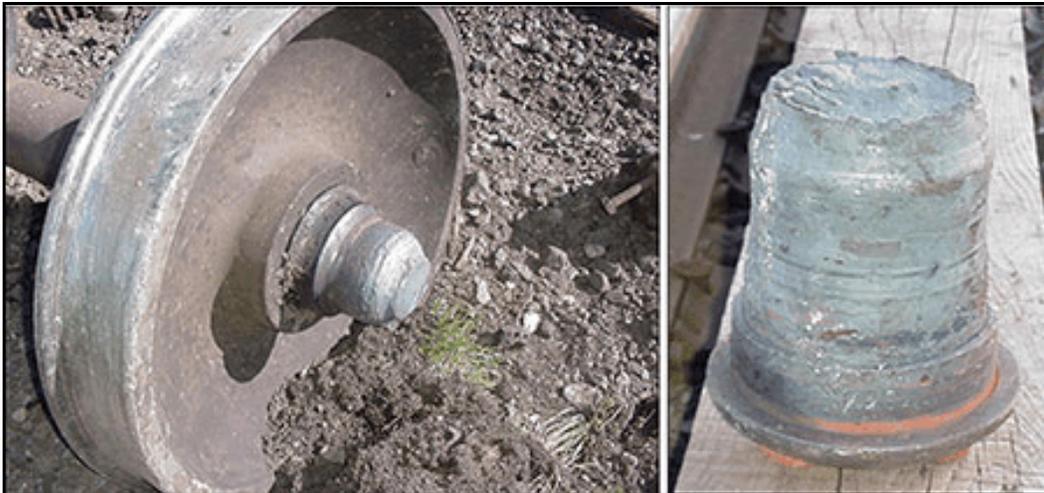
The derailment occurred when an overheated roller bearing seized, resulting in a burnt-off journal (BOJ) occurring on the 133rd axle of the train (see Photo 2). As the roller bearing overheated and seized, the axle extruded, causing a reduction in cross-sectional thickness. After sufficient thinning occurred, the overheated axle could no longer support the weight of the loaded car, resulting in a complete axle fracture. The exact cause of the roller bearing failure could not be determined due to the amount of damage sustained to the axle journal and the roller bearing. The analysis will focus on the warning systems and inspections used by railways, such as CPR, to detect roller bearing failures before a derailment occurs.

Photo 2. Photos of L3 wheel and burnt-off journal stub from car XPWX 2007 showing damage resulting from an overheated roller bearing.

1. The derailment occurred when an overheated roller bearing seized, resulting in a burnt-off journal on the 133rd axle of the train.
2. Although the hot box detector (HBD) scanner had identified the 133rd axle as a potential problem, the train crew's inspection did not detect any overheated axle components. The train crew allowed the identified car to continue in service.

Canadian Pacific Railway (CPR) has updated its computer system to provide the correct axle count information for Meyler cars in expressway service.

In September 2003, CPR implemented a bearing temperature trending process on its coal loop in British Columbia. By connecting the hot box detectors (HBDs) to a central system, CPR performs trending analysis to proactively set out cars with suspect bearings. CPR is reviewing the option of extending this bearing trending process to other locations.

CPR has installed and is testing a track-side acoustic detector system near Vancouver, British Columbia, which is the first such installation in Canada. This device evaluates acoustic signatures of bearings to identify bearing flaws before they reach a critical state.
