**RAILWAY INVESTIGATION REPORT**  
**R04T0161**

**DERAILMENT**

**CANADIAN NATIONAL**  
**FREIGHT TRAIN Q-111-31-25**  
**MILE 184.4, BALA SUBDIVISION**  
**BURTON, ONTARIO**  
**25 JULY 2004**

Report Number R04T0161

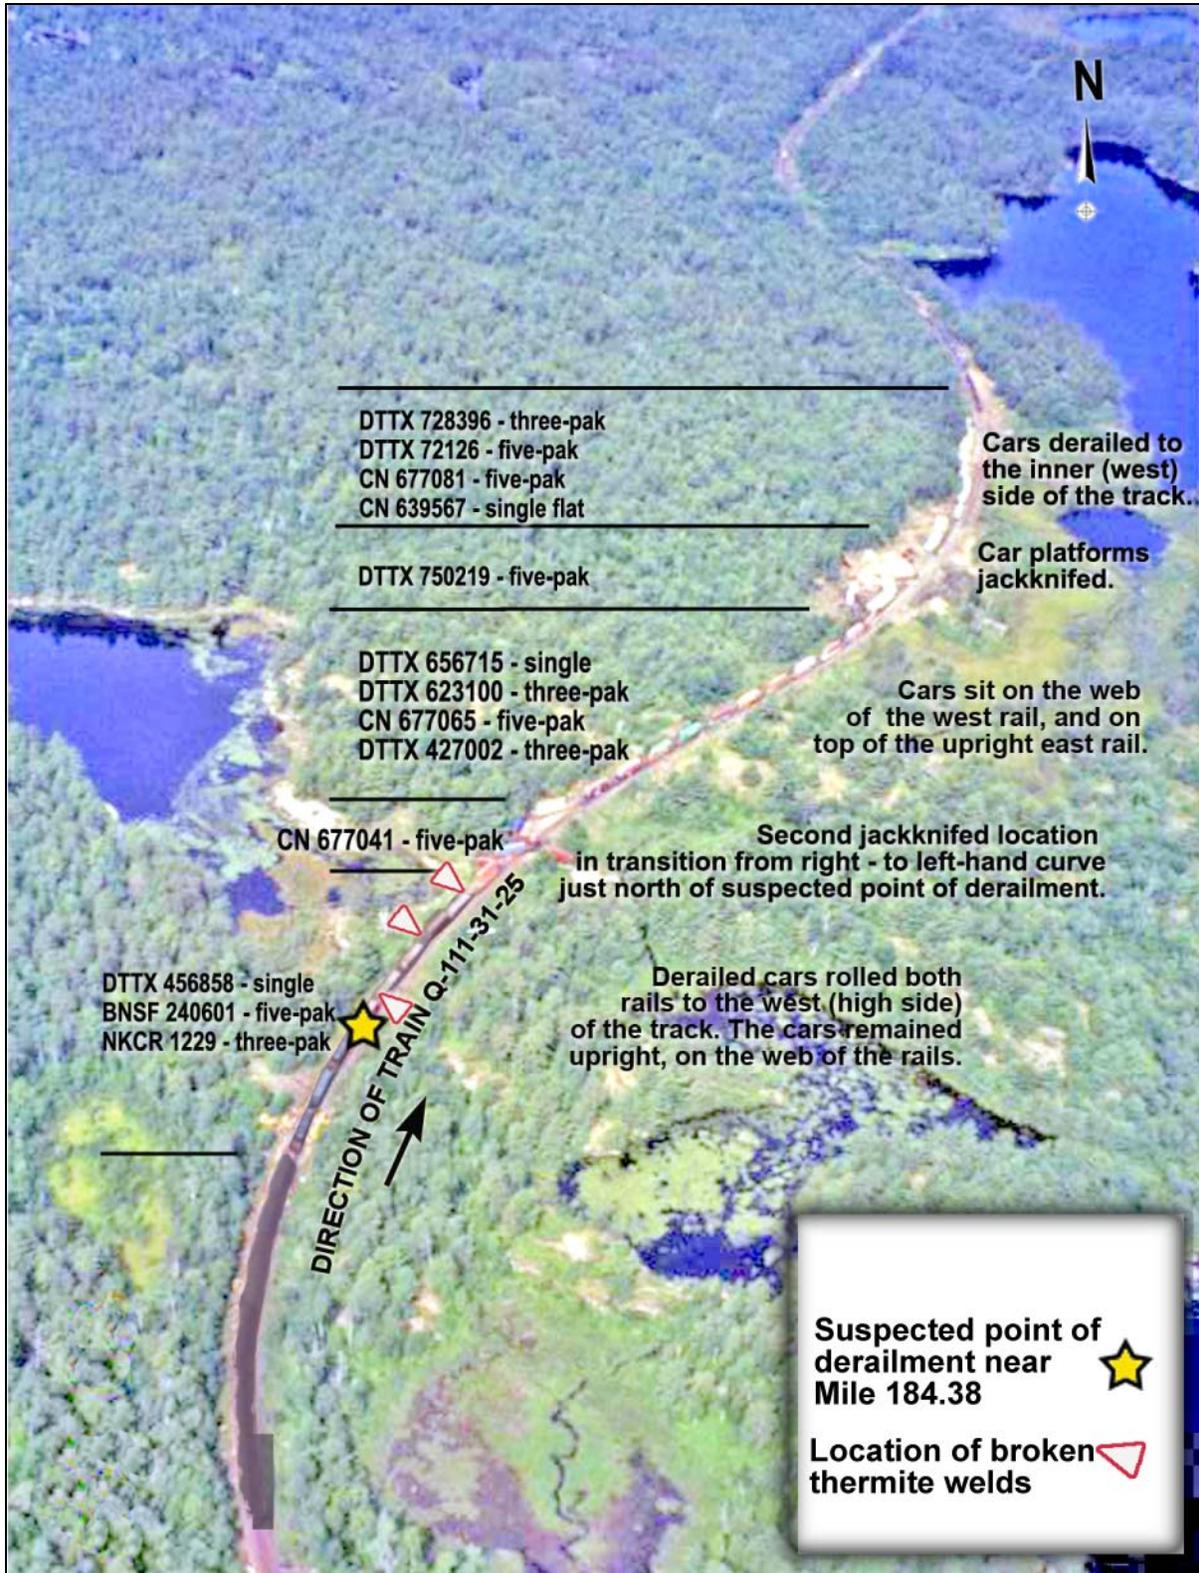
Car DTTX 728396, an articulated three-platform well car, was the 11th car in the train consist and the most northerly derailed car. The trailing truck of the third car body (B-platform) was derailed. All following cars, up to and including the 23rd car, NKCR 1229, were derailed (see Figure 2).

Figure 2. Aerial view of derailment site (Source: TSB photo)

The three cars behind car DTTX 728396 (the 12th, 13th, and 14th) were all derailed in a stringline manner to the inside of the left-hand curve, with the west rail rolled to the field side. The 14th car, CN 639567, was upright on the track bed and coupled to the 15th car, DTTX 750219.
