**RAILWAY INVESTIGATION REPORT  
R06C0104**

**MAIN-TRACK TRAIN DERAILMENT**

**CANADIAN PACIFIC RAILWAY  
FREIGHT TRAIN CP 803-111  
MILE 97.4, CANADIAN NATIONAL ASHCROFT SUBDIVISION  
LYTTON, BRITISH COLUMBIA  
31 JULY 2006**

Report Number R06C0104

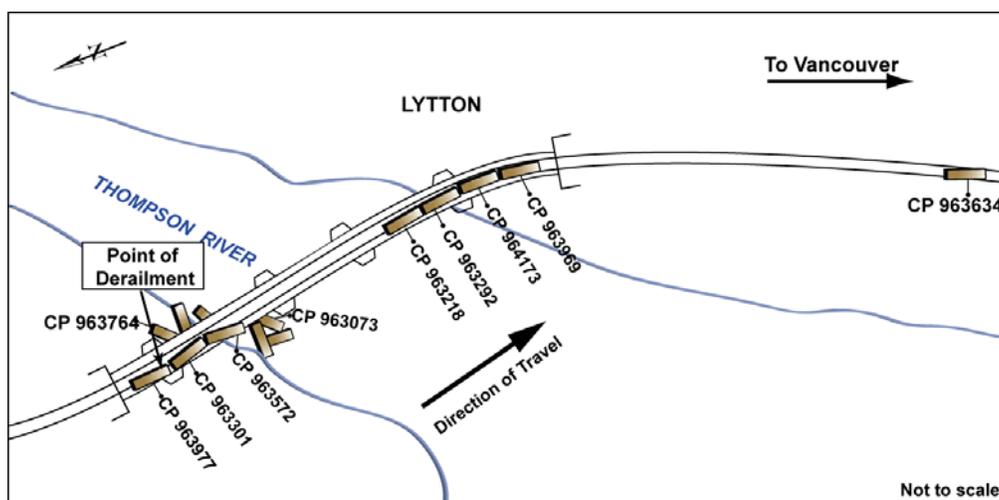
Figure 2. Derailment site

Twenty loaded hopper cars derailed in positions 77 to 96 behind the lead locomotive (see Figure 2). From the west to the east, the 77th car had its "B" end truck derailed approximately 15 car lengths west of the bridge. The next four cars (the 78th to 81st) had derailed upright at the west end of the bridge on spans four and five. The bridge consists of five spans numbered from east to west. Two cars, the 94th and 95th, had derailed and fallen into the steel structure of span 2. The 96th car "A" end truck had derailed and was upright on the east end of the bridge on span 1. Between the derailed cars at the east and west ends of the bridge, 12 cars (the 82nd to 93rd) had derailed and fallen off the bridge, 6 landing between the bridge pier and the east embankment and 6 landing in the river.

The derailment caused extensive damage to the deck on span 2, requiring replacement of all 97 ties. Portions of the deck on spans 3, 4, and 5 were also damaged, requiring replacement of some ties. There was extensive structural damage to the bridge on span 2. There was lesser damage to span 3.

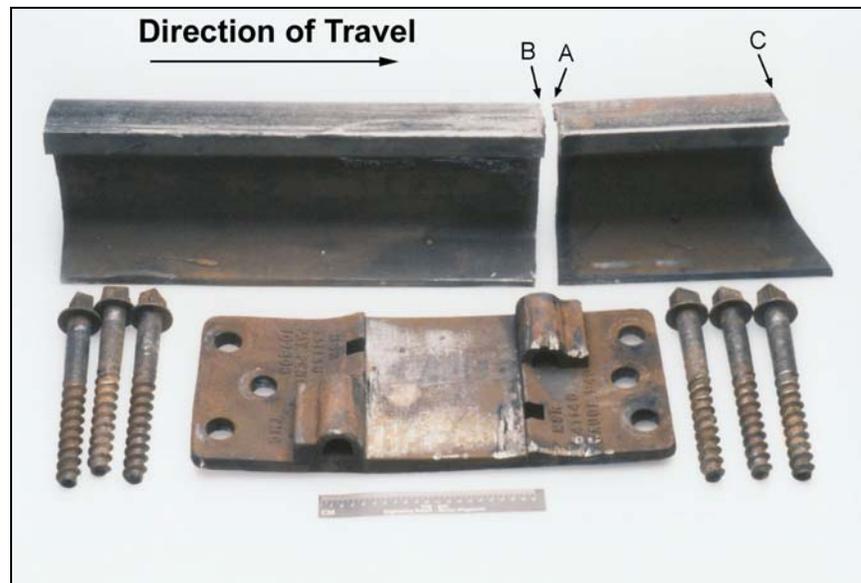
**Photo 1.** Recovered rail pieces and fastenings

The point of derailment was determined to be at a broken rail on a tie plate located approximately 67 feet, 4 inches west of the east abutment on the north (high) rail in the entry spiral of the eight-degree left-hand curve on the east end of the bridge. Two weeks later, another nine-inch-long piece of rail was found on the concrete pier directly below where the broken rail was found on the bridge. The two pieces of rail are shown in Photo 1 displaying fracture faces A, B, and C. The small rail piece with fracture faces A and C was ejected off the bridge deck. The rail with fracture face B remained on the bridge deck where it was struck by derailling rolling stock.

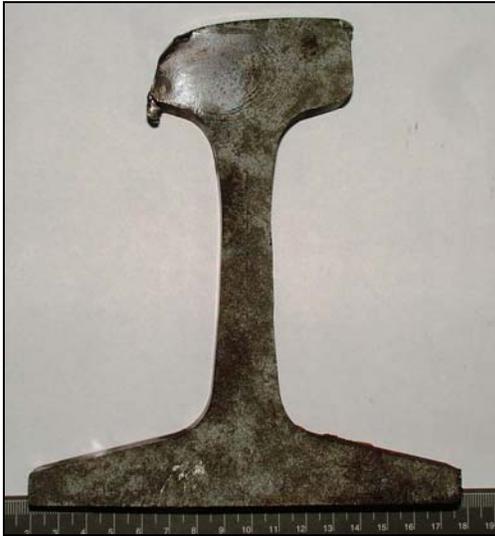
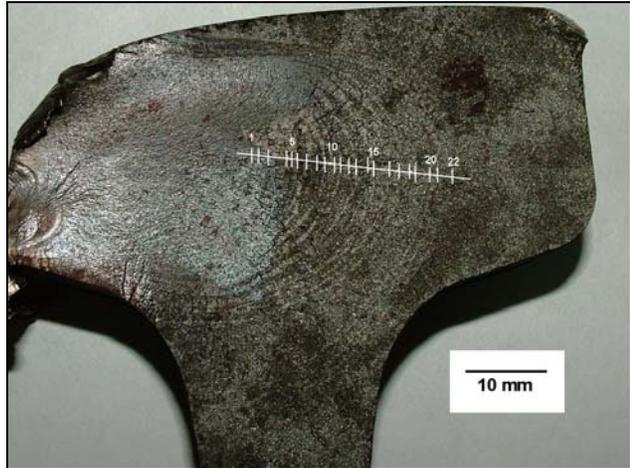
Fracture faces A and B matched and contained a progressive transverse fracture originating from the lower gauge corner that had propagated through a significant part of the head before it spread to the web (see Photos 2a, 2b, and 3). A significant portion of fracture face B was damaged by rubbing and impact damage was observed on the gauge corner. No corresponding rubbing damage was observed on fracture face A. Fracture face C on the east end of the smaller piece of rail also contained a progressive transverse fracture (see Photos 4a and 4b) that had propagated at an angle through the rail web and base. Beach marks<sup>2</sup> can be seen on fracture faces A and C marking the progression of the fracture.

**Photo 2a.** Fracture face A

**Photo 2b.** Fracture face A with beach marks in the fatigue crack region

For the broken rail in this occurrence, rings or beach marks that indicate the progressive growth of the detail fracture with each fatigue cycle in fracture face A, B, and C are shown in Photos 2a, 2b, 3, 4a, and 4b. As the size of the detail fracture increases, less of the head area is available to support the load. The critical size is reached when the remaining head area can no longer support the load and a sudden and complete failure of the rail occurs.

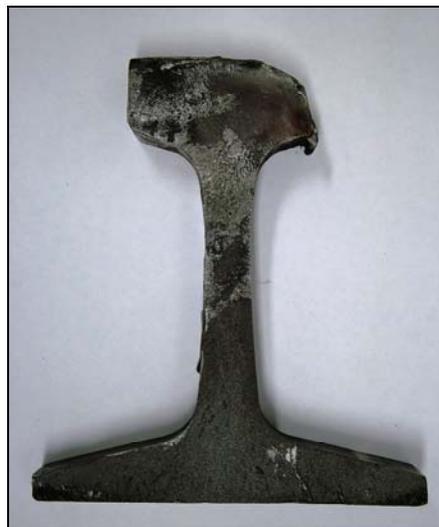
**Photo 3.** Fracture face B

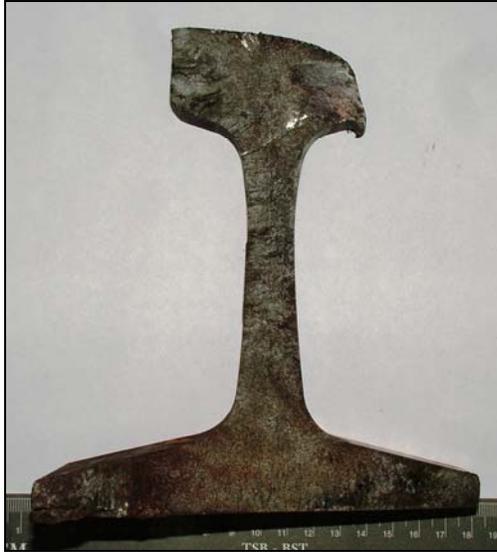
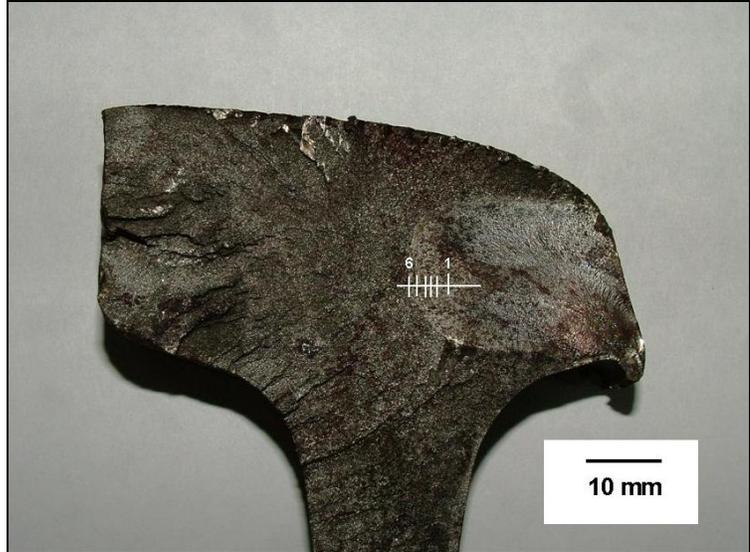
**Photo 4a.** Fracture face C

**Photo 4b.** Fracture face C with beach marks in the fatigue crack region

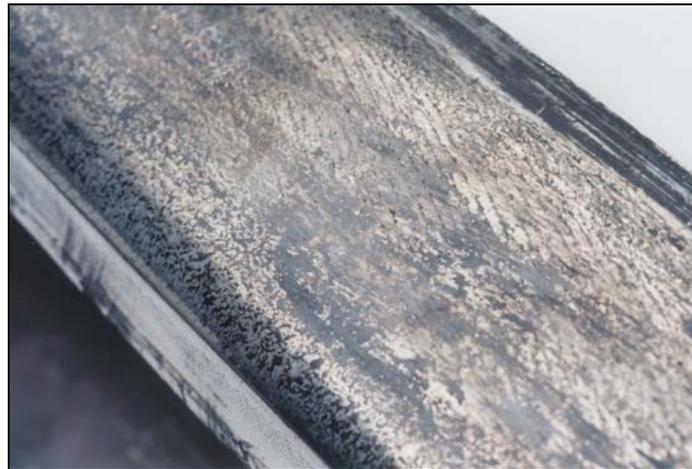
A visual inspection of the surface of the rail pieces showed fine head checking,<sup>3</sup> some minor spalling,<sup>4</sup> but no visible evidence of shelling<sup>5</sup> or corrugation (see Photo 5). Minimal lubrication was observed on the top and flange of the rail.

**Photo 5.** Head checks in larger piece of recovered rail

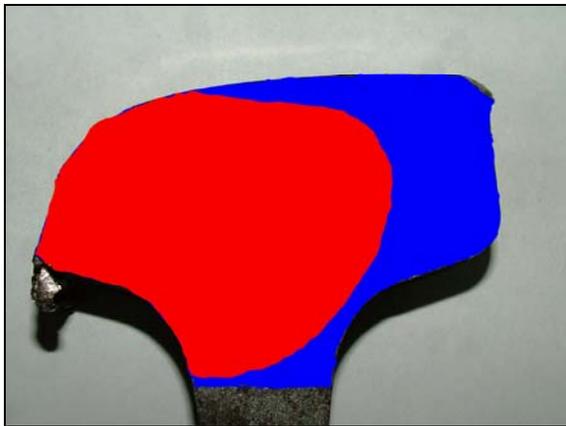
- On fracture face A, 70 per cent of the head cross-sectional area had failed due to fatigue (see Photo 6) and 34 per cent of the head cross-sectional area was burnished (see Photo 7). On fracture face C, 21 per cent of the head cross-sectional area had failed due to fatigue while 15 per cent of the head cross-sectional area was burnished (see Table 1). The size of the fatigue cracks and burnishing indicate that the defects were present for some time in the rail before the occurrence. The two defects were classified as large and medium as per the classification scheme described in the *CN Rail Defect Reference Manual*.

**Photo 6.** The fatigue crack area (red) of fracture surface A superimposed on rail head cross-sectional area (blue)

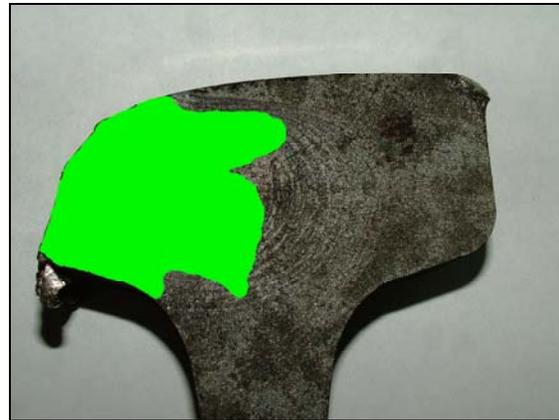
**Photo 7.** The burnished fatigue area (green) of fracture surface A

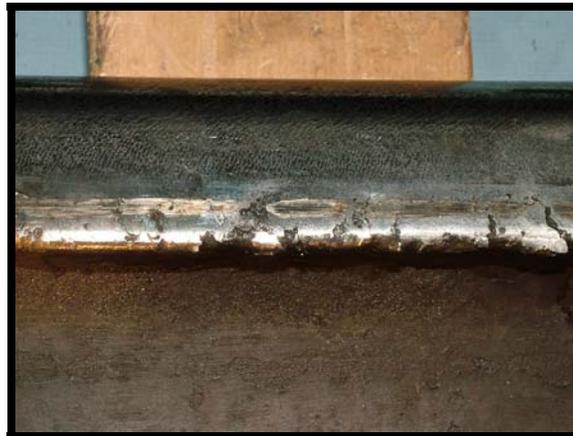
- Scuffing and tearing indicative of extreme loading were observed on the gauge side of the rail pieces (see Photo 8). In addition, heavily deformed pearlite grains and surface patches of martensite were observed on the gauge side. These observations are consistent with a rail loading condition conducive to the formation of subsurface shells that subsequently led to the initiation of transverse fatigue cracks.

**Photo 8.** Gauge face of rail showing indications of scuffing and tearing
