RAILWAY INVESTIGATION REPORT
R06V0183

RUNAWAY AND DERAILMENT
WHITE PASS AND YUKON ROUTE
WORK TRAIN 114
MILE 36.5, CANADIAN SUBDIVISION
LOG CABIN, BRITISH COLUMBIA
03 SEPTEMBER 2006

Report Number R06V0183

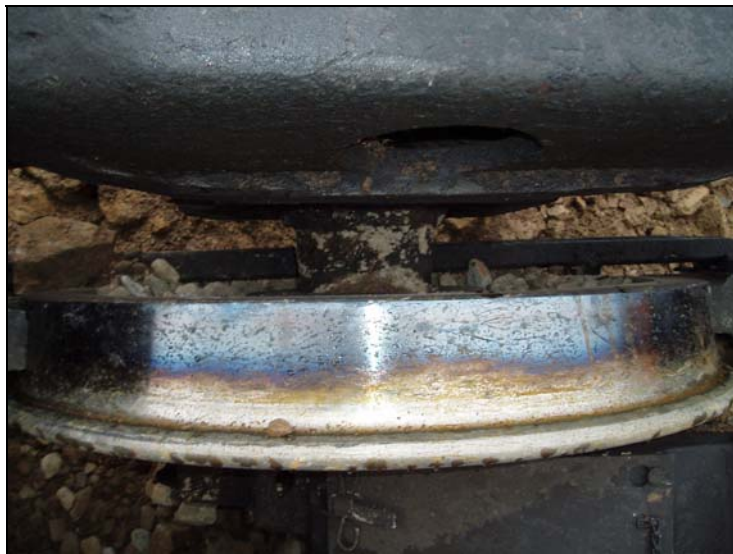
An examination of the locomotive showed that the wheel rims were blued⁹ (see Photo 2), with some showing signs of skidding. The brake shoes were thermally damaged.

Photo 2. Locomotive wheel

⁹ Blueing is a term that refers to the appearance of the wheel tread surface that results from subjecting the tread to excessive heat, usually from prolonged or heavy brake applications.
