## **RAILWAY INVESTIGATION REPORT**

**R08M0063**

### **NON-MAIN-TRACK COLLISION**

**BETWEEN CANADIAN NATIONAL TRAIN Q121-11-03  
AND VIA RAIL CANADA INC. TRAIN P614-21-02  
MILE 1.3, CANADIAN NATIONAL BEDFORD SUBDIVISION  
HALIFAX, NOVA SCOTIA  
03 JULY 2008**

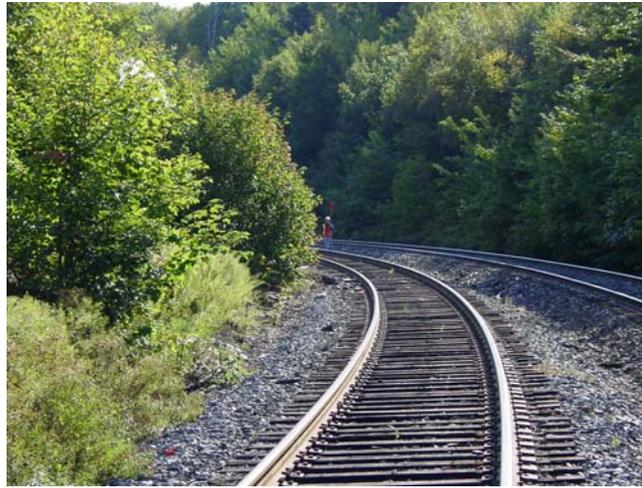
In the accident area, the track is approximately a four-degree curve and a one per cent descending grade for eastward movements. The sightlines were restricted due to vegetation, the curvature of the track, and the deep rock cut (see Photo 1).

**Photo 1.** Track curvature and sightlines at Mile 1.3 looking eastward

The VIA train had five additional cars due to Canada Day passenger traffic. Therefore, it needed to move further westward than usual to clear the tail end of the train for the transfer tracks. This placed the leading end of the VIA train in a location seldom encountered by other crews and in the curved part of the rock cut, where the sightlines were the most restrictive.

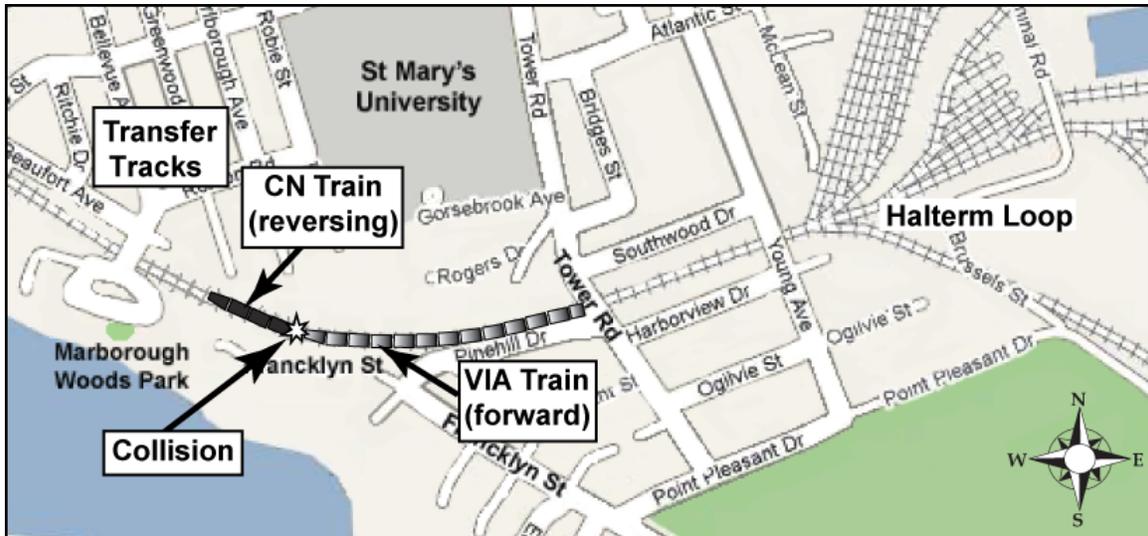
The conductor gave the locomotive engineer instructions to move five car lengths westward to clear the south transfer track switch. After moving about three car lengths, the locomotive engineer started throttling down while moving at 13 mph in preparation to stop. When he heard the CN conductor call his locomotive engineer, he put the VIA train into emergency. Shortly after, the trains collided (see Figure 2).

Figure 2. Schematic showing the direction and relative position of trains at the time of collision

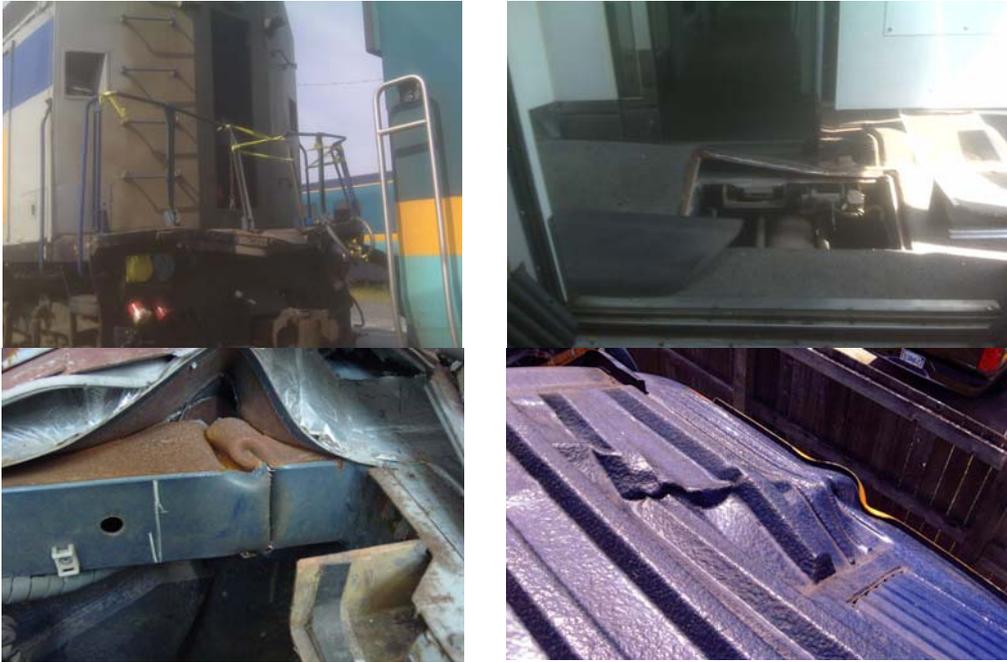
Subsequent inspection revealed that no equipment derailed. However, some of the vestibules and roofs of the Renaissance equipment were buckled.<sup>4</sup> The two VIA locomotives, a baggage car and five coaches were severely damaged (see Photo 3). No one was seriously injured. There was minimal track damage.

**Photo 3.** Damaged VIA equipment (top left: locomotive end damage, top right: buckled car vestibule floor, bottom left: collapsed crash management zone, bottom right: damaged car roof)

Due to their shock-absorbing capabilities, the VIA Renaissance cars are less likely to derail upon frontal impact with other equipment. The crash management zones on the Renaissance equipment functioned as designed and helped to protect the crew members and the maintenance employees who were on board from injurious impact forces (LP 023/09<sup>7</sup>).
