**RAILWAY INVESTIGATION REPORT
R13C0087**

MAIN-TRACK DERAILMENT

**CANADIAN PACIFIC RAILWAY
FREIGHT TRAIN 467-11
MILE 0.30, RED DEER SUBDIVISION
CALGARY, ALBERTA
11 SEPTEMBER 2013**

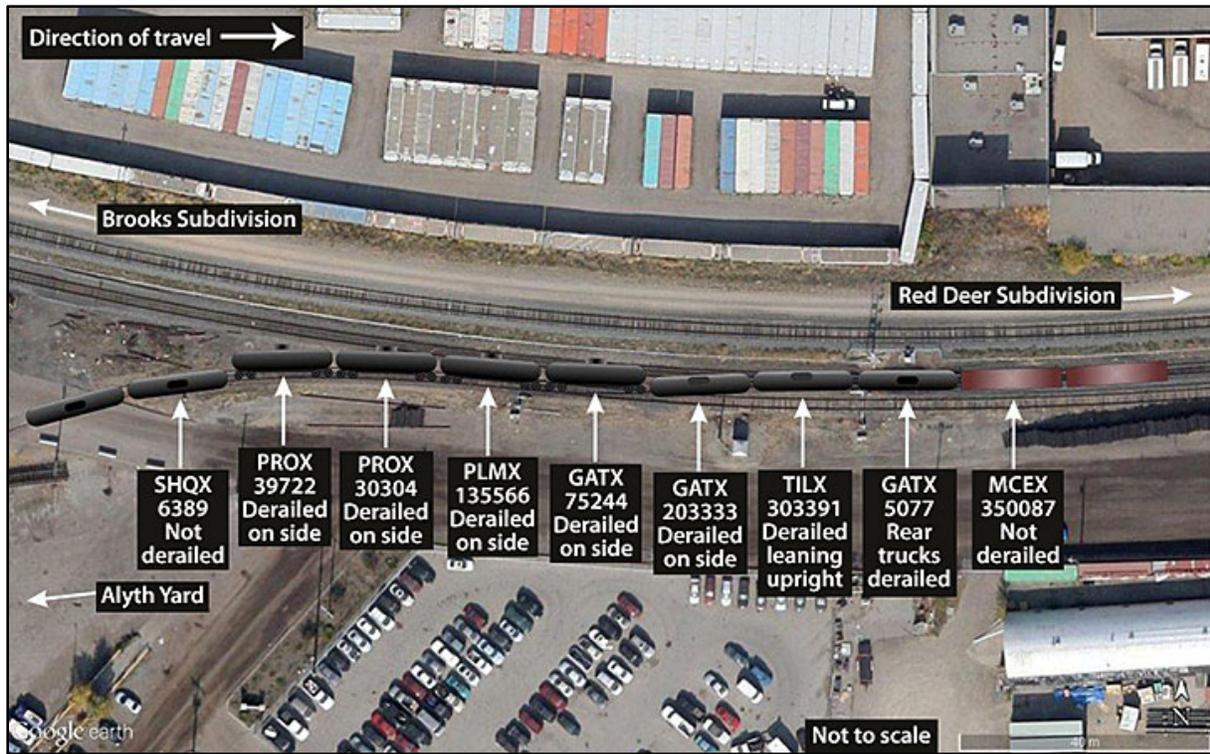
Figure 2. Layout of derailed cars (source: Google Earth, with TSB annotations)

The derailment occurred in the neighbourhood of Inglewood in an urban/industrial area of Calgary (see Figure 2). The first derailed car (GATX 5077) was upright, and the trailing A end truck and wheels were derailed. The following tank car was derailed and leaning to the south side of the track. These cars were followed by 5 tank cars that had derailed on their sides (see Photo 1).

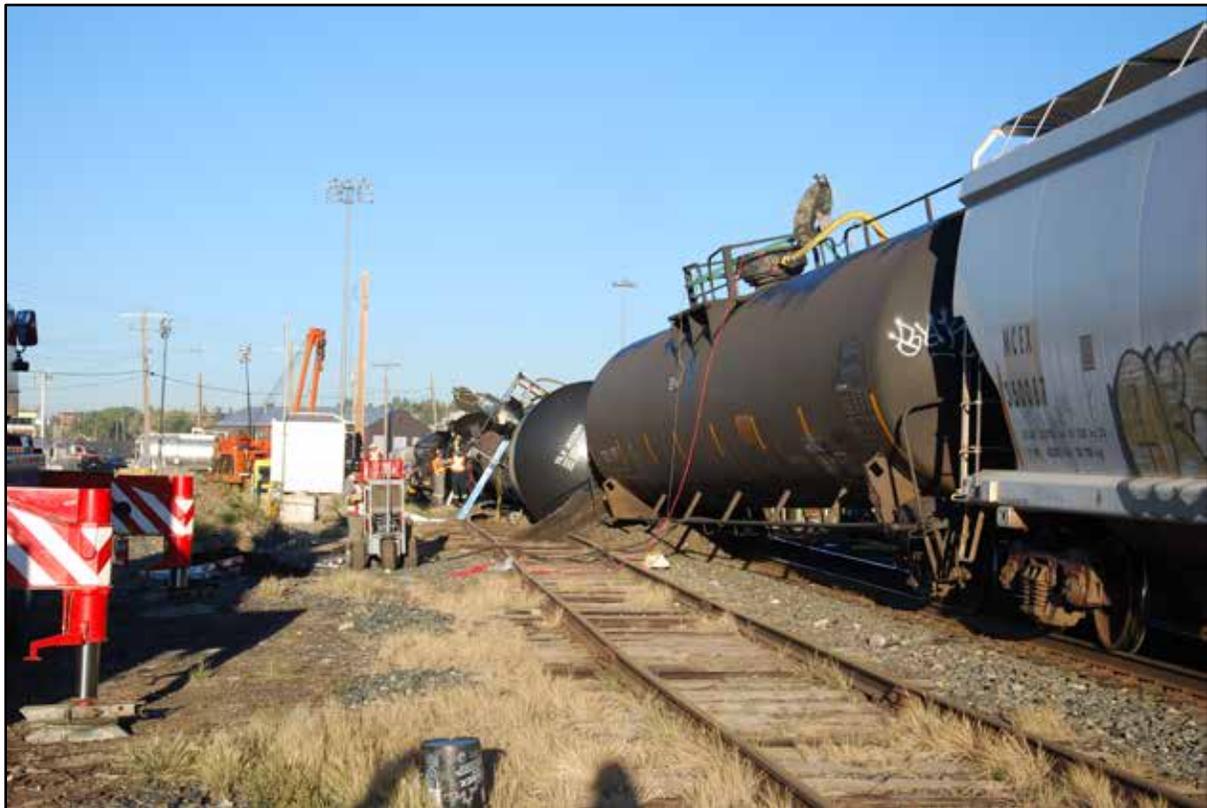
Photo 1. Derailed cars

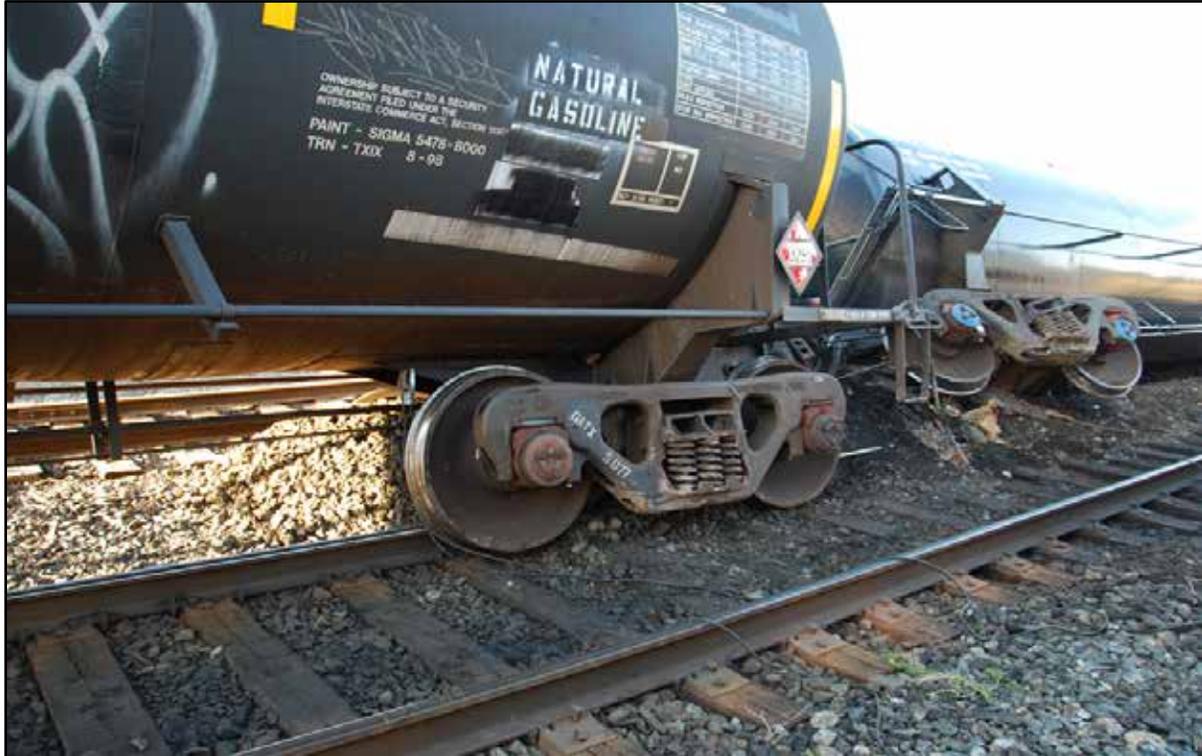
The derailed tank cars were loaded with liquid hydrocarbons, not otherwise specified (N.O.S). The product was placarded as UN 3295, which is commonly referred to as natural gasoline condensate or natural gasoline (see Photo 2). This product is most commonly used as a diluent for bitumen⁴ to lower its viscosity so it can flow through pipelines.

Photo 2. Natural gasoline stencilled on car with UN 3295 placard

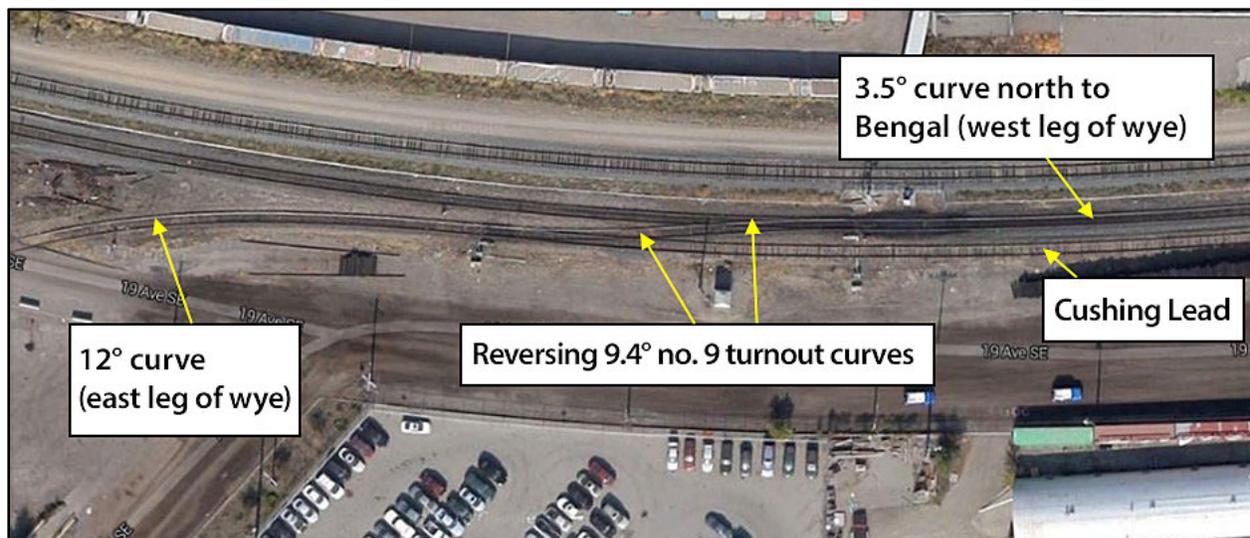
Figure 3. Track layout at Mile 0.3, Red Deer Subdivision

After negotiating the 12° curve, trains enter a short tangent section (about 50 feet) leading to the crossover at Mile 0.3. This crossover consisted of two 115-pound no. 9 turnouts connected with reversing 9.4° curves. Exiting the crossover, trains enter a 3.5°, 6072-foot-long left-hand curve that is the west leg of the wye (see Figure 3). This track and the Cushing Lead run parallel to each other northward to Bengal where they join before crossing the Bow River.

Departing from Alyth Yard for the Red Deer Subdivision, the train was travelling through a sharp, 12° right-hand curve, crossover turnouts with 9.4° reverse curves and a 3.5° left-hand curve. Parts of the train were located on these sections of track at the same time. Furthermore, just prior to the derailment, 31 empty cars had traversed the turnout (the 133rd car to 163rd car). Due to their relatively light weight and the slow speed of the movement, it is likely that the empty cars would be tracking away from the standard switch point (stringlining through the turnout curve) while loaded cars would be tracking more towards the standard switch point. Given the track layout, including a combination of curves and short tangent sections, the transition from empty to loaded cars entering the crossover likely resulted in the wheels of the loaded cars tracking more towards the standard switch point.

Canadian Pacific Railway (CP) removed the crossover switches at Mile 0.30 to prevent any risk of a subsequent incident. The Cushing Lead was strengthened and upgraded to 136-pound rail and surfaced. At Mile 1.1, a new No. 15, 136-pound turnout was installed to replace an existing 115-pound turnout. In its present configuration, the east and west legs of the wye now function independently and are joined at the new turnout at Mile 1.1 at Bengal.

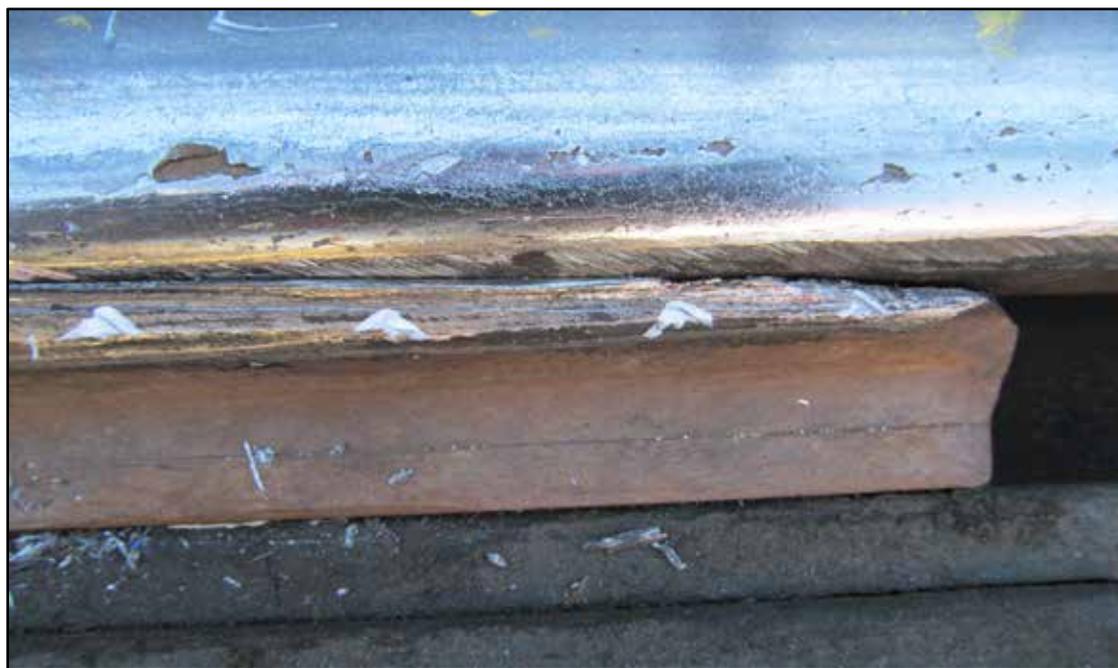
The point of derailment was determined to be at Mile 0.3, where there is a crossover from the Alyth Yard track to the Red Deer Subdivision. Impact marks and flange markings were observed post-accident on the running surface of the right-hand switch point of the divergent route of the turnout (see Photo 3). Wheels had climbed up on top of the switch point and had travelled along the top of the rail before falling between the point and the stock rail.

The crossover turnouts were installed with head-hardened switch points measuring 16 feet 6 inches, rail bound manganese frogs and spike and screw fastenings. The right-hand switch point was a non-Samson, standard point and had been replaced earlier that week due to regular wear (see Photo 3). The left-hand switch point was a Samson point (see Photo 4). The Samson point was in good condition as was the stock rail and the other turnout components. Both Samson and non-Samson switch points can be safely used in the same turnout.

Photo 3. Right-hand non-Samson switch point (note batter and wheel impact marks on the switch point)

As the train entered and transitioned through the crossover between the east and west legs of the wye, it encountered a recently installed, right-hand, standard, non-Samson switch point. For a standard switch point, lateral forces on the point rail can be substantial, even under normal train handling conditions. The point rail, a section of straight rail planed to a fine tip, represents a location where there is an abrupt change in wheel set contact. Specifically, when negotiating a non-Samson turnout, the wheel sets will encounter the point rail with a more aggressive angle of attack, resulting in higher flange forces at the wheel-rail interface, particularly if the point does not have a tight fit against the stock rail. The derailment occurred when wheels climbed up on top of the right switch point of the south crossover switch and travelled along the top of the point until falling between the point and stock rail near the heel block. Wheel flanges striking the non-Samson switch point resulted in overstress impacts on the tip of the point, creating a ramp for a wheel flange to climb up on top.

1. The derailment occurred when wheels climbed up on top of the right switch point of the south crossover switch and travelled along the top of the point until falling between the point and stock rail.
2. Wheel flanges striking the non-Samson switch point resulted in overstress impacts on the tip of the point, creating a ramp for a wheel flange to climb up on top.
3. Given the track layout, including a combination of curves and short tangent sections, the transition from empty to loaded cars entering the crossover likely resulted in the wheels of the loaded cars tracking more towards the standard switch point.

1. If the right-hand or diverging route switch point had also been a Samson point, the risk of switch point damage and wheel-climb derailment would have been significantly reduced.

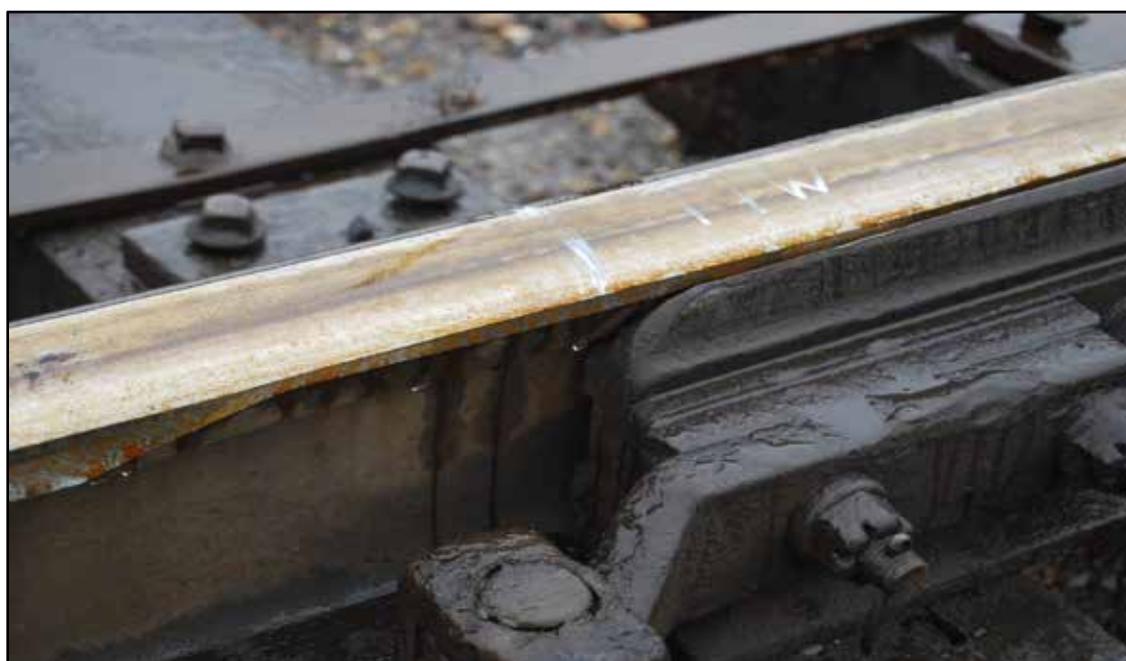
Photo 4. Left-hand Samson switch point

In this case, most traffic is northward using the diverging route of the turnout, which did not have a Samson point and stock rail. While the Samson switch point was protected from wheel flanges on through movements to the Cushing Lead through the turnout, the non-Samson switch point was exposed to many more wheel flanges (and potentially more overstress impacts) on movements taking the diverging route to the Red Deer Subdivision. Samson switch points lessen the angle of attack by wheel sets at the wheel-rail interface and reduce overstress impact from wheel flanges. If the right-hand or diverging route switch point had also been a Samson point, the risk of switch point damage and wheel-climb derailment would have been significantly reduced.

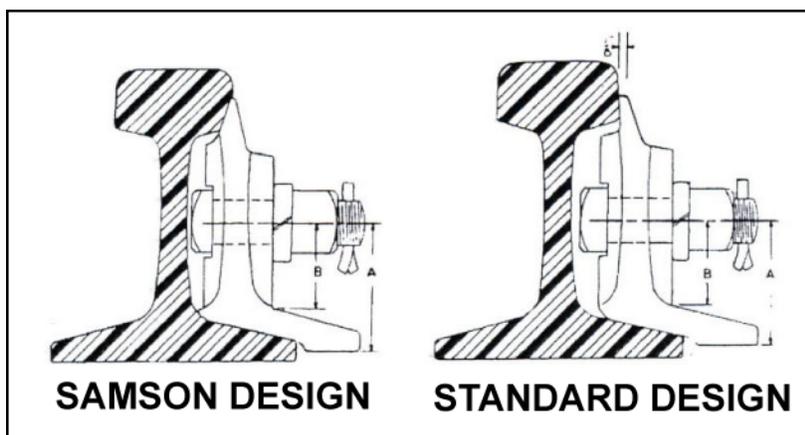
Figure 4. Samson and standard switch points

Figure 4 presents a schematic cross section of the Samson switch point and of the standard switch point. The Samson switch point design ensures that wheel flange impacts from rolling stock travelling through the switch point are reduced. Specifically, for Samson switch points, the lower corner of the head of the stock rail (on the gauge side) is machined at an angle. This machining on the stock rail is referred to as an undercut that houses the point under the stock rail. The undercut protects the switch point from direct impact from the oncoming wheel flanges. In addition, the angled fit resists “scissor action” between the switch point and the stock rail. Stock rails for Samson switch points are supplied from the manufacturer with the undercut.

Samson switch points are usually installed on both rails or, if only one is to be used, it is preferably installed on the more heavily travelled route through the turnout, if available. Both Samson and non-Samson switch points can be safely used in the same turnout. When only one Samson point is installed, preference is given to installation on the divergent route. However, it is good maintenance practice to have them both Samson.
