**RAILWAY INVESTIGATION REPORT
R13W0260**

EMPLOYEE FATALITY

**CANADIAN NATIONAL RAILWAY
TRAIN L586 41-18
MILE 61.0, TISDALE SUBDIVISION
TISDALE, SASKATCHEWAN
18 NOVEMBER 2013**

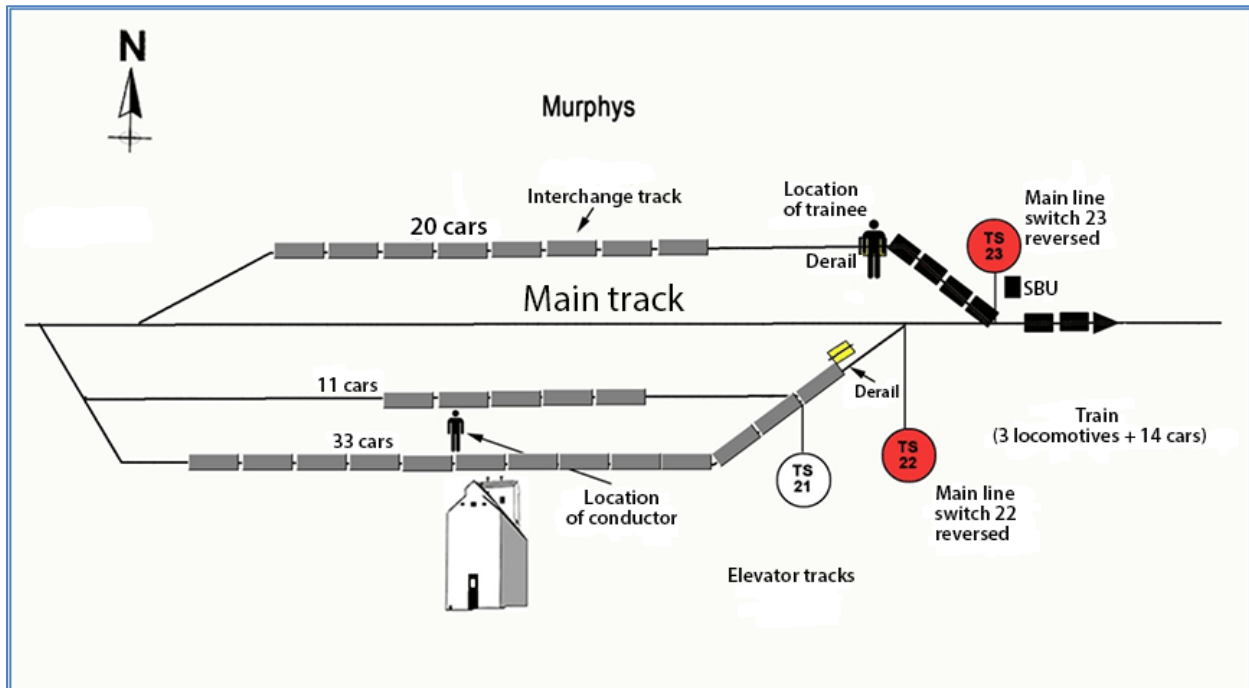
Figure 2. Diagram of the accident site, showing locations of the conductor, the trainee, and the train components and derrails.

Upon arrival at Murphys (Mile 61.0), the following events occurred² (Figure 2):

1817: Instead of lining TS 22, the trainee inadvertently reversed switch TS 23, which lined it for the interchange track, and then reported (on the radio) that the mainline switch had been lined and locked in the normal position for the main track. The crew acknowledged the radio transmission as required. However, the entire crew was unaware that the train was being routed into the wrong track.

1818: With switch TS 23 set in the reverse position, the train reversed into the interchange track instead of reversing westward on the main track.

The trainee was positioned between the rails of the interchange track (i.e., track TS 23) with his back to the train as he worked to secure the derail, which was located between

the rails. Unaware of the train's approach, the trainee was struck by the train and sustained serious injuries. After striking the trainee, the train coupled heavily to the cars that had been set off on track TS 23. The loud noise alerted the crew in the area that something may be wrong. At about the same time, the trainee broadcasted over the radio that he was hurt. The pilot locomotive engineer detrained and located the trainee. While providing comfort and emergency first aid, the pilot locomotive engineer notified the rest of the crew to stay clear and to initiate an emergency call for immediate medical assistance. Subsequently, the trainee was transported by ambulance to a hospital in Tisdale, but succumbed to his injuries while en route.

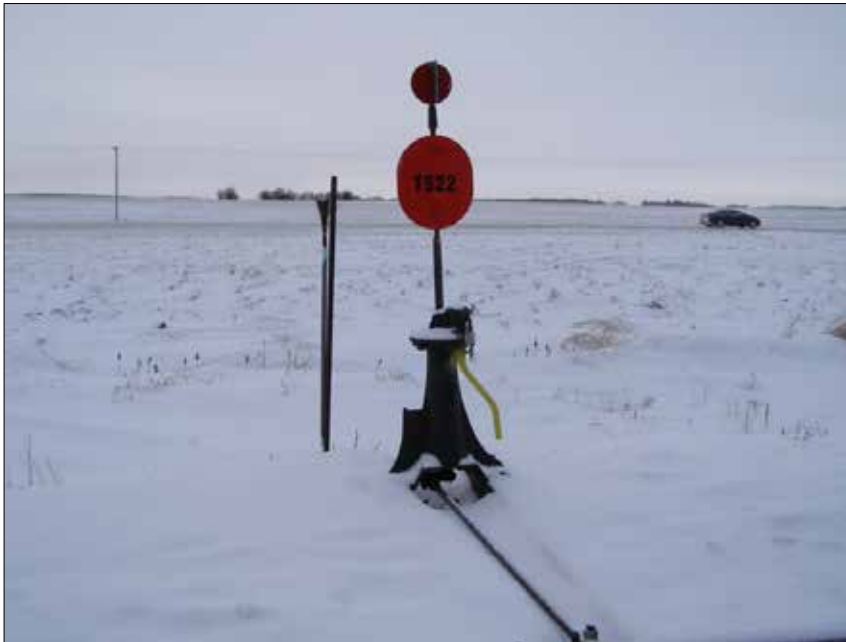
Photo 1. Mainline track switch TS 22 in the normal position

- 1757: The conductor reversed mainline track switch TS 22⁵ (switch TS 22) and removed the derail for the elevator tracks (i.e., track TS 21 and track TS 22 [Photo 1], located south of the main track) in preparation for spotting 44 empty grain cars onto the elevator tracks. The conductor was positioned at the east end of track TS 21 to make the cut after the first 11 cars were set off in track TS 21, and in preparation for setting off the remaining 33 cars in track 22.
