Collision between OC Transpo bus and VIA passenger train: Executive summary

This summary of the Transportation Safety Board of Canada's (TSB) Railway Investigation Report R13T0192 contains a description of the accident, an overview of the analysis, findings, and safety action taken to date, as well as the five key recommendations that highlight what more needs to be done to help ensure an accident like this does not happen again.

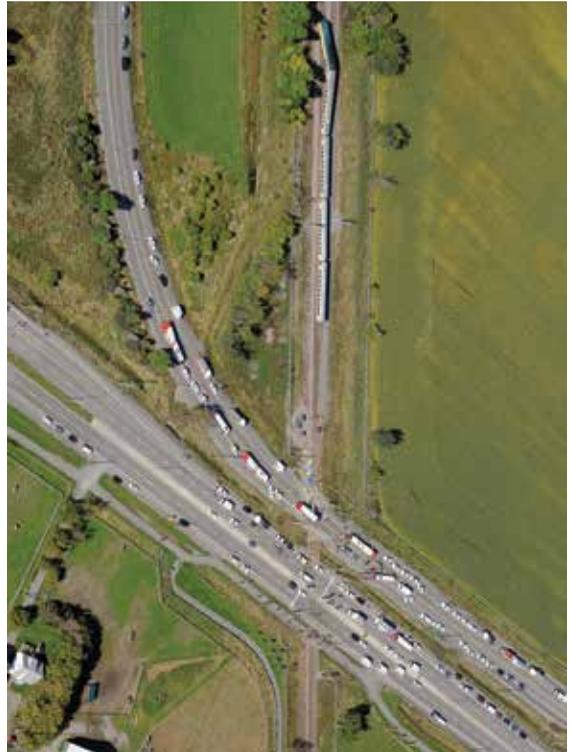
Source: Ottawa Police Service

As a result of the collision, the bus was extensively damaged. The driver and five passengers sustained fatal injuries, nine other passengers were seriously injured, and about 25 passengers incurred minor injuries. Although the train derailed, none of the VIA crew or passengers were injured.

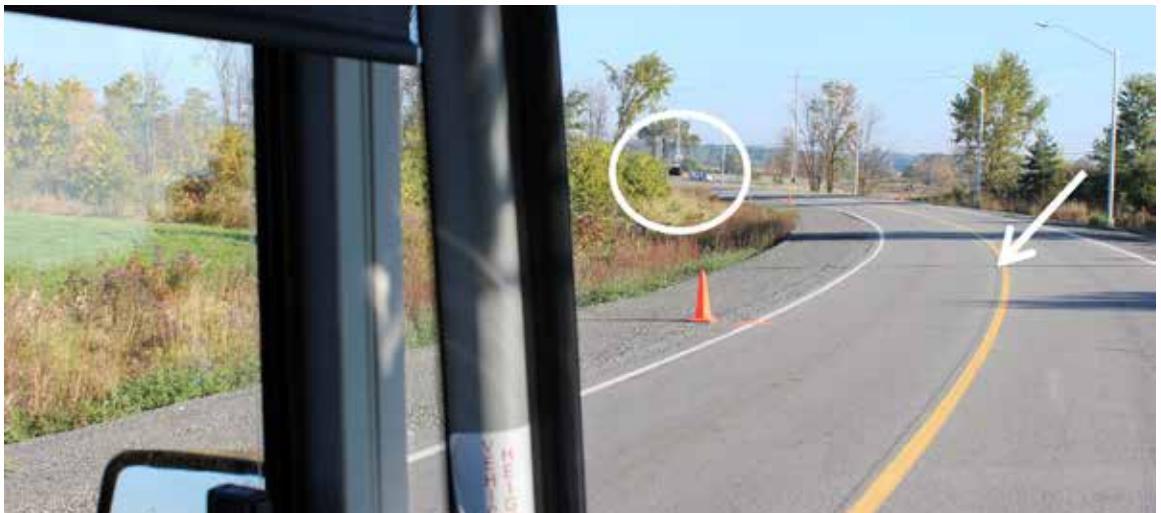
Moreover, studies measuring driver eye movements show that, when negotiating a curve, drivers tend to look in the direction that the vehicle is turning. Visually, they rely on a “tangent point” on the inside of the curve, and they tend to make only anticipatory glances toward the “occlusion point,” or the nearest point where the view of the road ahead is blocked. In this occurrence, this was an area that was obstructed by trees, shrubs, foliage, and Transitway signage, as well as by the frame of the bus itself.

View of the approach to the crossing on the Transitway. The arrow identifies the tangent point of the curve. The circle identifies the occlusion point toward which drivers would make anticipatory glances. Note the large sign in the occlusion point.

The City of Ottawa has since improved driver sightlines in the vicinity of the Transitway crossing by trimming or removing trees, shrubs and foliage. Signage has also been enhanced—including by the addition of an advance warning sign with a light that continuously flashes—and the posted speed limit in both directions approaching the crossing has been reduced to 50 km/h.

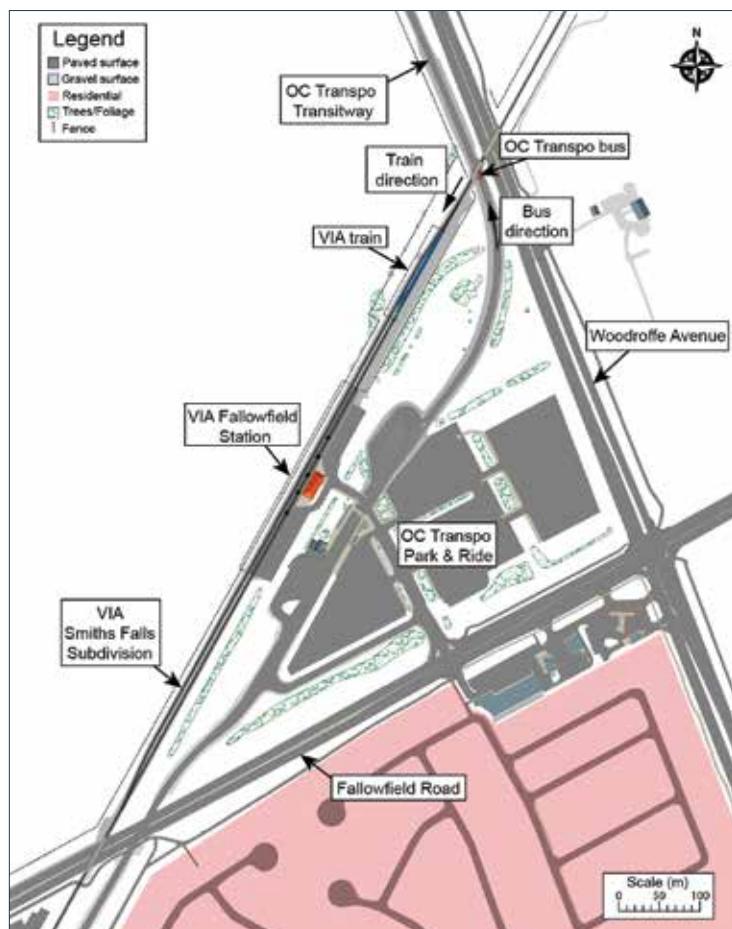
The railway tracks traverse Woodroffe Avenue and the Transitway at an angle of 50 degrees. Both crossings are equipped with active warning devices that include flashing lights, bells, and gates. At the time of the accident, these operated as designed; the bells and lights were activated about 49 seconds before the train arrived at the crossing, and the gates were fully horizontal at least 26 seconds prior to the accident.

Although the Transitway was built in accordance with established standards, its configuration, with a significant left-hand curve and relatively short approach to the crossing, proved to be problematic. For a bus travelling at the posted speed limit of 60 km/h, the recommended stopping sight distance (SSD) was 130 m (426.5 feet). At the time of the accident, the flashing lights and gates—even though they were activated before the bus left OC Transpo's

Fallowfield Station—were obstructed by trees, shrubs, foliage, and Transitway signage. This reduced a northbound driver's SSD to 122.5 m (402 feet).

The new Transport Canada *Grade Crossings Regulations* (November 2014) now require that an approach with similarly reduced SSD be equipped with an active advance warning sign with lights that are interconnected with the crossing signals, to provide the driver advance warning of the train's approach.

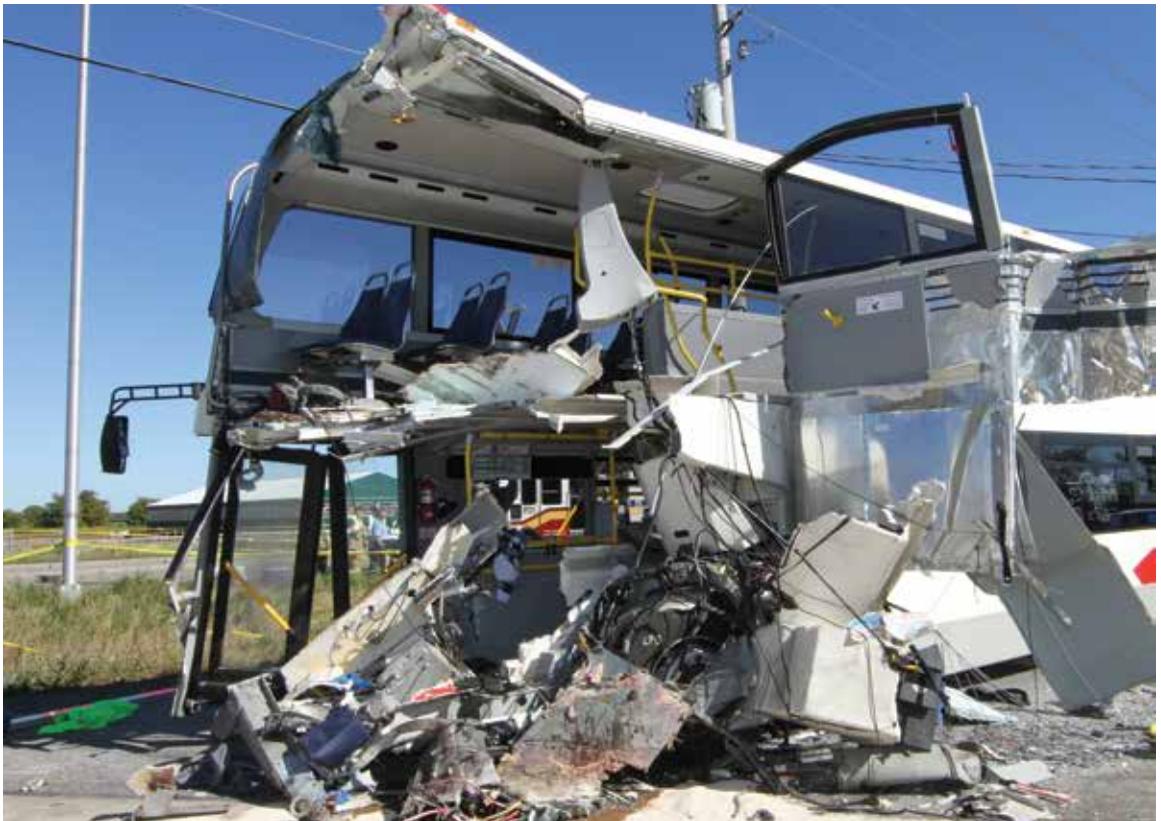
In this occurrence, the bus had no front bumper, and its front-end frame was not designed to provide impact protection. Unlike automobiles, which must meet stringent crashworthy performance testing requirements, the CMVSS contain no requirements for frontal impact, side impact, rollover, or crush protection for buses in this category. Although not required by regulation, a more robust front structure and crash energy management design might have reduced the damage to the bus and prevented the loss of a protective shell for the occupants.
