**RAILWAY INVESTIGATION REPORT  
R14T0180**

**MAIN-TRACK TRAIN DERAILMENT AND COLLISION  
CANADIAN NATIONAL FREIGHT TRAIN M36831-01 AND  
VIA RAIL CANADA INC. PASSENGER TRAIN NO. 47  
MILE 153.92, KINGSTON SUBDIVISION  
GANANOQUE, ONTARIO  
01 AUGUST 2014**

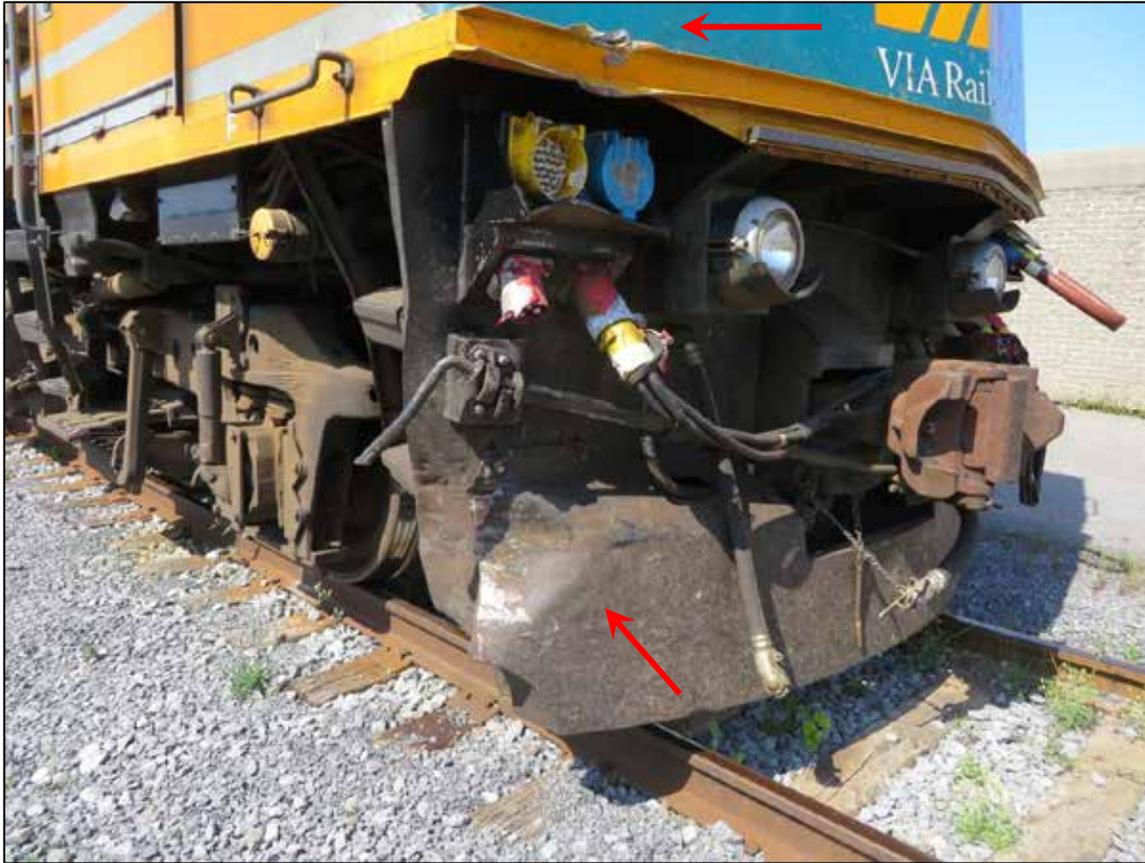
VIA 47 had been brought to a stop with the head-end of the train at about Mile 151.13. The north side of the VIA locomotive (Photo 1) and of all 5 coaches were damaged. The fuel tank on the VIA locomotive was punctured about halfway up its leading corner and about 1000 litres of diesel fuel had been released.

Photo 1. Locomotive VIA 6424 showing impact damage (red arrows)

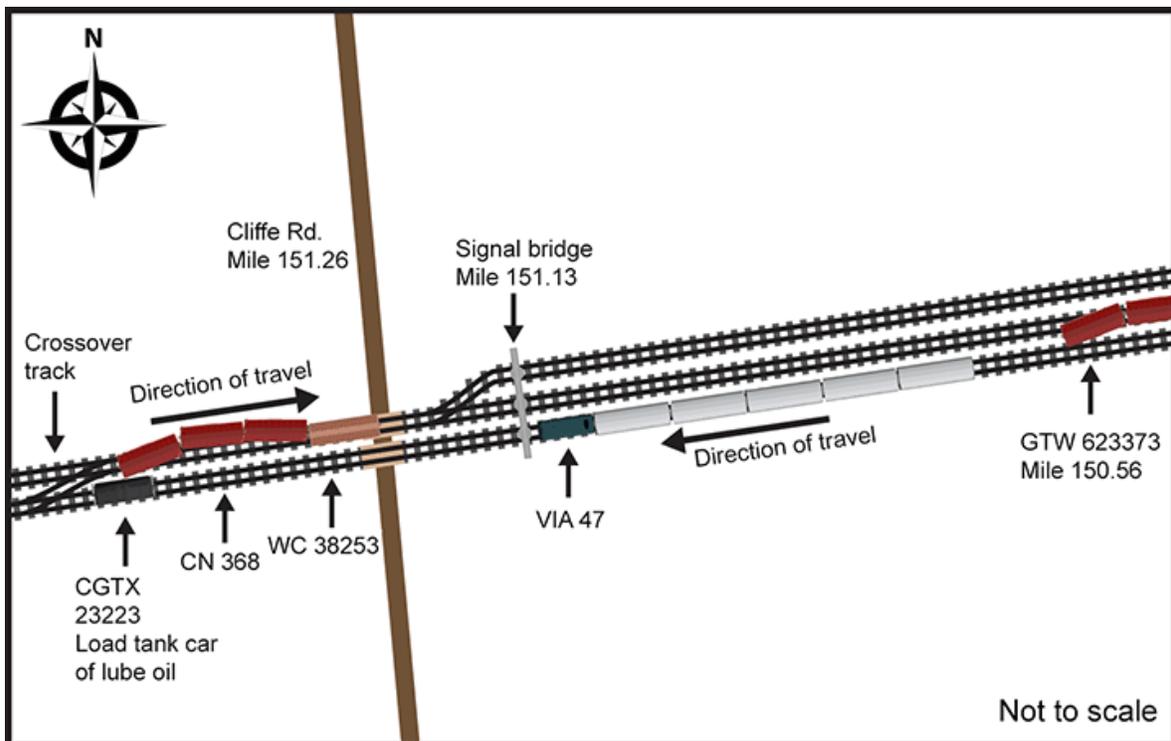
Figure 2. Derailment site diagram

- The trailing A-end truck had all wheels derailed to the south fouling the south main track. The A-end wheel treads exhibited heavy damage that was consistent with derailment damage sustained while travelling on the ballast of the track road bed. The top of the A-end bulkhead and the south side of the car body exhibited impact damage.

- The leading truck of the 5th car from the tail end (WC 38253), an empty centre beam bulkhead flat car, came to rest on the north track on the west side of the crossing. All 8 of the car wheels had remained on the rail, but were displaying moderate damage

- The wheel treads of the leading truck of the 4th car from the tail end (CN 598296), an empty boxcar, had remained on the rail but were displaying light wheel tread damage. The trailing truck was derailed to the north side.
- The 3rd and 2nd cars from the tail end (empty box cars) were derailed and were leaning to the north.
- The tail end car (CGTX 23223), a Class 111 tank car loaded with lube oil, a non-regulated product (i.e. not classified as dangerous goods), came to rest upright on the south track with all wheels derailed at about Mile 151.30.

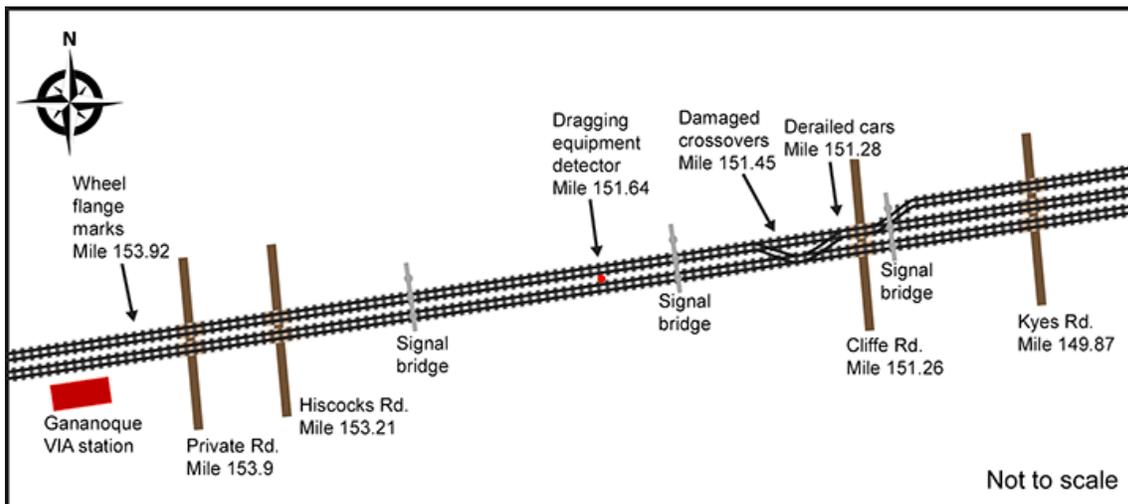
Figure 3. Area diagram

The first derailment marks on the north main track were located at about Mile 153.92. (Figure 3). Wheel flange marks were present on the gauge side of the running surface on the south rail head. The marks continued eastward along the running surface toward the field side for about 32 feet, where the marks fell off to the field side. From there, the marks continued eastward for about 60 feet on the base of the rail, on the tie plates and on the ties, before impacting the planks of the private crossing at Mile 153.9. Corresponding wheel flange marks were also present on the ties between the rails. Intermittent track damage continued eastward beyond the private crossing up to the main track crossover at Mile 151.45.

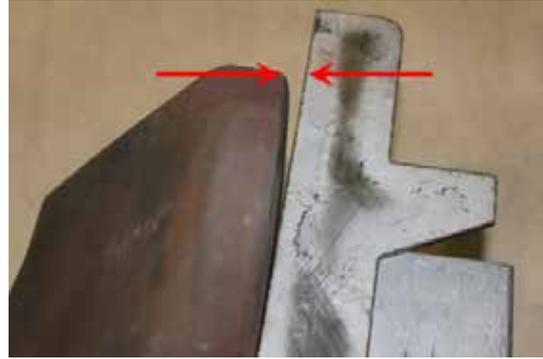
- Both friction wedge castings were worn to a convex shape while the corresponding truck side column wear plates mating surfaces were worn to a concave shape. This wear pattern suggests that the truck had reduced warp resistance (Photo 3).
- The elastomer element of the B-end left side (BL) CCSB was permanently deformed and was likely past its service life. The height range indicator was not visible (Photo 4).
- For the elastomer element of the B-end right side (BR), the height range indicator was visible (Photo 5).

**Photo 3. Representative friction wedge showing extent of wear (arrows point to the gap between the contact surface and a straight edge)**

The examination concluded that the loss of damping, as well as the wear in the friction castings, is indicative of a truck that has reduced stiffness and was likely susceptible to excessive hunting.

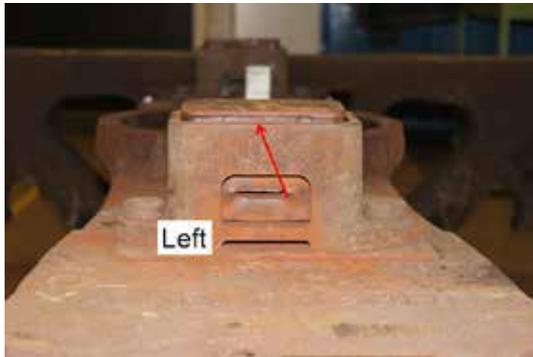
**Photo 4. B-end left side (BL) constant contact side bearing in its cage. The height range indicator is not visible (arrow).**

The GTW 623373 B-end left side (BL) CCSB was past its condemning limit, which indicates that it had lost its preload and was no longer providing effective damping. The worn condition of the leading B-end truck friction wedge castings indicated that the truck's warp resistance was even further reduced. Because the trucks were both installed new in 1994 and were subject to the same operating conditions while in service, it is likely that the conditions observed in the leading B-end truck were also present in the trailing A-end truck which derailed. The A-end truck of empty centre beam flat car GTW 623373 was the first truck to derail as a result of excessive truck hunting. Given the circumstances, it is most likely that the excessive truck hunting on car GTW 623373 was influenced by the type of car, the speed

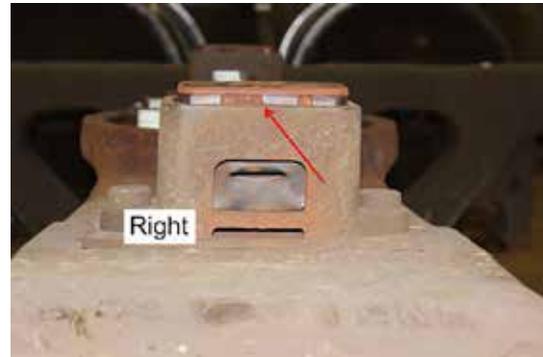
**Photo 5. B-end right side (BR) constant contact side bearing in its cage. The height range indicator is visible (arrow).**

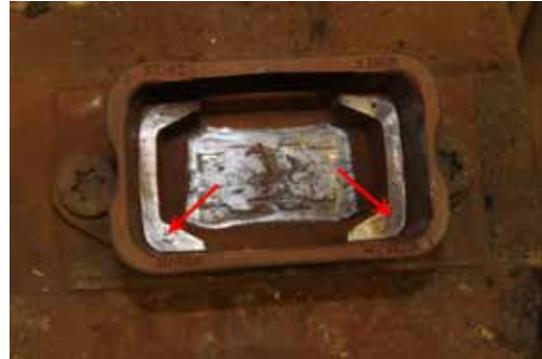
- Wear observed on the CCSBs, their cages, and the corresponding body side bearings was consistent with wear observed on trucks with CCSBs that have lost their dampening characteristics. In particular, the lugs of the CCSB cage were polished, indicating that the CCSB had bottomed out (Photo 6).
- The height of the side bearings of the subject truck assembly was measured between the bolster pad and the side bearing contact plate. The measured heights on the left and right sides were  $4\frac{5}{8}$  inches and 5 inches respectively, giving a total value of  $9\frac{5}{8}$  inches, which is  $\frac{1}{8}$  inch below the AAR condemning limit.

Photo 6. Left side constant contact side bearing cage. Arrows point to worn areas where the metal portion of the CCSB has made contact with the cage
