**RAILWAY INVESTIGATION REPORT
R14W0137**

MAIN-TRACK DERAILMENT

**CANADIAN NATIONAL
FREIGHT TRAIN M34641-23
MILE 93.38, FORT FRANCES SUBDIVISION
FORT FRANCES, ONTARIO
23 MAY 2014**

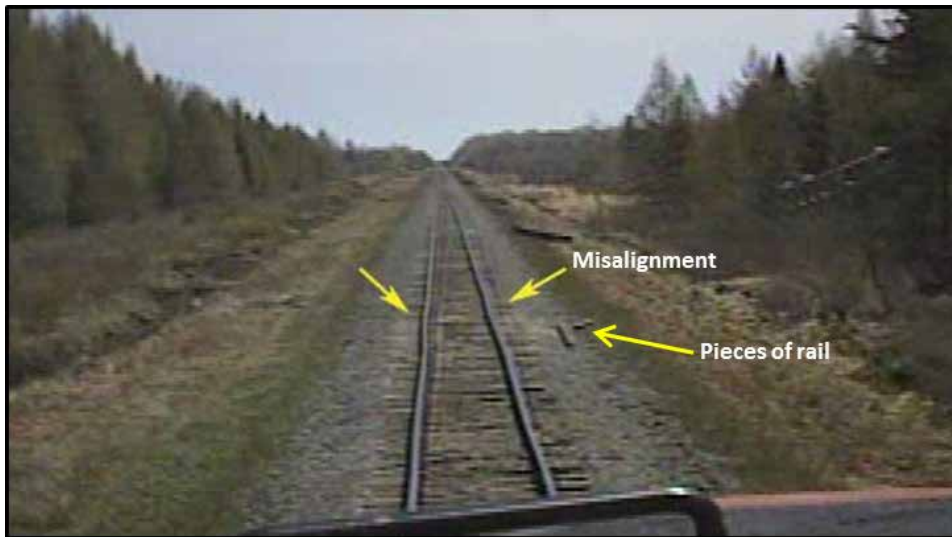
While proceeding at 46 mph on the descending 0.2% grade between Mile 93.0 and Mile 93.5, with the train air brakes released and the dynamic brake (DB)² in position 2, the forward-facing video camera on the lead locomotive of train G840 recorded a slight track misalignment at Mile 93.38 (Photo 1). The locomotive shifted from side to side as it proceeded over the track misalignment.

Photo 1. Train G840 forward-facing video camera view approaching Mile 93.38, looking east (Source: Canadian National)

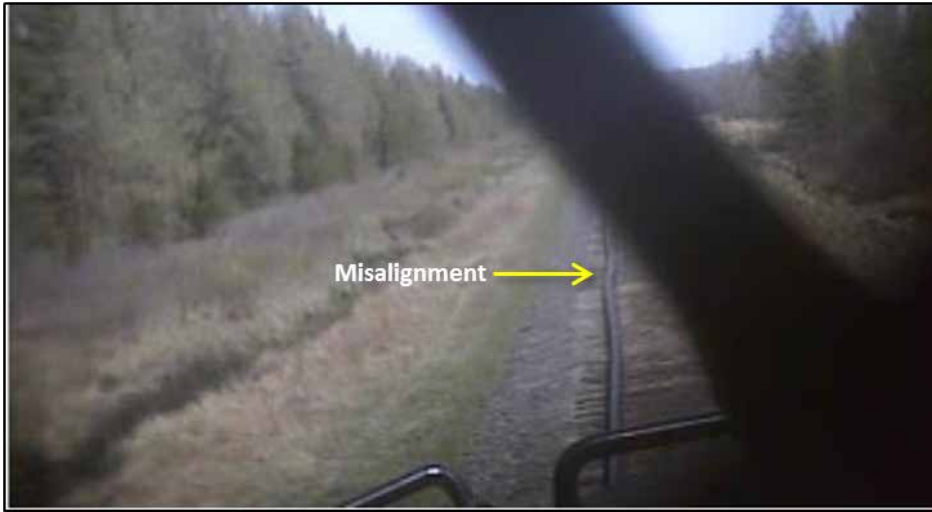
Photo 2. Train M346 forward-facing camera view approaching Mile 93.38, looking east
(Source: Canadian National)

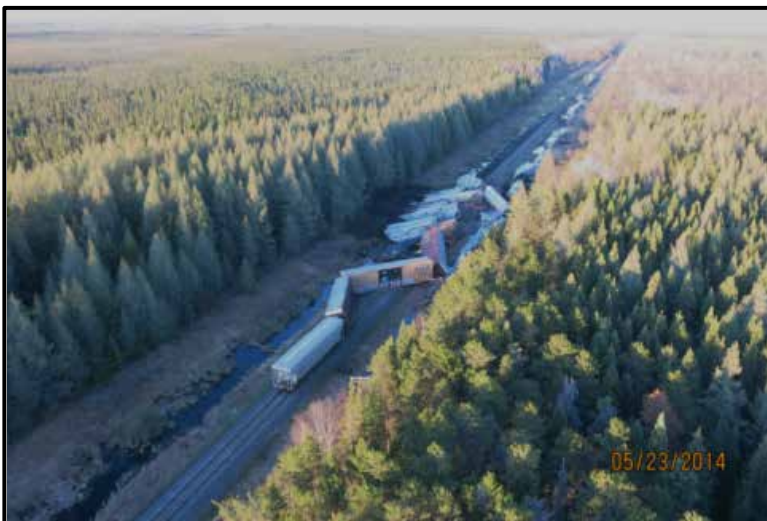
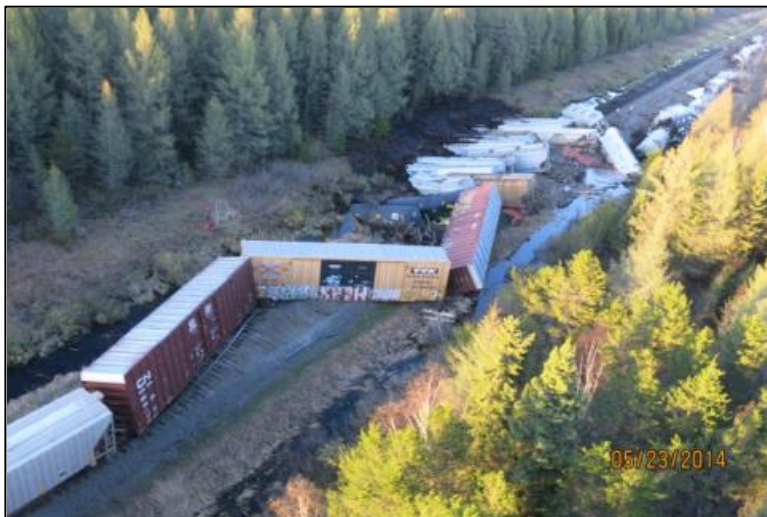
During site examination, it was determined that the 31st to the 65th cars from the head end had derailed (photos 3 and 4).

Photo 3. Derailment site looking eastward in the direction of train movement (Source: Forest Helicopters Inc.)

Photo 4. Derailment site looking eastward in the direction of train movement (Source: Forest Helicopters Inc.)

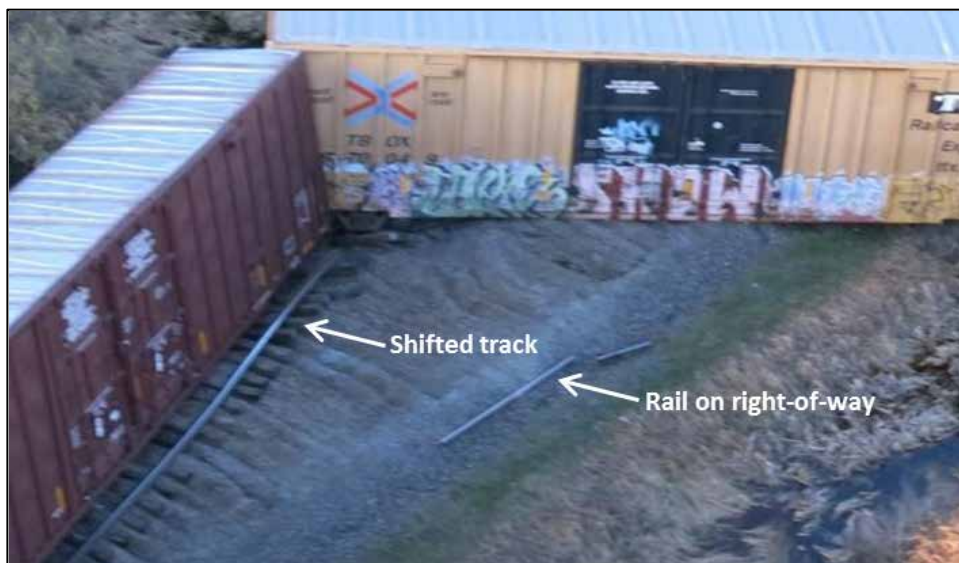
Beginning at the west end of the derailment site, the track had shifted to the north (Photo 5). The 65th car came to rest upright, along the track structure in advance of the track panel shift, with only the leading truck derailed. The 64th and 63rd cars from the head end came to rest upright over the portion of track that had shifted north. Two pieces of rail laid along the track shoulders adjacent to the shifted track.

Photo 5. West end of the derailment site showing the shifted track and 2 pieces of rail on right-of-way (Source: Forest Helicopters Inc.)

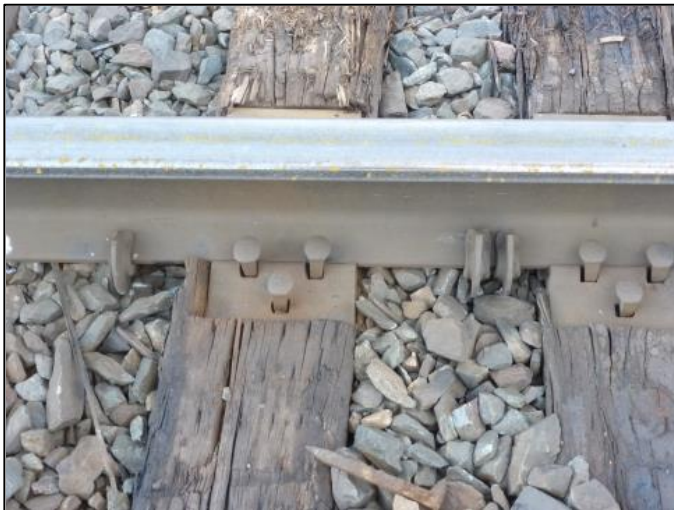
- Numerous bundles of new ties were situated along the track right-of-way.
- In a number of locations, anchors were loose, missing, or situated in the centre of the tie crib (i.e., not positioned adjacent to each tie) (Photo 6).

Photo 6. Anchors situated away from the tie

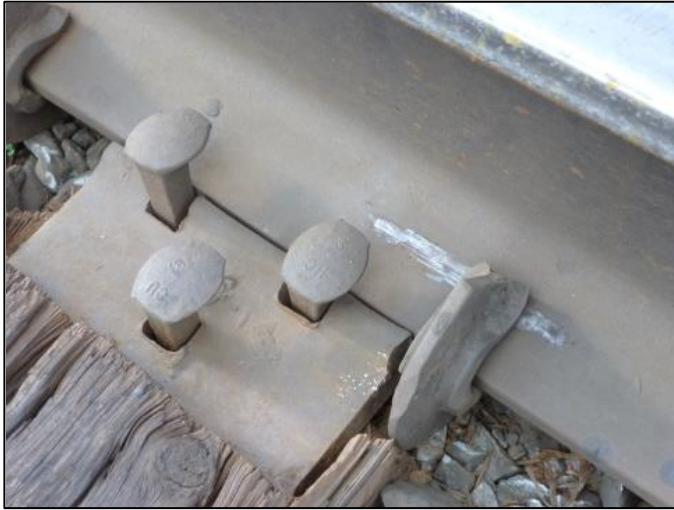
- Spike and anchor abrasion marks were present on the base of the rail, indicating movement of the south rail (Photo 7).

Photo 7. Anchor abrasion markings on the rail base

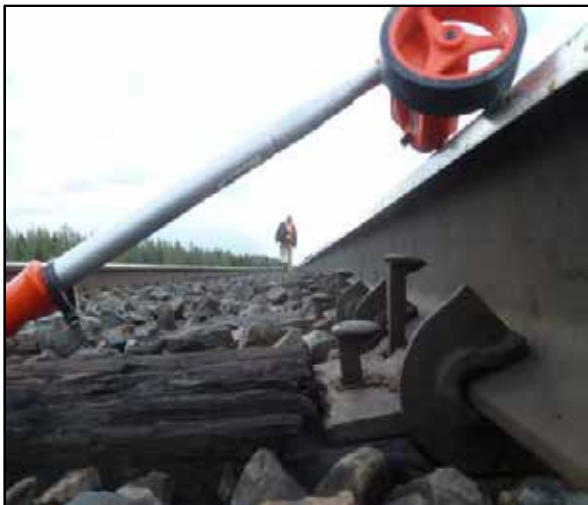
- There were several locations where the spike anchoring of the rail on 3 or 4 consecutive ties was rendered ineffective as there were missing or high spikes (Photo 8) or the tie was spike killed³ (Photo 9).

Photo 8. High spikes

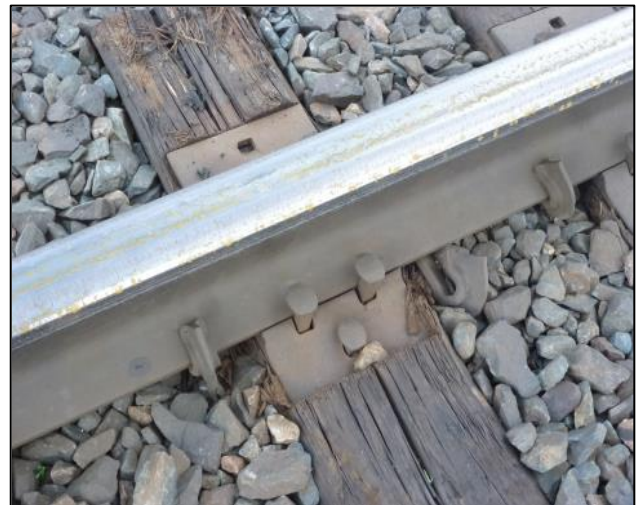
Photo 9. Spike-killed tie

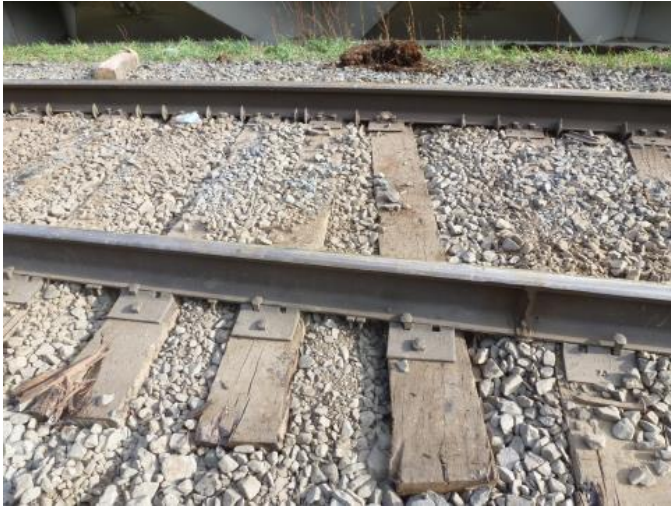
- Many ties were split or skewed as a result of rail movement (Photo 10).

Photo 10. Skewed ties

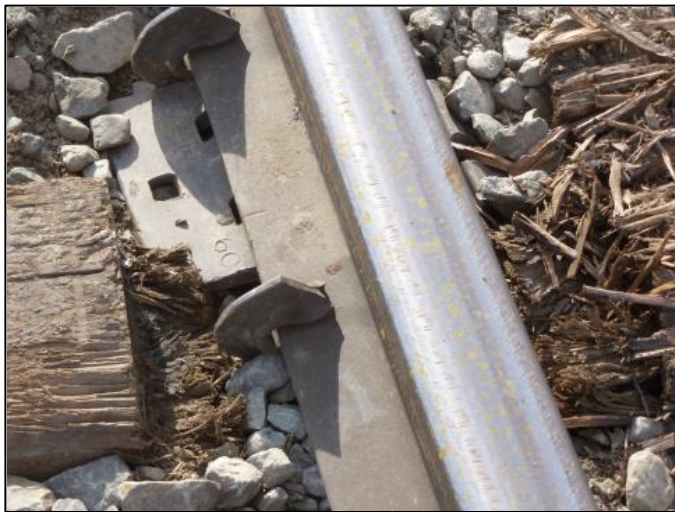
- Both dry rot and wet rot was present on many ties (Photo 11).

Photo 11. Dry rot

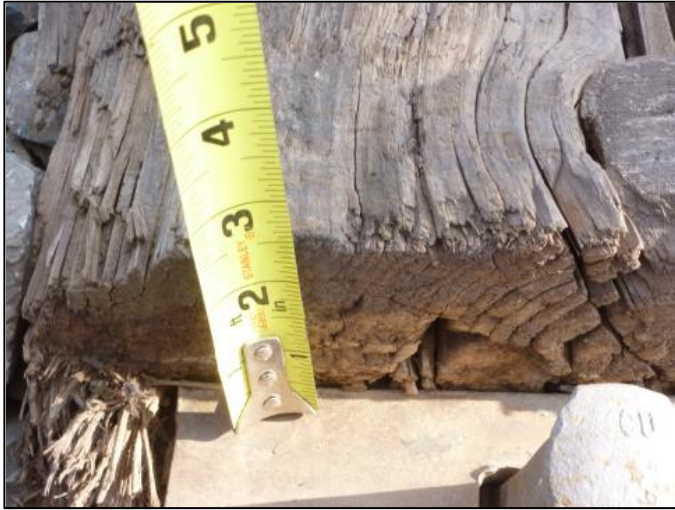
- Numerous ties were plate cut between $\frac{3}{4}$ and $1\frac{1}{2}$ inches (Photo 12). Some were plate cut by up to $2\frac{1}{2}$ inches.

Photo 12. Plate-cut tie

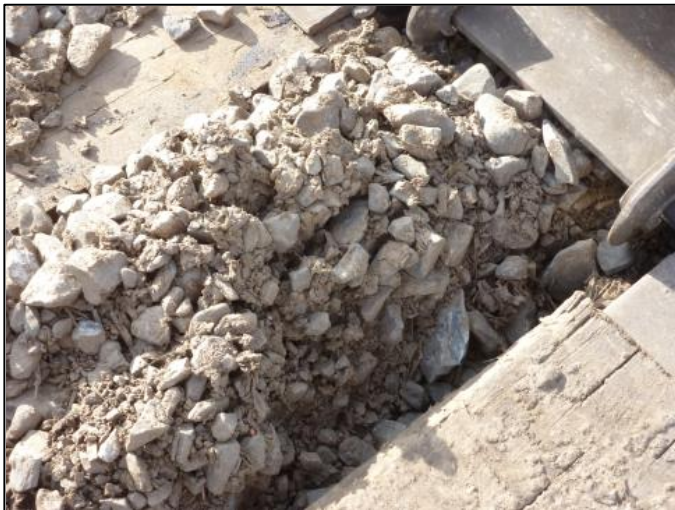
- Over a short section of track containing 100 ties, CN had previously marked 43 ties for removal. During site examination, 60 of the same 100 ties were identified as broken, spike killed or plate cut. Within that section of track, there were 2 locations where 9 or 10 consecutive ties were rendered ineffective by deficiencies in either anchoring or tie condition (i.e. spike killed, broken, split, rotten or skewed).
- The cribs were full and the shoulders ranged from 18 to 24 inches wide. The ballast was composed of 1-inch to 2½-inch angular rock. Beginning from Mile 93.75 and extending eastward to the derailment site, the ballast condition progressively worsened, becoming severely fouled with silt and fine-grained material (Photo 13).

Photo 13. Fouled ballast being plowed by the tie

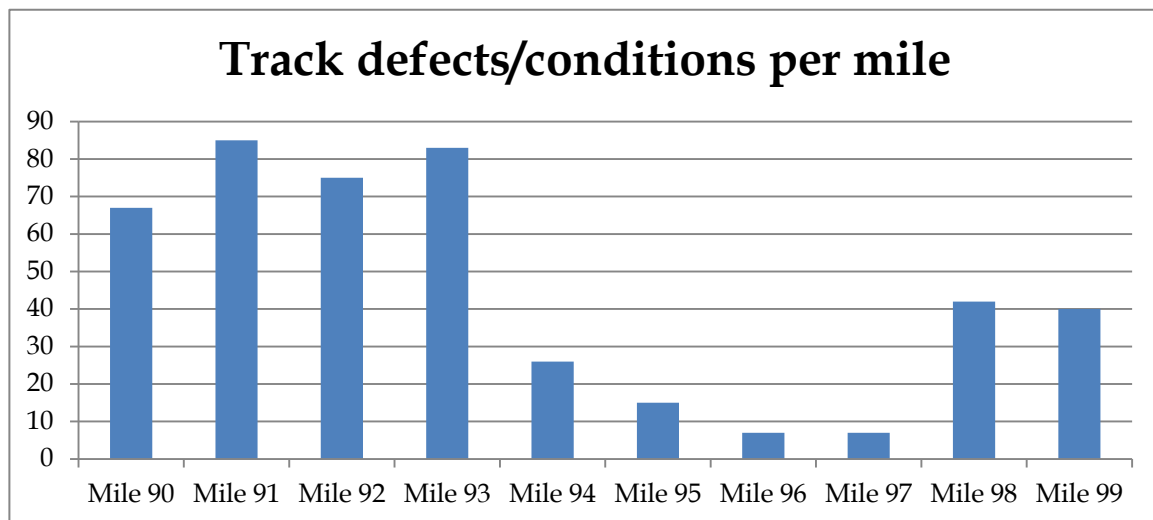
Figure 4. Track defects/conditions, February 2012 to May 2014

The inspection results (geometry car, ultrasonic, visual, and ad hoc inspections) for the period between February 2012 and May 2014 indicated that there were 427 track defects and conditions that required monitoring between Mile 90.2 and Mile 99.5 (Figure 4). Of the 427 track defects and conditions, 330 (77%) were from the section of track between Mile 90.2 and Mile 94.0. Excessive cant and narrow gauge conditions accounted for 141 of the 330 (43%). Many of these track defects and conditions had been recurring. For example, all but 26 of the track defects and conditions had been identified during earlier inspections (i.e., identified multiple times). Excessive cant and narrow gauge can be indicators of a deteriorated tie condition.
