**RAILWAY INVESTIGATION REPORT  
R15D0073**

**DERAILMENT  
CENTRAL MAINE & QUÉBEC RAILWAY  
FREIGHT TRAIN 2-10  
MILE 6.3, ADIRONDACK SUBDIVISION  
FARNHAM, QUEBEC  
10 AUGUST 2015**

Railway Investigation Report R15D0073

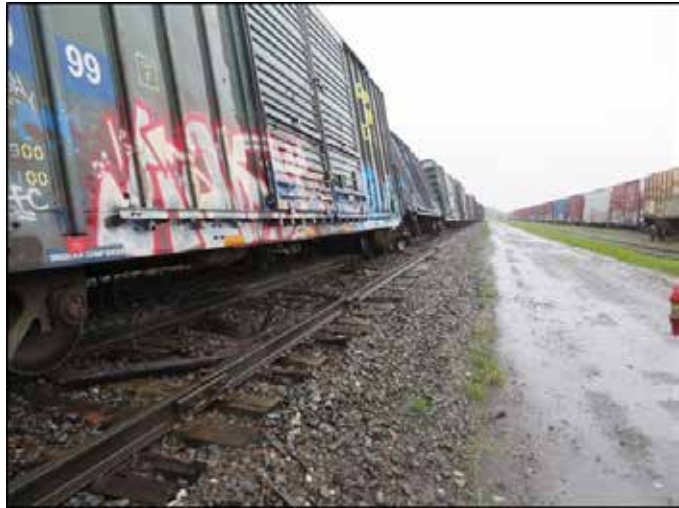
At about 2230, as it was leaving Farnham Yard, the train reached a speed of about 10 mph when it began to slow down. The LE tried to compensate by gradually moving the throttle to position 7, but the train continued to slow until a train-initiated emergency brake application brought it to a stop. Upon inspection, the train crew found that 15 cars, positions 8 to 22, had derailed (Photo 1).

Photo 1. Derailed cars (view looking south)

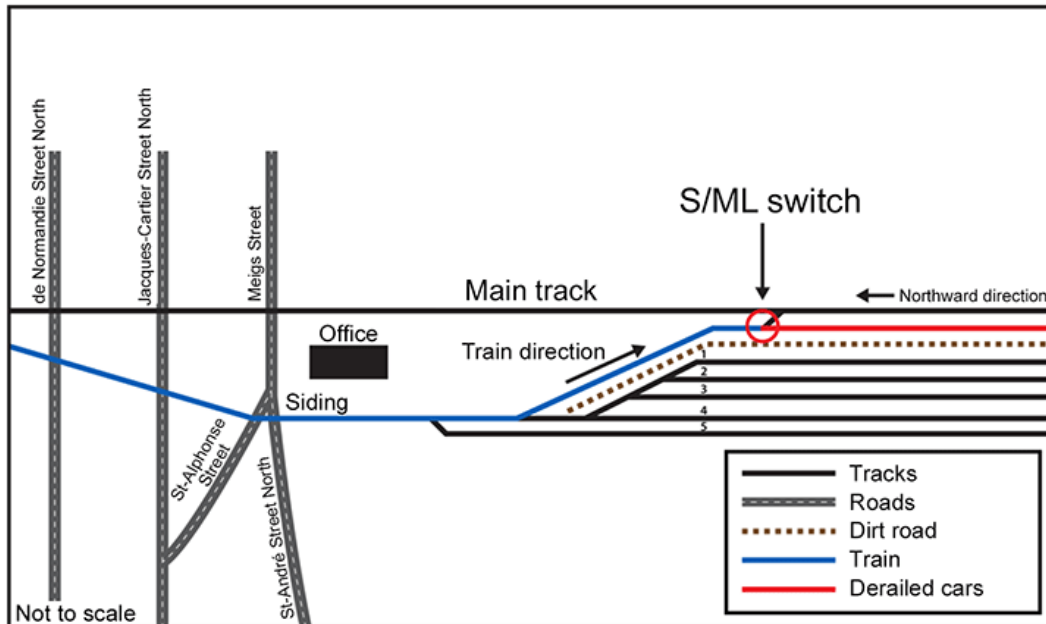
Figure 2. Farnham Yard schematic

Farnham Yard is located in the centre of the town of Farnham. The Farnham Yard siding is located on the west side of the Adirondack Subdivision main track. A gravel road between the siding and the first yard track (track number 1) makes it possible to drive from one end of the yard to the other. Opposite the north end of track 1 is a hand-operated crossover<sup>2</sup> linking the siding to the main track. A train travelling southward on the siding makes a “facing point” movement<sup>3</sup> (Figure 2).

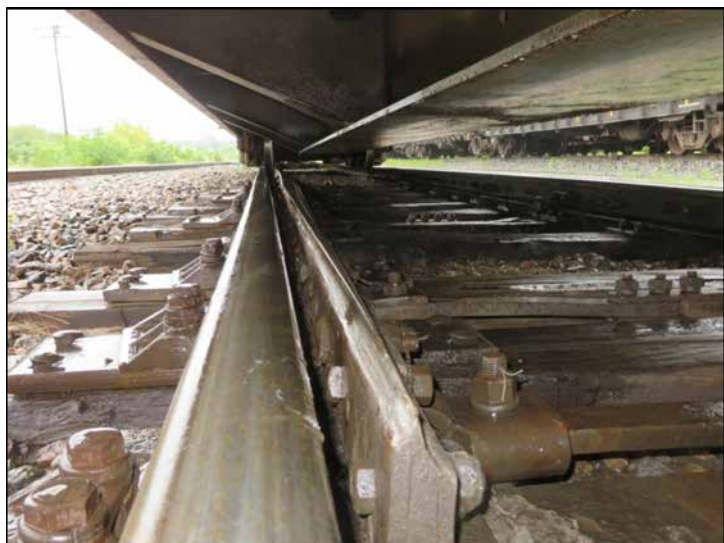
The left switch point (east) of the S/ML turnout was about 2 inches from its stock rail (Photo 2). That switch point did not show any sign of impact or wear or any abnormal markings. The right switch point (west) of the turnout was 3 inches from its stock rail. It was chipped over a length of about 14 inches. Between the bent stock rail and the siding's rail, there were impact marks on the switch stop lugs, frog, tie plates, spikes and several ties. No switch rods were damaged.

Photo 2. Left switch point (east)

1. The train derailed while it passed on the siding crossover switch, which was out of adjustment.
2. The flange of the R3 wheel of car WCTR 866845 became lodged between the left switch point and the bent stock rail, causing the derailment of that car and the next 14 cars.
3. The misalignment of the switch points was caused by the pickup truck's impact with the switch stand.

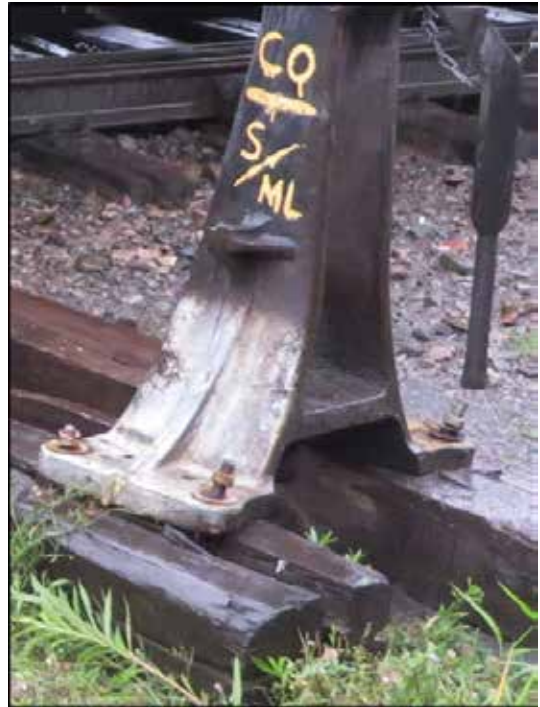
The S/ML turnout was locked in normal position. One of the long ties under the switch stand was split. Three of the four bolts securing the switch stand to the long ties were bent southward (Photo 3), and the switch stand was loose. The ballast surrounding these ties was displaced southward.

Photo 3. Switch stand S/ML

An opening between the switch point and its stock rail indicates that the switch is either damaged or improperly adjusted. The fact that the switch points and the rods were not damaged excludes the possibility that the switch was run through by rolling stock. The long ties supporting the switch stand of the S/ML turnout were displaced southward, and the bolts used to secure the switch stand to the ties were bent in the same direction. In addition, there were rub marks on the north side of the switch stand. That damage indicates an impact of sufficient force to misalign the switch points and create an opening between the left switch point and the bent stock rail occurred. Since the damage to the bumper of the pickup truck was consistent with that observed on the switch stand, the misalignment of the switch points was caused by the pickup truck's impact.

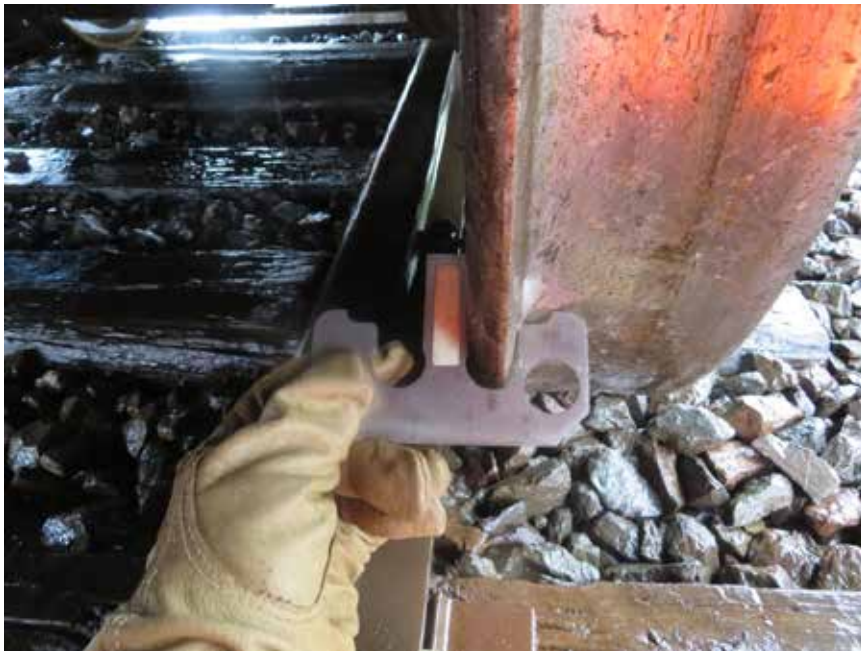
Grooves were visible on the ties from the S/ML turnout to car WCTR 866845. Examination of the car wheels revealed that the R3 wheel flange exhibited wear that was near the 2014 *Field Manual of the AAR Interchange Rules* allowable limits ( $1\frac{5}{16}$  inch) (Photo 4).

Photo 4. Wheel R3 of car WCTR 866845

Since the constant contact side bearings (CCSB) and friction wedges of the trailing truck of car WCTR 866845 were worn beyond the allowable limits, the car's ability to negotiate curves was compromised. After exiting the curve immediately preceding the turnout, the trailing truck was no longer symmetric, forcing the flange of the lead wheel (R3 wheel) against the inside of the east rail. As a result, the flange of the R3 wheel became lodged between the left switch point and the bent stock rail, increasing the gap between the switch point and the bent stock rail, causing the derailment of that car and the next 14 cars.

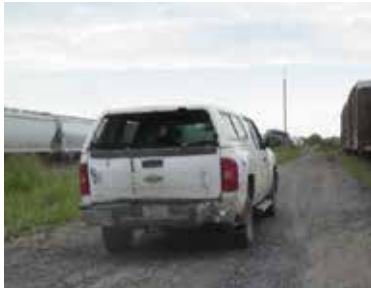
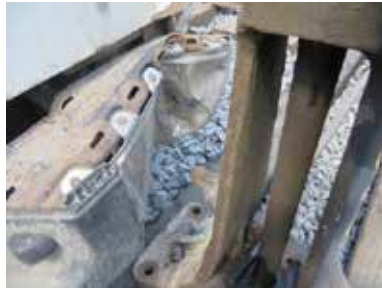
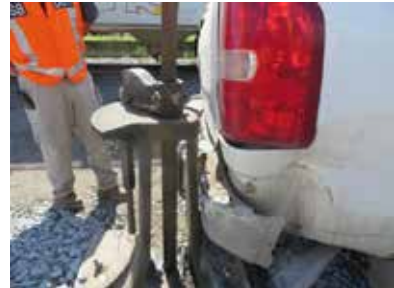
Following the derailment, an examination of the pickup truck revealed damage to the rear bumper. That damage was not present when the inspector began his shift.

During a re-enactment, the damage to the bumper of the pickup truck was compared to the switch stand of the S/ML turnout. The shape of the damage to the bumper was consistent with the shape of the switch stand (photos 5, 6, and 7).

**Photo 5. Pickup truck used during train inspection**

**Photo 6. Damage to the pickup truck's bumper**

**Photo 7. Pickup truck backed up to the switch S/ML**
