RAILWAY INVESTIGATION REPORT

R16W0059

Uncontrolled movement of railway equipment

Cando Rail Services

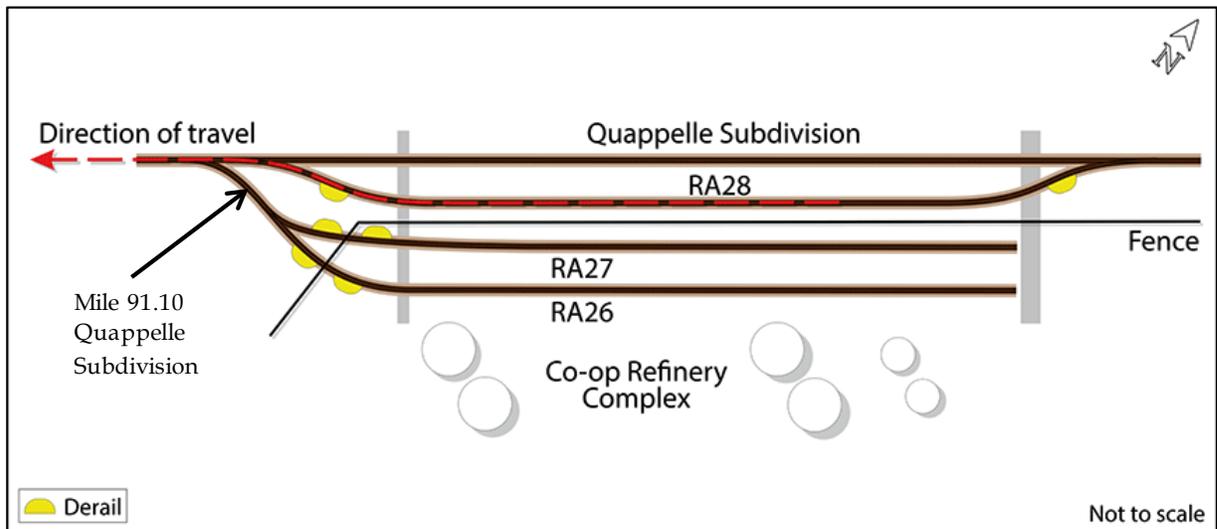
Figure 2. Track arrangement and equipment position at the Co-op Refinery Complex

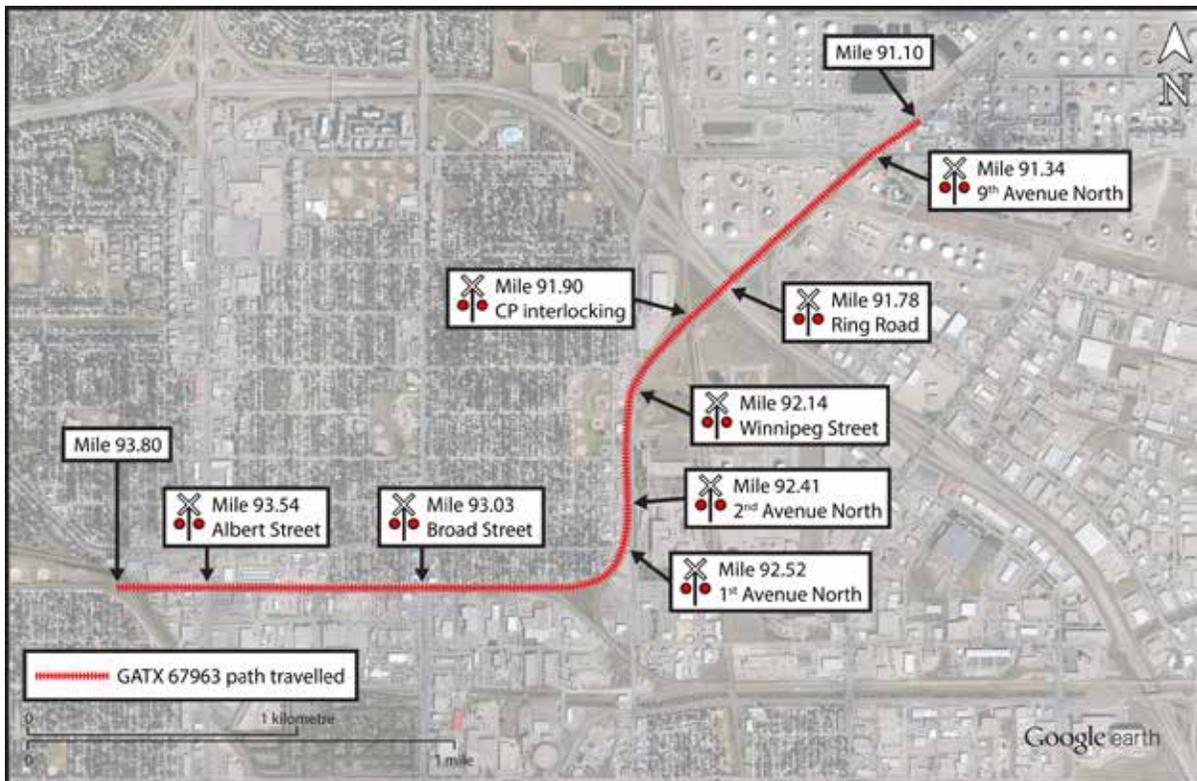
A short time later, conductor 2 located car GATX 67963, which had come to a stop at approximately 0007, after travelling up an ascending grade near Quappelle Junction (Mile 93.80). The car had rolled uncontrolled for approximately 2.7 miles and had traversed 7 public roadway crossings and a railway interlocking (Figure 3).

Figure 3. Map of uncontrolled tank car route (Source: Google Earth, with TSB annotations)

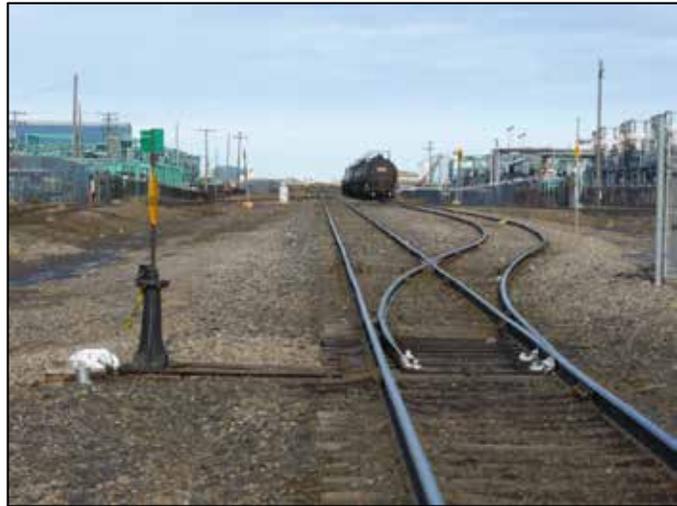
loading on track RA26, with room for 1 car of cetane improver.⁶ Four other cars are spotted on track RA27 for slurry loading. Loaded cars pulled from tracks RA26 and RA27 (located within a fenced compound) are switched for destination using the subdivision track and non-main track RA28 (Photo 1).

Photo 1. Subdivision track on left; track RA28 on right with loaded tank cars
