AVIATION OCCURRENCE REPORT

LOSS OF OFF-WING SLIDE IN FLIGHT

**AIR CANADA
BOEING 767-233 C-GAUH
VANCOUVER, BRITISH COLUMBIA
06 APRIL 1995**

REPORT NUMBER A95P0073

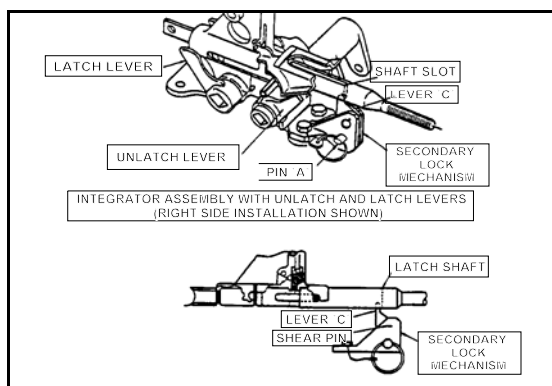
Figure 2 - Integrator Assembly
(adapted from 767 MEL MANUAL, Section 52-71-01 "Door Indication System")

The integrator was originally designed and manufactured without a secondary lock. After many incidents in the early 1980s of the off-wing slide compartment door opening in flight, the integrator was re-designed. A secondary lock mechanism was included on new integrators to prevent vibrations from causing the latch shaft to migrate to the unlatched position. Existing integrators were also modified to incorporate this feature. A key characteristic of the secondary lock is the shear pin which holds the secondary lock lever in place during normal operation, but easily shears to allow the actuator to release the door latches. The shear

pin is designed to shear at a pre-determined force, and thus allow the opening of the door latches, and in turn, the door. The design of the off-wing slide system is such that the actuator cannot be fired without shearing the secondary lock shear pin.

Inspection of the aircraft after it had landed in Vancouver revealed that the slide inflation trigger was disconnected and the high pressure inflation cylinder was full; the door opening actuators and the latch opening actuator had not fired and the latch pins were in good condition; the sensors and the door warning system functioned normally; and the integrator was found unlatched but in good condition, except for the secondary lock shear pin which had sheared in three pieces but remained in place. A visual inspection of the secondary lock would not reveal that the pin was sheared.

Although the pin was sheared into three pieces, the pieces stayed in place in the secondary lock. Thus, it was not readily apparent upon visual inspection that the pin was sheared. Instead of acquiring a new shear pin from the stores department, or from the left off-wing slide integrator, the technician conducted an external visual inspection of the shear pin, and concluded that it did not need to be replaced.

The sheared shear pin allowed the secondary lock latch lever to rotate out of position and the latch shaft to migrate out of position towards the unlatched position, likely due to vibration. At the first movement, the proximity switches that monitor the system triggered the warning lights and the EICAS message during de-icing of the aircraft prior to departure. The warnings temporarily disappeared when the ramp technician handled the system during inspection, but the primary cause was not resolved.

- to confirm the integrity of the secondary lock shear pin, the MEL was revised to require turning one end of the pin while observing the other end; also, a once-around check is underway to ensure that five spare shear pins are stowed at the integrator on each side of the aircraft;
- "A" Check Job Tickets were changed so that the off-wing door is no longer deactivated during an "A" Check and a warning sign is placed over the interior of the door to reduce the possibility of inadvertent over-wing slide deployment; and
- maintenance procedures for the door indication system were revised, and two projects are in the approval process (Service Bulletin (SB) 25A0131 to replace the integrator, and SB 25-0212 to improve the off-wing slide arm/disarm mechanism).

Boeing has released Service Bulletins 767-25-0051, 767-25A0104, and 767-25-0185 to provide more direct verification of slide door latching, and to improve the integrator locking and latching mechanism.

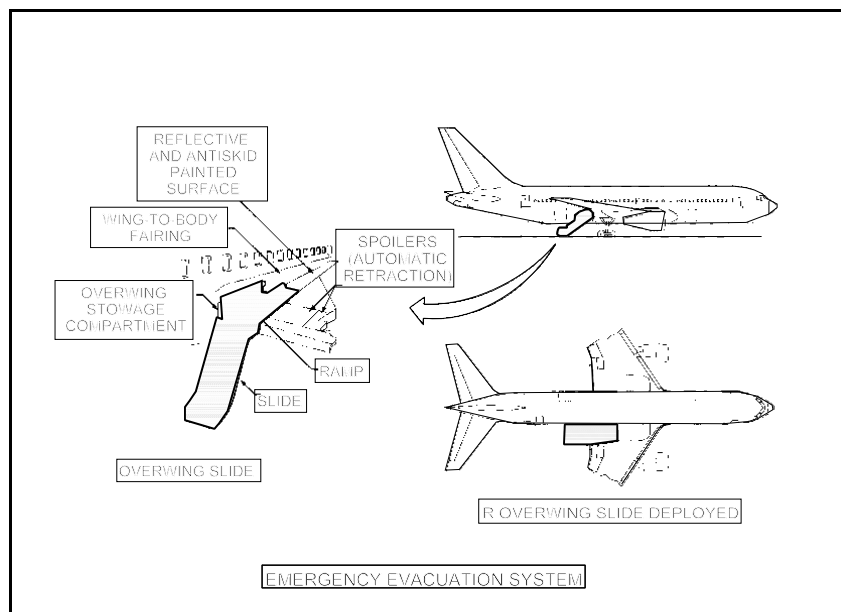
Figure 1 - Right Off-wing Slide
(The Boeing Commercial Airplane Group, "767 Systems", p. 16-16)

The Boeing 767 incorporates an inflatable slide at the inboard rear of each wing to allow the evacuation of passengers who use the over-wing exits during an emergency. Slide deployment is initiated by opening the exit hatch from the inside. The hatch opening motion actuates electrical switches that simultaneously (1) operate a relay to ground out any position command going to the main hydraulic spoiler power controller actuator, and (2) fire the spoiler override actuator which rotates the inboard spoiler to the down position. After a two-second time delay (from the spoiler actuator firing), the latch opening actuator is fired. The latch opening actuator opens the escape slide compartment door latches and fires the door opening actuators located in the escape slide compartment. The slide compartment door, with the escape slide packboard assembly attached, is rotated outboard by the actuators. When the door opens, a mechanical link to a high pressure inflation cylinder triggers the release of gas that inflates the slide. Proximity sensors monitor the position of the door latches, and are used to trigger warning lights and EICAS messages on the flight deck.
